# **NTSB Battery Nail Penetration Tests**

## ***Final Report for 787 Battery (Asset 445) Tested at 15°C, Grounded***

J. Thomas Chapin, PhD  
Pravinray D. Gandhi, PhD, PE  
Paul W. Brazis, Jr., PhD  
May 29, 2014

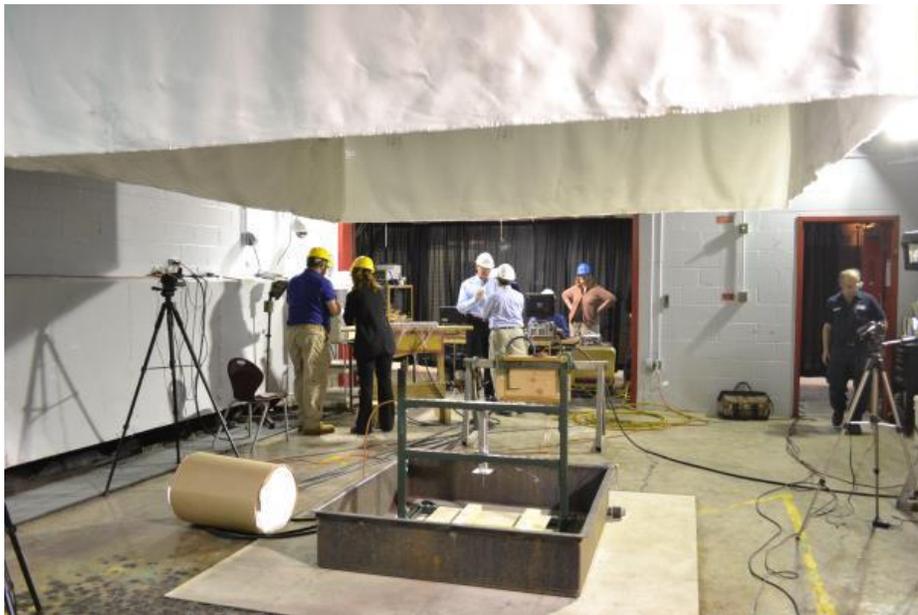
The tests were conducted in UL's Cell A test facility. The test cell is a 35 x 35 x 40 ft. high test room equipped with a 14 x 14 ft. collection hood to collect fire effluents (smoke, and gases). The collection hood is connected to UL's smoke abatement system through a 24 in. exhaust duct. Incorporated in the exhaust duct, is an instrumented section for measurement of smoke density and gases from a fire. The smoke density is measured using a photometric system consisting of a white light source and a photo detector to measure the opacity of the smoke. Heat release rate is calculated using an oxygen consumption technique<sup>2</sup>. To enable this, duct velocity is monitored using a bi-directional probe, and the exhaust gases are monitored using a paramagnetic oxygen analyzer. The heat release rate system in Cell A has a capacity to measure a maximum 2 MW fire size. A photograph of the Cell A is shown in Figure 1.

Figure 1. Cell A

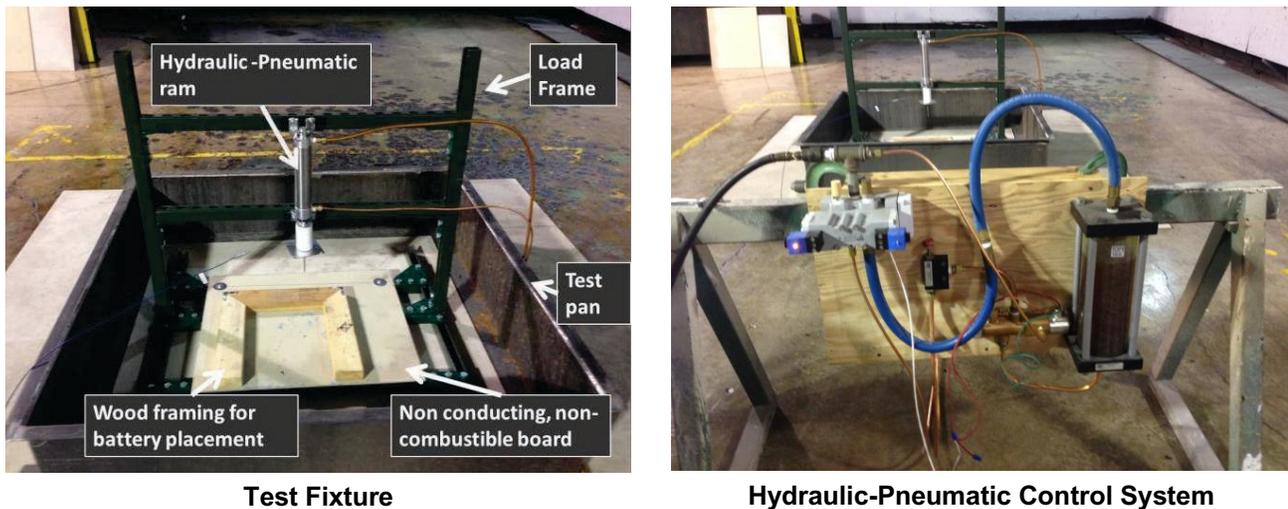
A nail penetration test fixture was developed to enable controlled nail penetration of the test batteries. The set-up included a load frame with a fixture that contained a nail penetration ram. The ram was designed such that its downward direction was controlled using hydraulic fluid pressurized by compressed air; and upward direction was controlled by compressed air. A photograph of the nail penetration test set-up is shown in Figure 2.

Figure 2. Nail Penetration Test Set-Up

A non-conducting and non-combustible board was placed at the bottom of the load frame, and a wood frame screwed into the board to allow precision placement of the test battery with respect to the nail.

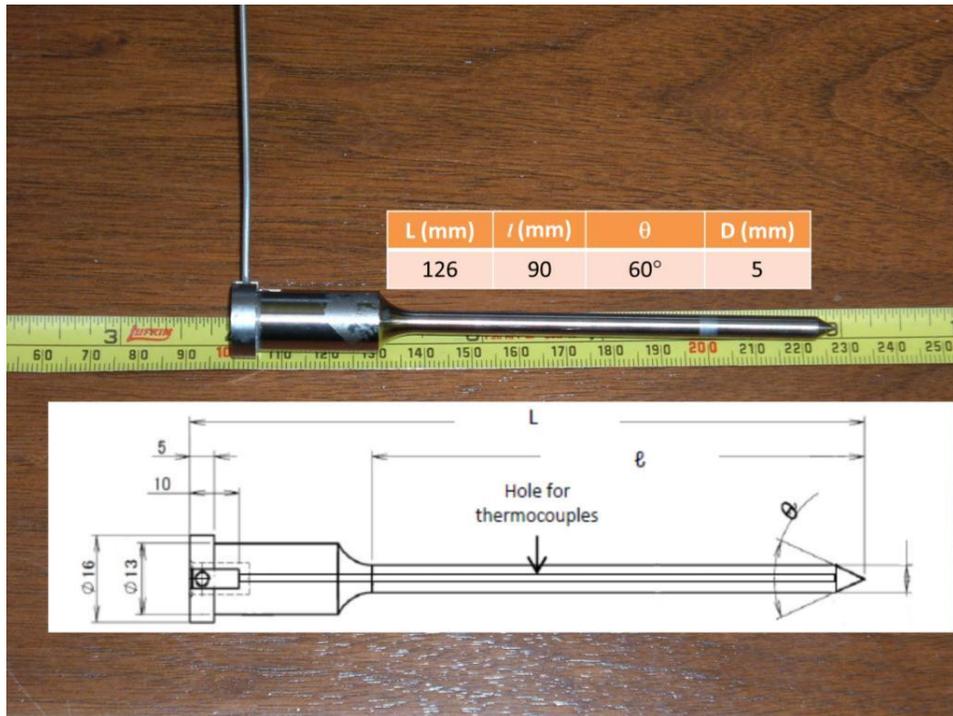
A specially designed nail<sup>3</sup> was used in the test. The nail is 126 mm long, with a diameter of 5 mm, and nail angle of 60°. A unique feature of the nail is an embedded thermocouple that provides temperature of the cell as it penetrates the battery. An annotated photograph of the nail is presented in Figure 3.

Figure 3. Test Nail

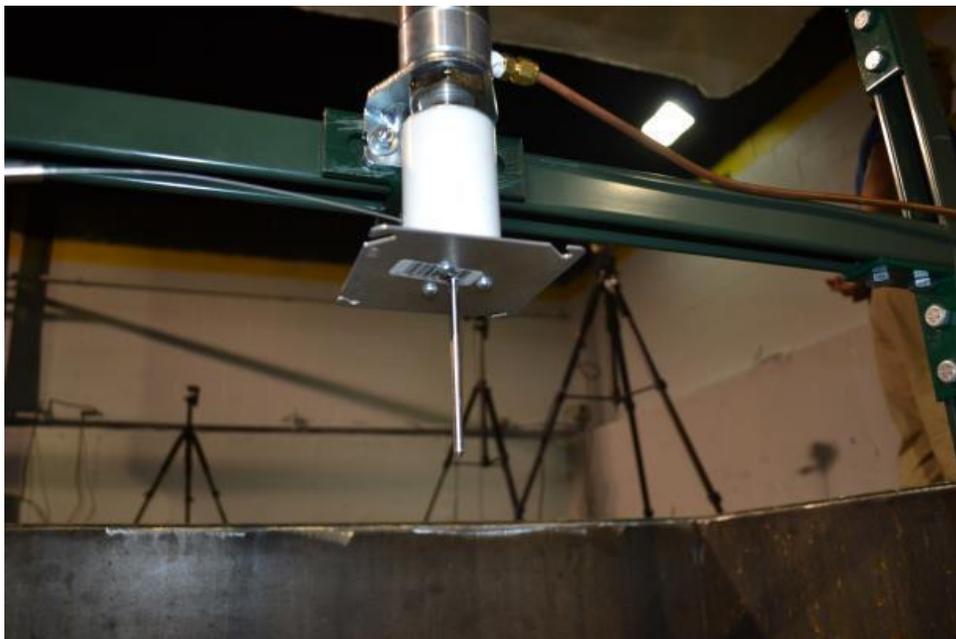
A close-up of the nail in the load frame is shown in Figure 4.

Figure 4. Test Nail in Load-frame

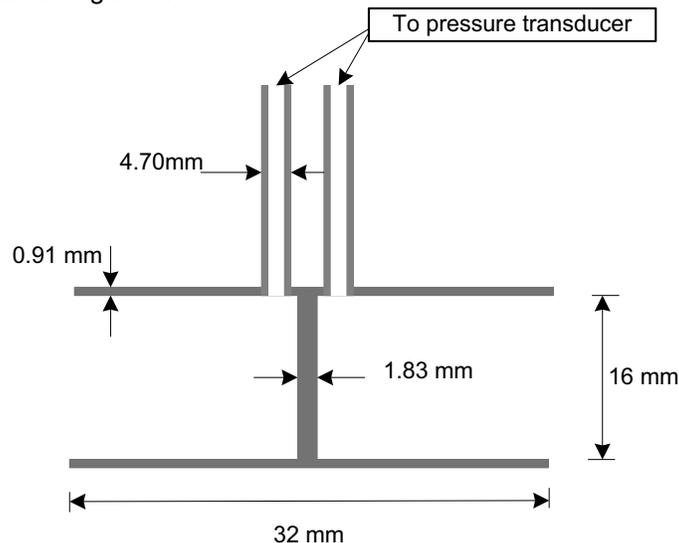
The velocity is measured using a bi-directional probe and a thermocouple. A schematic of the bi-directional probe is shown in Figure 5.

**Figure 5. Bi-directional Probe**

The bi-directional probe was connected a pressure transducer (MKS, Model: 220B) with a range of 0 – 10 mm Hg. The thermocouple used was 0.125 mm Inconel sheathed, Type K thermocouple.

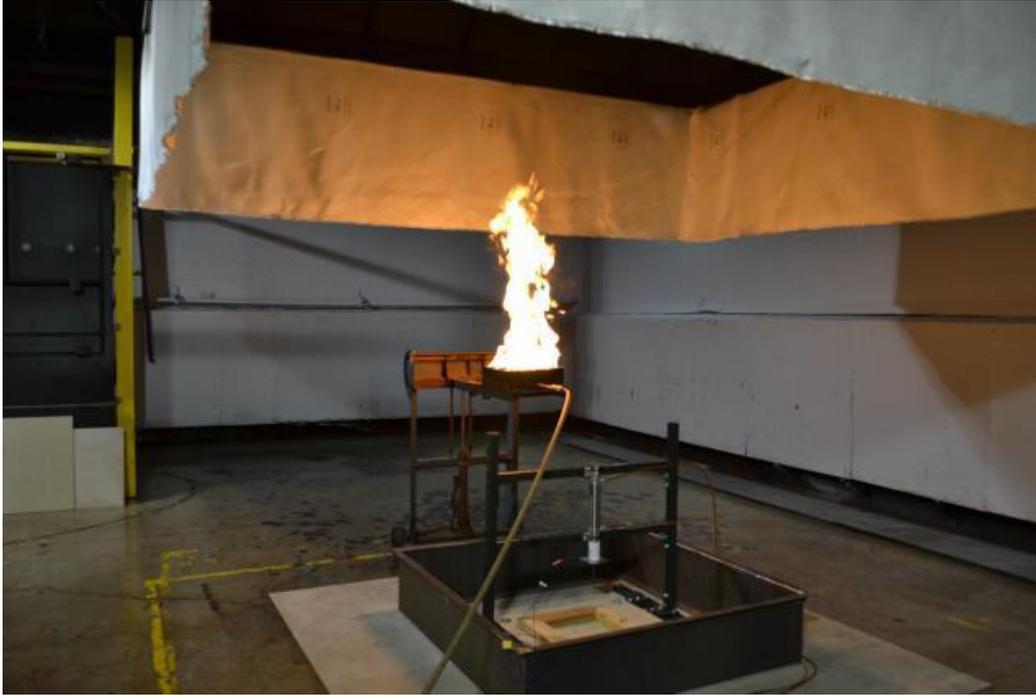
The heat release rate system was calibrated using propane gas sand burner with known fire sizes of 75, and 200 kW; and a calibration factor was calculated. This range of the calibration fire sizes were selected based upon anticipated fire size during the test. The calibration for heat release rate is depicted in Figure 7. A calibration factor of 0.92 was applied to the calculation of heat release rate data during the test.

A photograph of the set-up used for heat release rate calibration is presented in Figure 6.

Figure 6 – Heat Release Rate Calibration Set-Up

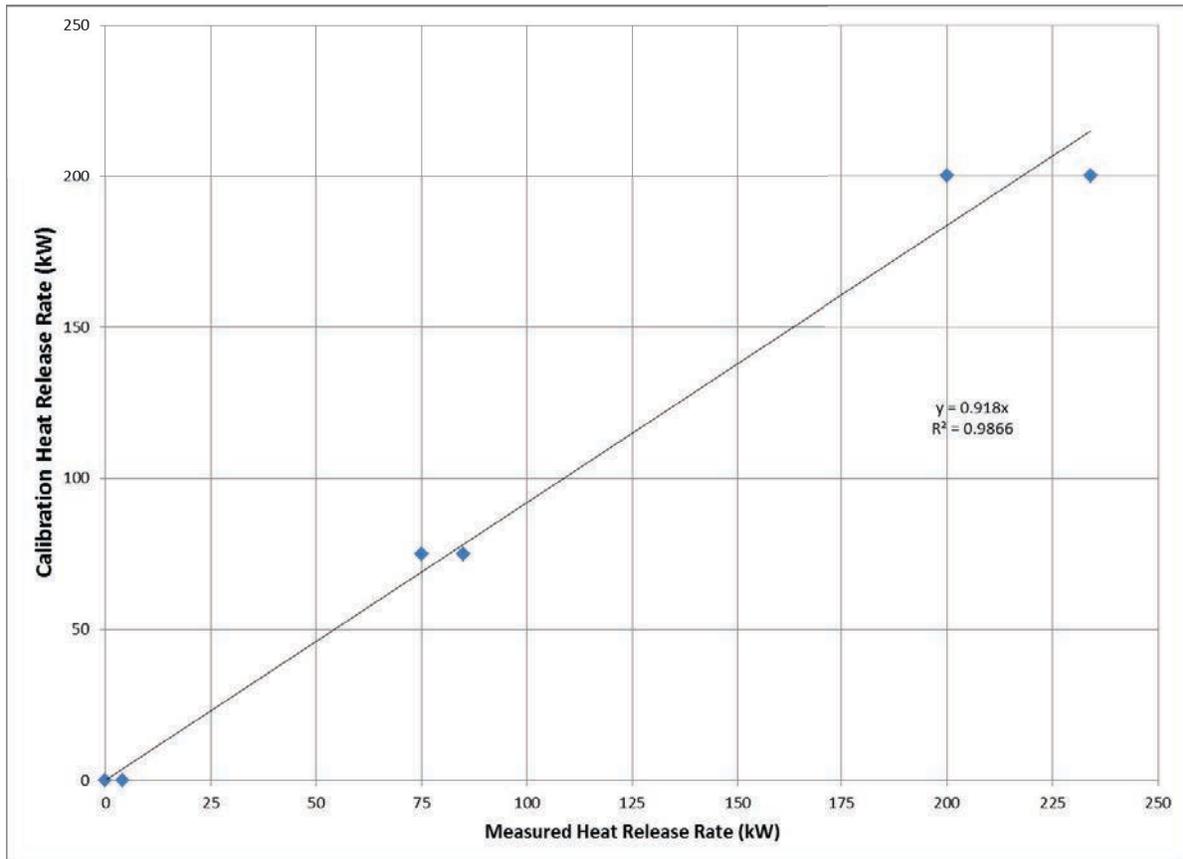
Figure 7. Heat release rate calibration

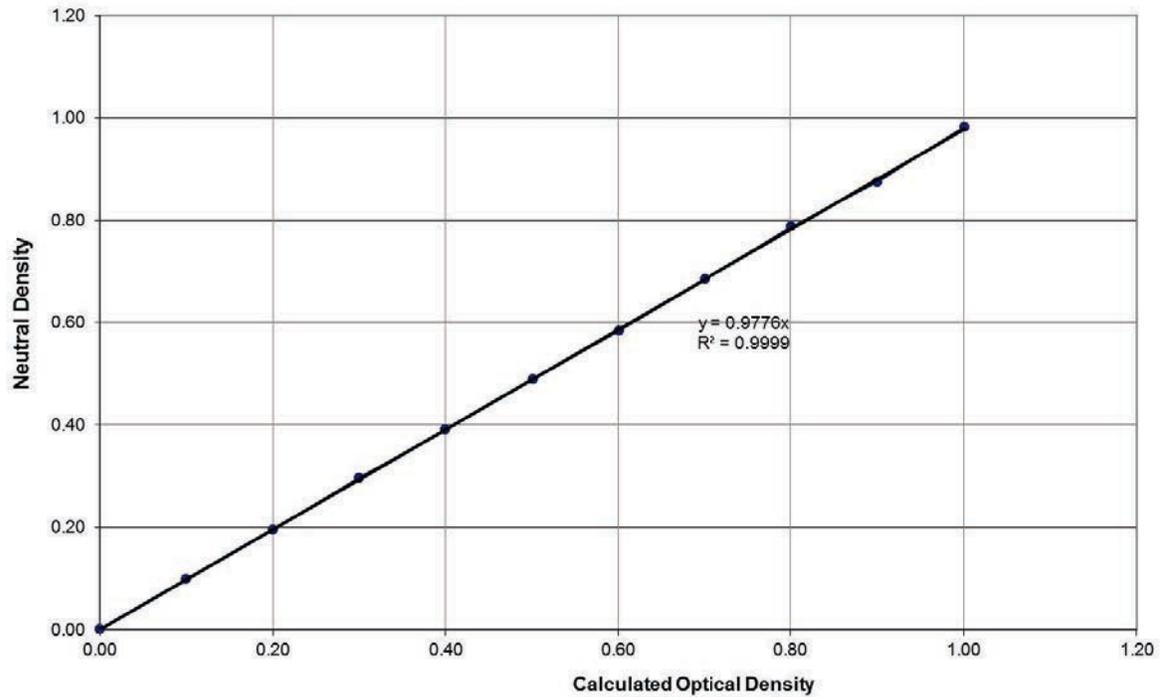
The smoke measurement system was calibrated using neutral density filters. The calibration for the smoke measurement system is shown in Figure 8. A correction factor of 0.98 was applied to the calculated optical density data from the test.

A calibration constant was then developed by correlating the calculated optical density with the neutral density filters as shown in Figure 8.

Figure 8. Smoke obscuration system calibration.

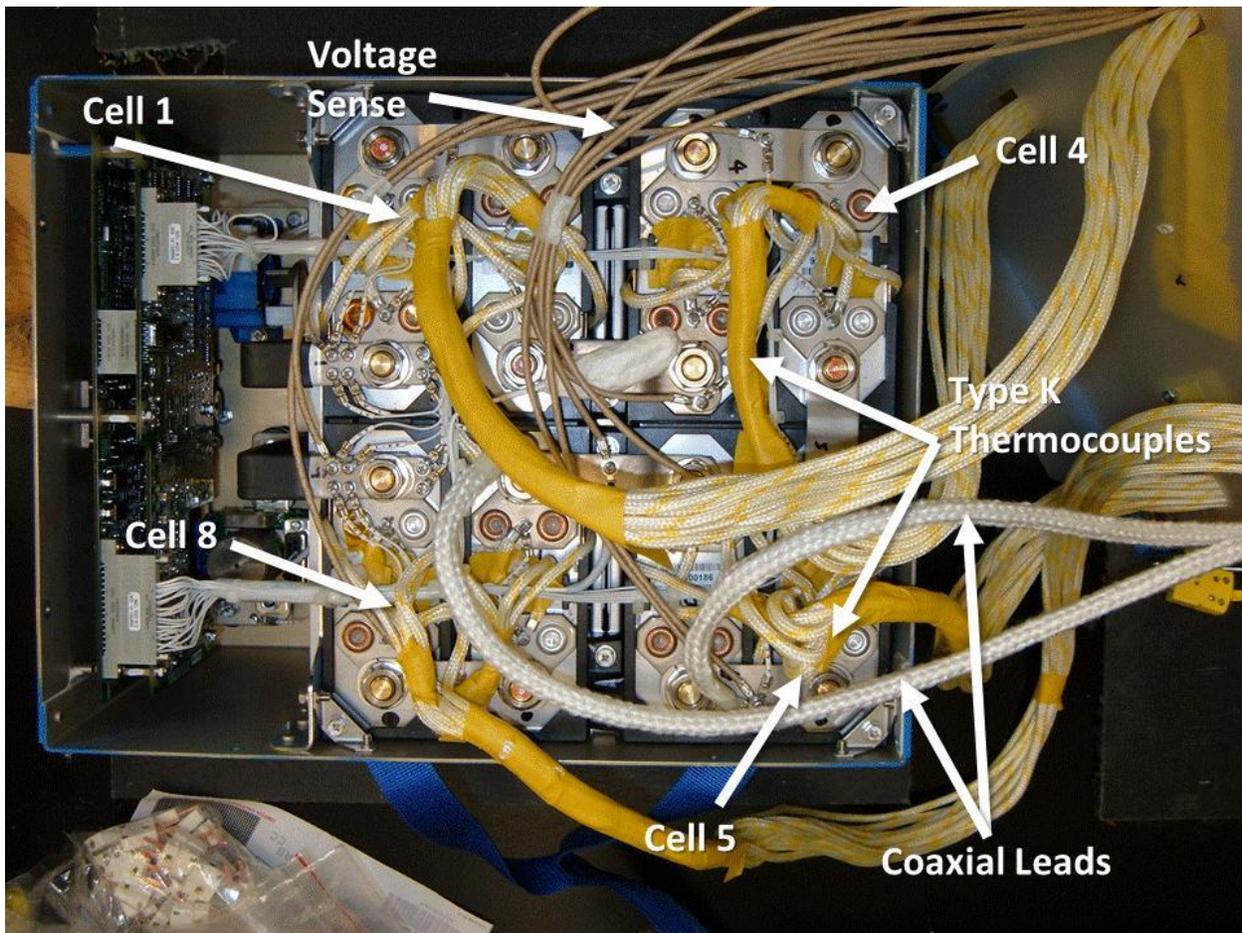
Voltage leads were attached at nine electrical nodes in order to monitor the voltage across each of the eight cells. Three additional voltage leads were added to monitor the voltage at the grounding connector on the battery box, the voltage on the case of Cell 6, and the voltage at the positive terminal on the main battery power connector. Ground and battery voltages were referenced to the negative terminal of the battery (connected to the negative terminal of Cell 1). These voltage leads were constructed using insulated oven wire, Type MG, nickel-plated copper, shielded with fiberglass insulation over mica tape. This cable is specified for operation at 840°F, selected to maximize operational lifetime for the test.

Figure 9. Photo of voltage and temperature sensing wiring for 15°C battery.

Voltage leads were made by crimping ring terminals to each of the voltage leads, and then attached using the existing screw terminals. The case connection to Cell 6 was made through compression of a bare voltage sense lead between the metal case of Cell 6 and the black plastic frame holding Cell 6 into the battery assembly. This interconnect was verified using a handheld multimeter and mechanically checked for integrity after installation.

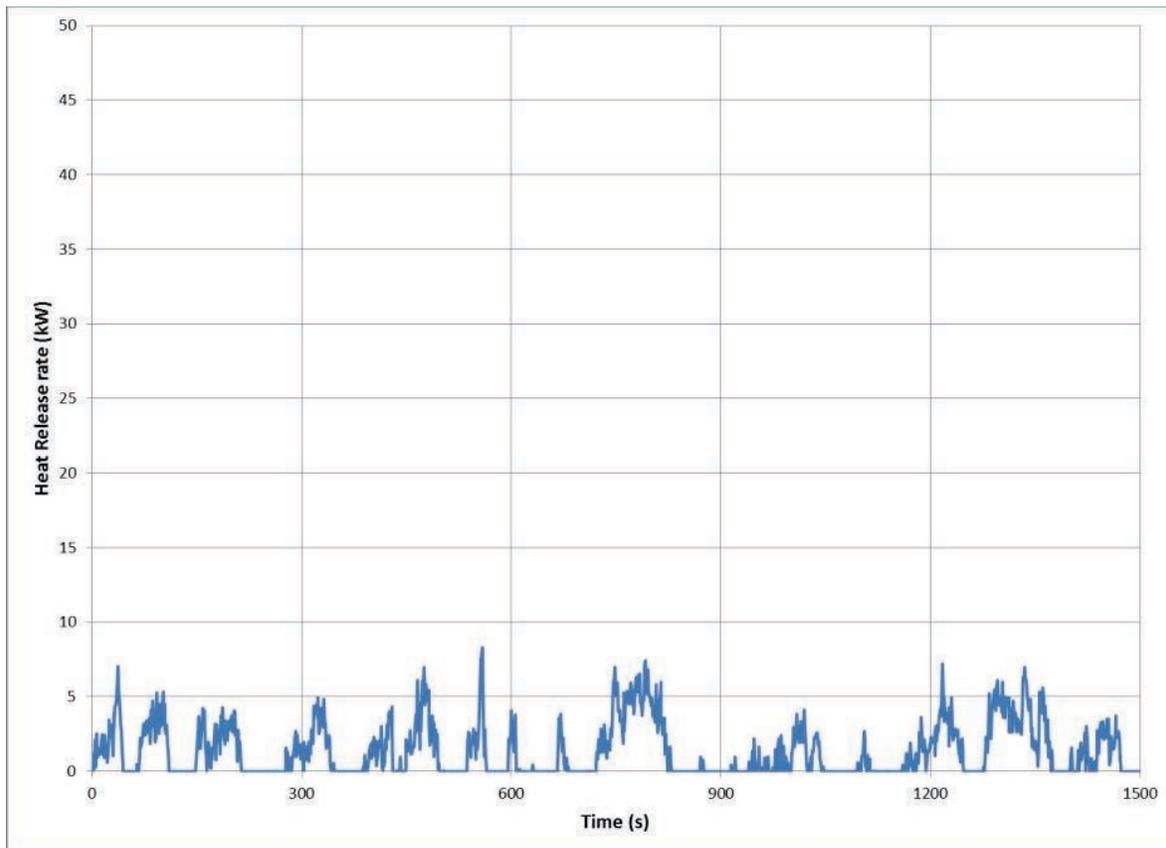
The heat release rate for the test is shown in Figure 10. There was one vent event in Test 2; and the calculated heat release rates were relatively small, and are below the resolution of the Cell A heat release calorimeter.

Figure 10. Heat release rate for the 15°C test.

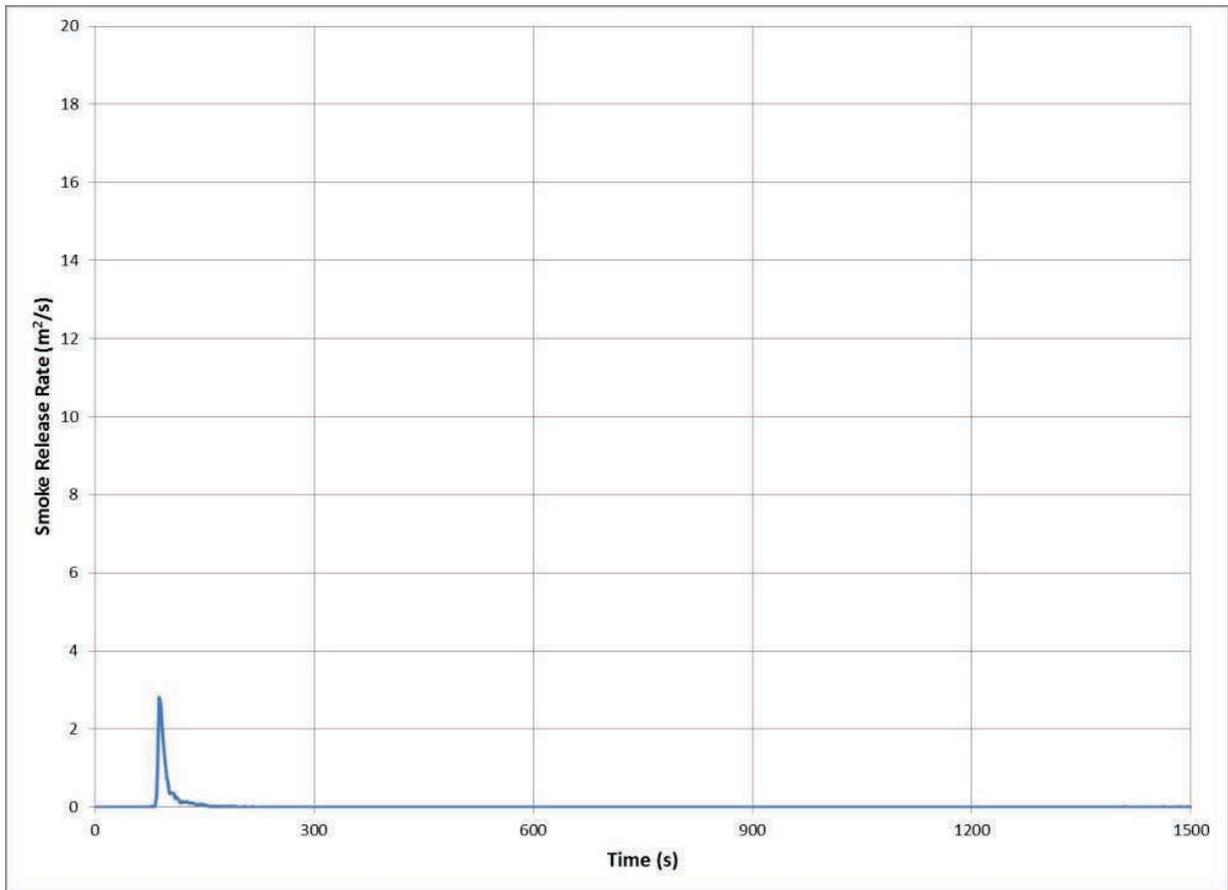
Smoke release rate is calculated using optical density and duct velocity data as shown in Eq. 5. The smoke release rate data are presented in Figure 11. The data shows distinct release of gases after the Cell 6 was shorted with nail penetration procedure. In this test, only Cell 6 vented.

Figure 11. Smoke release rate from the 15°C test.

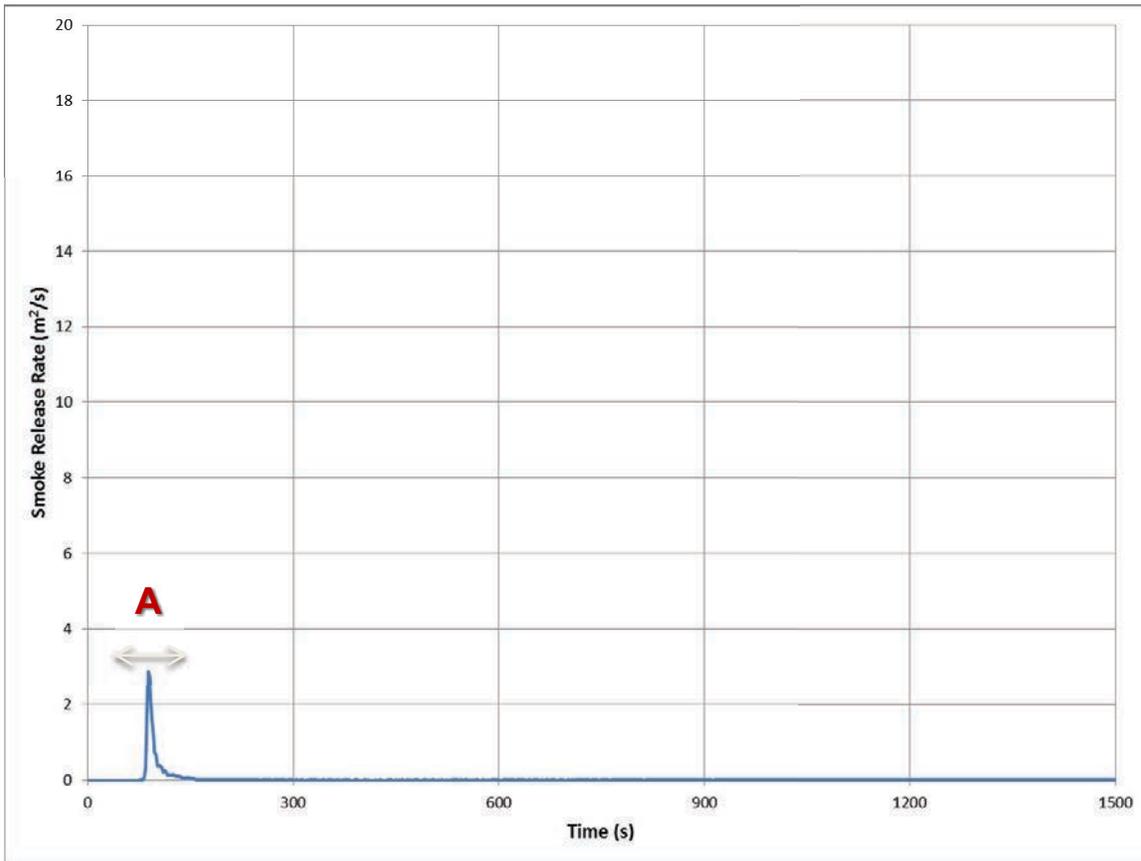
Gas effluent analysis is a specific method to define gas species by using FTIR technique. Aldrich vapor phase sample library, EPA vapor library, and UL in house library were used to identify the species in the effluent. The smoke release rate figure was tagged to enable linking the gases released to specific vent events as shown in Figure 12. There was only one vent event in this test.

Figure 12 – Vent Event Identified for Gas Analysis

The gas effluent analysis results correlated to the Smoke Release Rate data were shown in Table 1. In the venting period (Zone A), the species in the vented smoke include the solvents in electrolyte, small hydrocarbons, CO, CO<sub>2</sub>, and water.

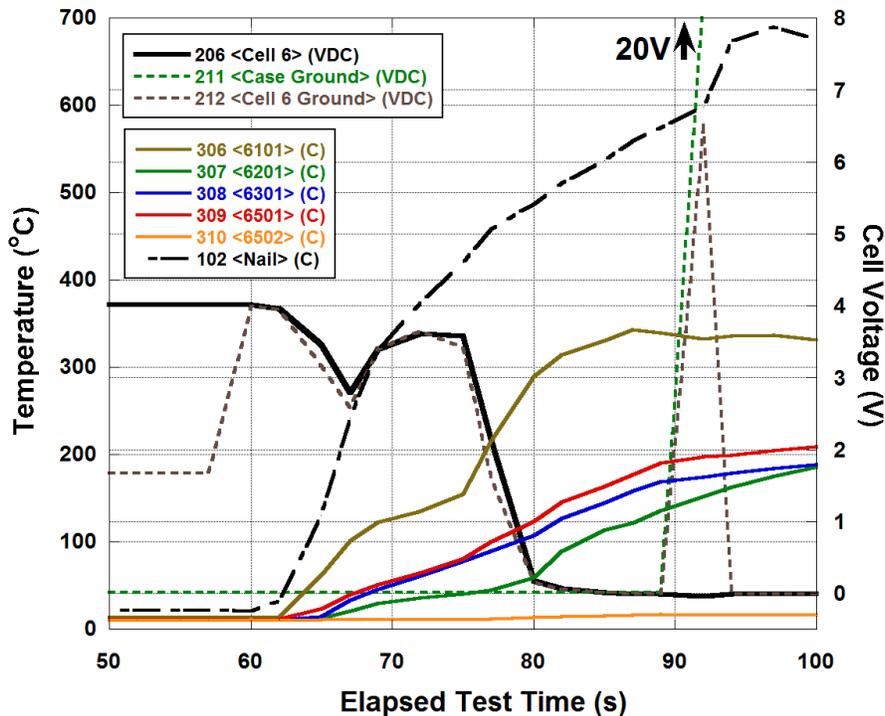
Nail penetration into Cell 6 occurred at between 57 and 60 seconds after the start of the test. This was characterized by shorting of the Cell 6 case to the cell positive terminal, likely through the conductive nail. Temperature rise within the battery began to occur no less than two seconds after the penetration event. This rise coincides with the first drop in cell voltage, likely due to the failure and internal shorting of one of the three sub-cells. This causes a rise in temperature observed at the faces. Once this internal short clears, cell voltage returns to 4V and the rate of heating decreases. Temperature rise resumes once the other cells fail and cell voltage drops towards zero.

As with the prior test, the nail temperature (and therefore the battery interior) was at a higher temperature than that at the faces of the battery. As is seen in Figure 13, Face 1 exhibited the most temperature rise, particularly in relation to Face 2 (where the venting hole was located). As can be seen in Figure 14, temperature rise at Faces 2 and 3 continues for 400-500 seconds after nail penetration, and then commences a cool down for the remainder of the test. While significant heating was observed on the positive terminal of Cell 6 (thermocouple 6501), far less heating was observed on the negative terminal (thermocouple 6502). The reason for this is not clear, though it is possible that the thermal path was far more established to the positive side of the battery and the cell case, reflected in the Cell 6 case voltage rising to 4V and following the positive terminal voltage. This suggests electrical, and therefore, thermal shorting between the positive terminal, the cell interior, and cell case.

moment of the short formation. This shorting event lasted less than 3 seconds and fused open the 12 AWG ground wire, reducing the ground current to zero. After opening of the ground wire, the battery case was biased at 20V (referenced to the negative terminal of the battery) for the remainder of the test. The heating profile of Face 1 (thermocouple 6101) suggests that this short to the case was formed at Face 1 of Cell 6, as the temperature at Face 1 dropped at the instant of the high-current event, and then returned to a rapid temperature rise after opening of the ground wire. This suggests thermal transfer from Face 1 to the case at the moment of the establishment of metal-metal contact. The rate of heating observed at the nail also increased after the formation of the short to the case, which would reflect internal cell heating due to the flow of high current from Cell 6. The voltage rise to 20V suggests that the short was between the negative terminal of Cell 6, connecting the total voltage potential of Cells 1 through 5 to the battery case (referenced to the negative terminal of the battery, which is connected to the negative terminal of Cell 1). The Cell 6 case voltage showed a momentary increase to 6.5V then a drop to zero. This suggests that a momentary resistive path occurred through the interior of Cell 6 connecting the (initially shorted) positive terminal and the case of Cell 6 through a resistive path to the ground fault and therefore raising the potential of the case of Cell 6 towards 8V (the voltage across Cells 7 and 8). Once the ground fault cleared, this circuit either became highly resistive or opened, breaking the electrical connection between the case of Cell 6 and the positive terminal of Cell 6 (and therefore electrical connection to Cells 7 and 8).

Figure 13. Voltage and temperature data for Cell 6 in the vicinity of the nail penetration event.

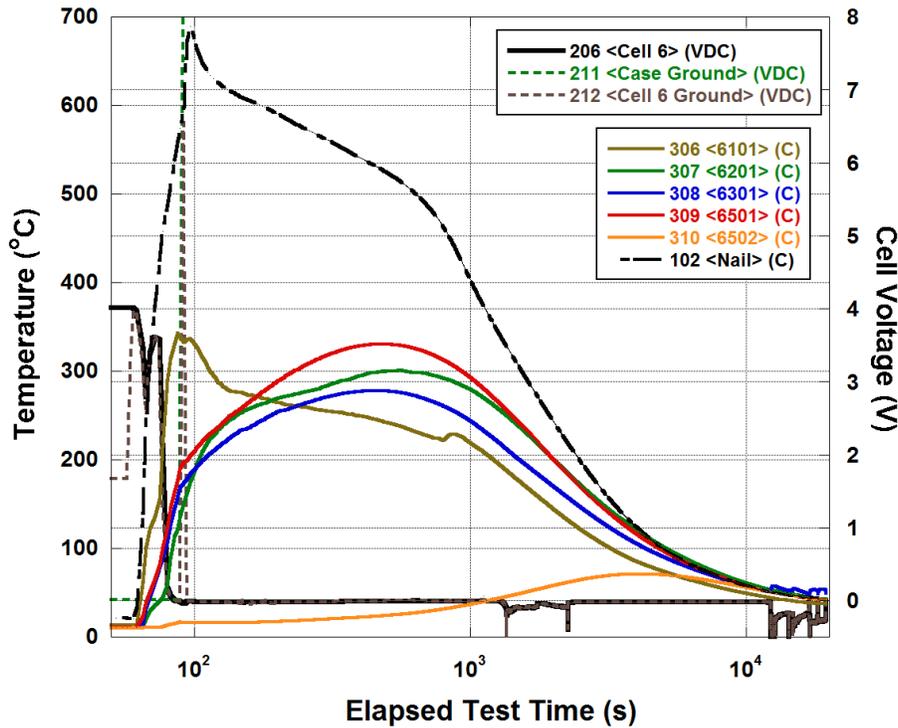
Figure 14. Voltage and temperature data for Cell 6, shown over the entire test duration.

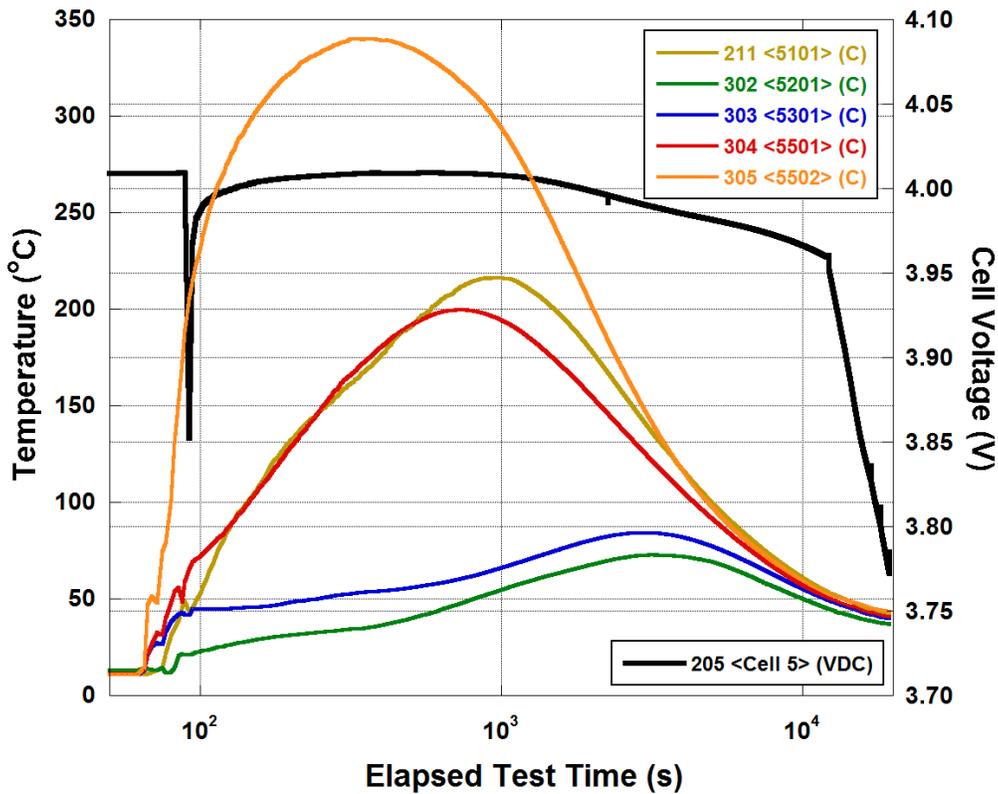
Cells 5 and 7 were the only other cells to be exposed to temperatures above 70°C after venting of Cell 6. The most significant temperature rise was observed on the busbar between Cells 5 and 6, particularly in comparison to the measured temperatures on the other busbars connected to Cells 5 and 7. Most notably, the busbar connected between Cells 6 and 7 remained far cooler (by nearly 150°C) than the one between Cells 5 and 6. Considering also that Cell 5, and not Cell 7, showed a significant voltage drop during the shorting event, it is concluded that the short was located at (and biased to) the negative terminal of Cell 6, likely through the case of Cell 6 to the battery case. This placed a low-resistance short across Cells 1-5 (since the negative terminal of Cell 1 is connected to system ground), causing high current drain until the 12 AWG ground wire blew open. Once the current path blew open, the battery frame remained shorted to the negative terminal of Cell 6, biasing the case at 20V (the voltage across Cells 1-5). This high current flow then resulted in additional heating on the busbars between Cells 1-5. The busbar between Cells 5 and 6 received additional thermal energy from the venting event of Cell 6, rising the temperature of this busbar higher than the others. Since voltage was observed across the entire battery at the end of the test, it appears that the positive terminal of Cell 6 remained in electrical contact

Thermal energy from the venting of Cell 6 was transferred to Cells 5 and 7 through their respective Faces 1 and 3, which were physically adjacent to Cell 6. Temperature rise was observed to roughly 1000 seconds, then reverting to cooling as thermal energy was transferred to Cells 1-4, as well as to the surrounding environment. The highest temperature on the faces of Cell 7 was observed on Cell 2, possibly due to exposure of hot escaping gases during the venting of Cell 6. This suggests that the gases escaped towards Cell 8 rather than towards Cell 5. However, since thermocouple 8201 (located on Face 2 of Cell 8) was not operating during the test, it is not possible to trace whether Cell 8 also received thermal energy from the flow of hot gases from Cell 6.

Figure 15. Voltage and temperature data for Cell 5 shown over the entire test duration.

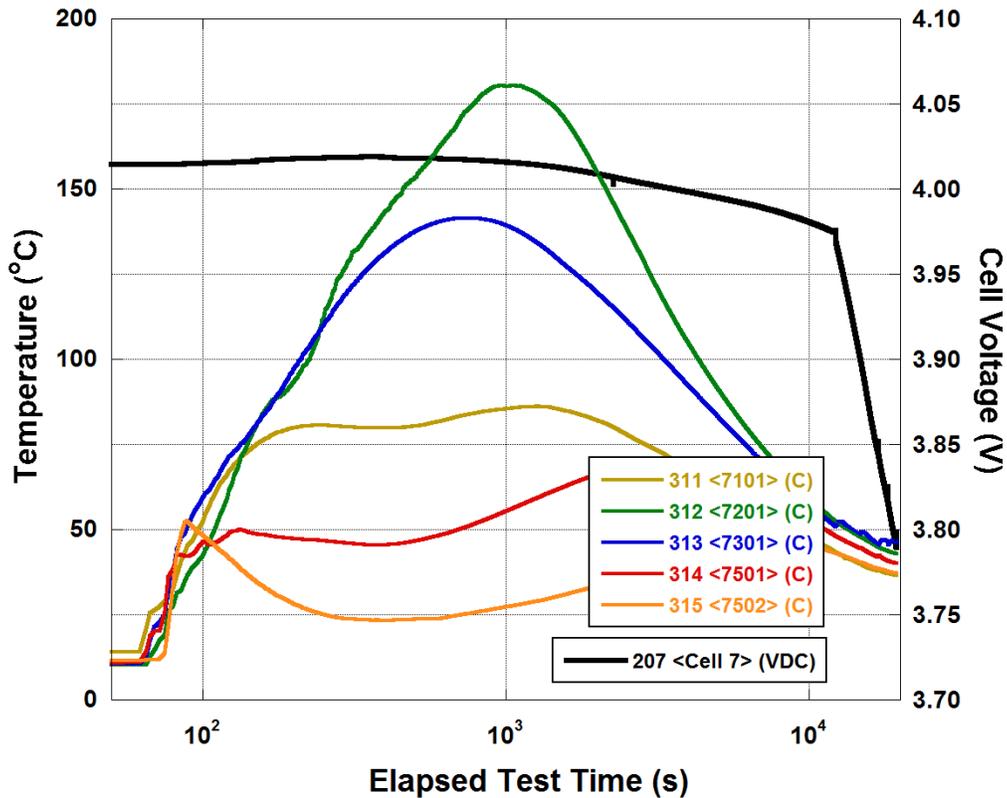
Figure 16. Voltage and temperature data for Cell 7 shown over the entire test duration.

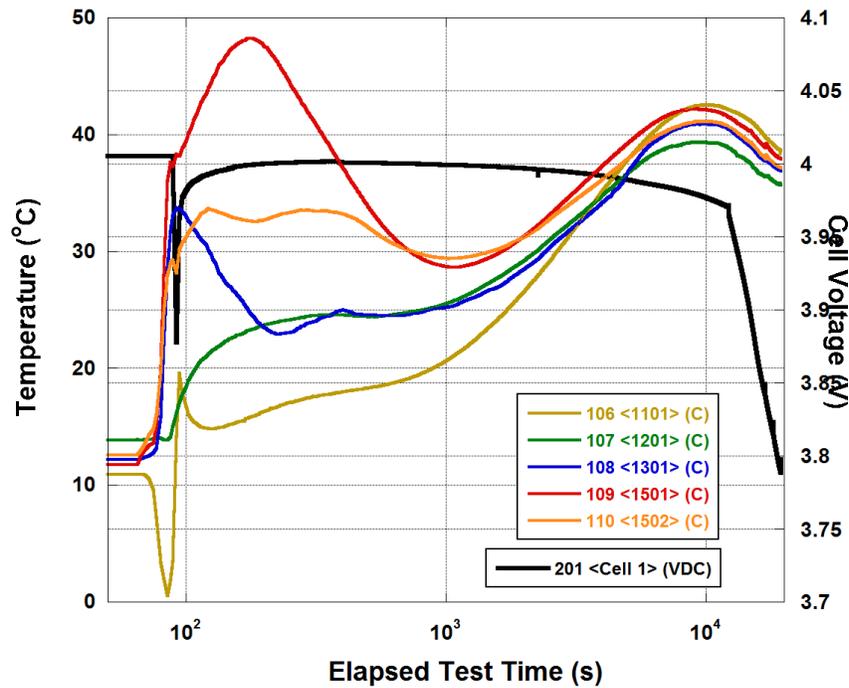
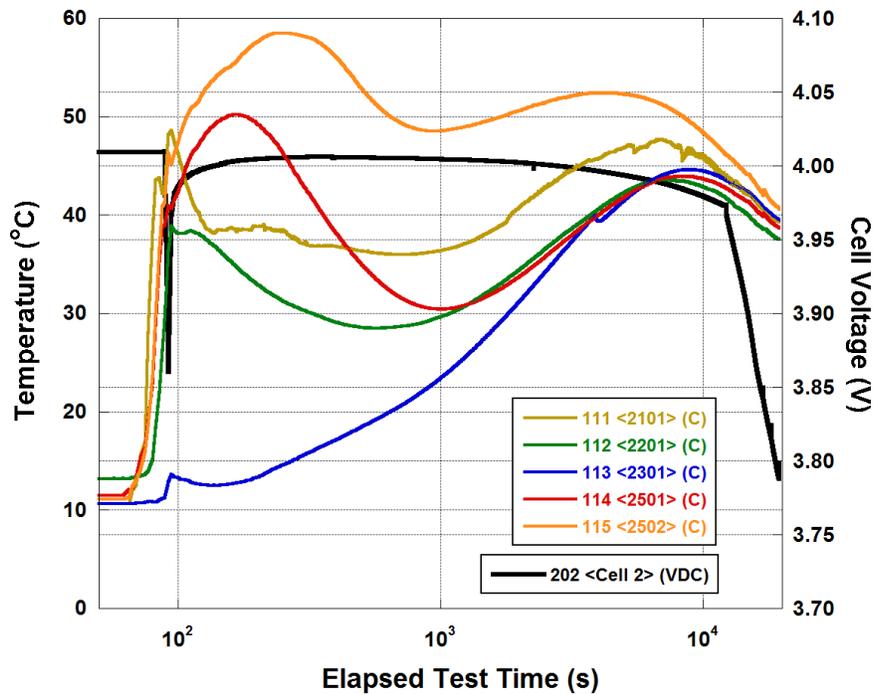
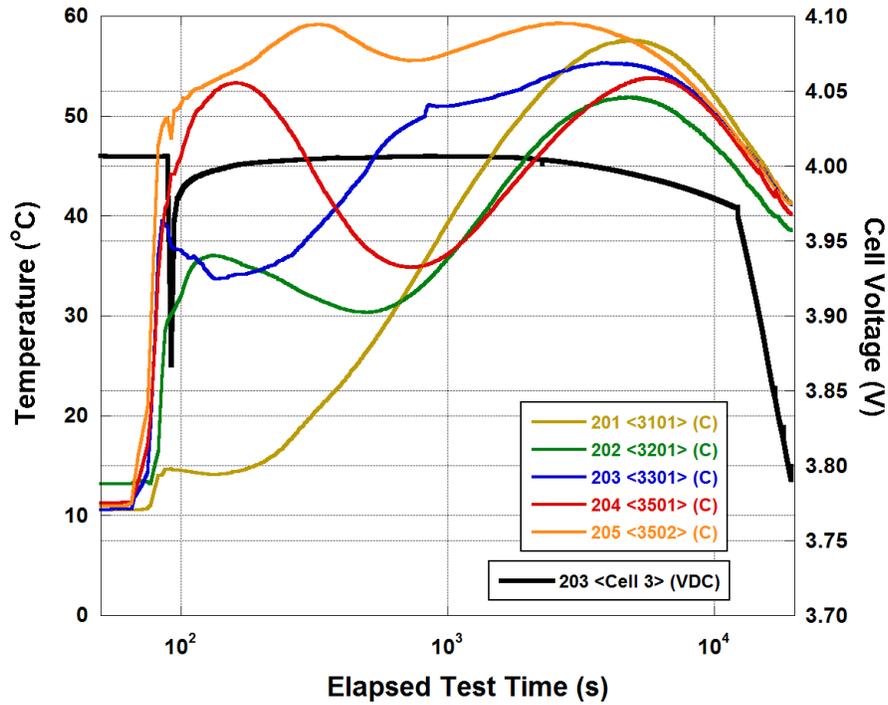
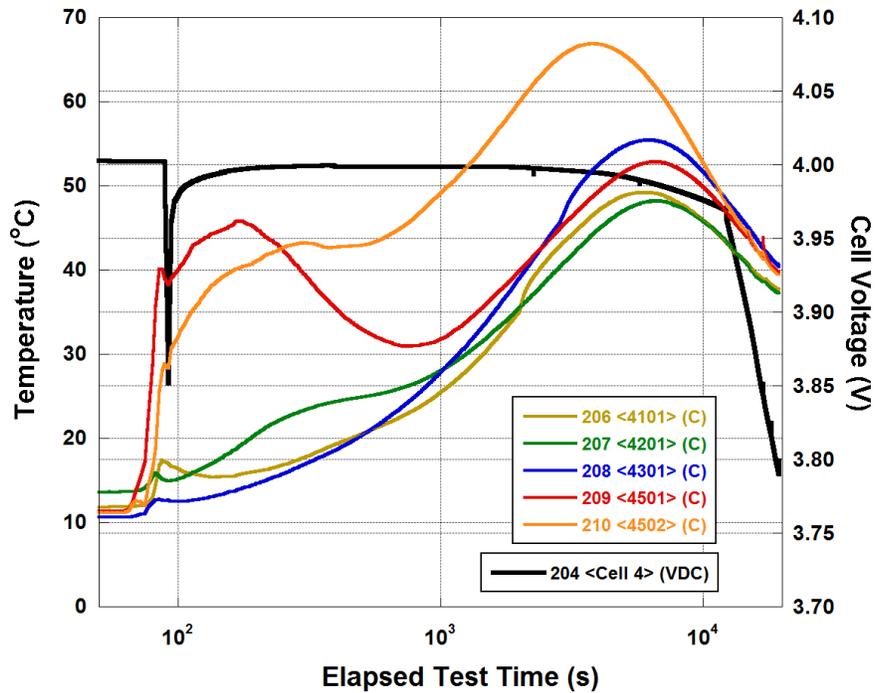
Cells 1 through 4 remained below 70°C throughout the entire test and did not vent. The most significant heating was observed during the shorting of Cell 6 case to the battery case, where the busbars of each cell increased in temperature. This was most likely due to Joule heating from the high current flow from the battery cells to the shorting event. This is followed by longer-term cooling, which reverses beyond 1000 seconds when excess heat from Cells 5-8 begins to transfer to Cells 1-4. The battery then begins to reach thermal equilibrium around 10000 seconds into the test and begins losing heat to the surrounding environment. No further events are observed in Cells 1-4.

Figure 17. Voltage and temperature data for Cell 1 shown over the entire test duration.

Figure 18. Voltage and temperature data for Cell 2, shown over the entire test duration.

Figure 19. Voltage and temperature data for Cell 3 shown over the entire test duration.

Figure 20. Voltage and temperature data for Cell 4 shown over the entire test duration.

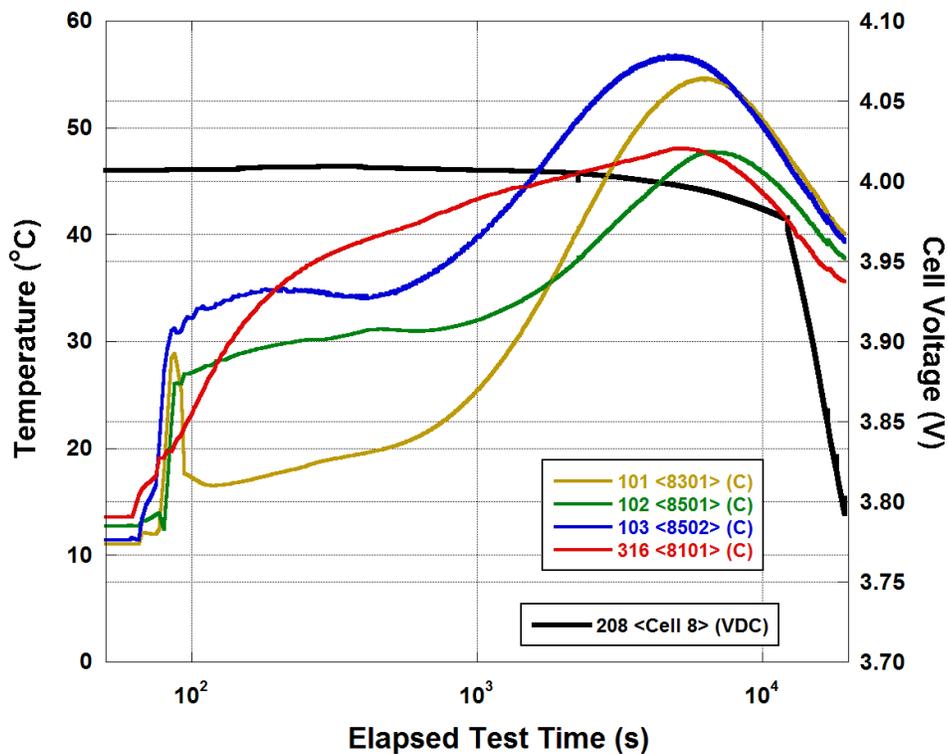
The thermal data for Cell 8 (Figure 21) was similar to that as Cells 1-4, except for the absence of the busbar heating during the shorting event. This further supports the conclusion that the short within Cell 6 was between the negative terminal of Cell 6 and the battery case and an open circuit at the positive terminal, which resulted in no change in potential external to Cells 7 and 8, and therefore insignificant current flow from those cells since no other load was placed on Cells 7 and 8 (the positive terminal of Cell 8 was floating during the test). Heating therefore was only after 400-500 seconds into the test when the entire battery moved towards thermal equilibrium. Throughout the entire test, Cell 8 remained below 60°C.

Figure 21. Voltage and temperature data for Cell 8 shown over the entire test duration.

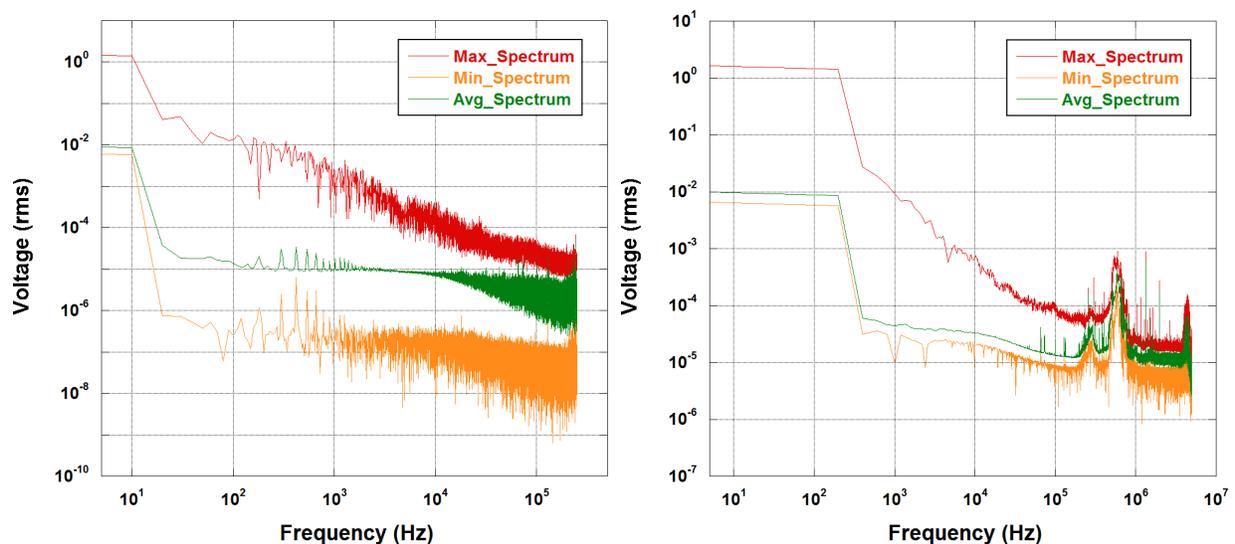
The second spectrum is generated by breaking the 100 ms waveform into twenty segments of 5 ms each. Each of these segments is passed through a Hanning filter and the FFT is calculated for each. These twenty spectra are then averaged together to give an average spectrum for the twenty segments. This method reduces the effect of random noise and preserves resolution at the highest frequencies. Resulting spectra have 200 Hz resolution to a maximum frequency of 5 MHz.

Figure 22. Maximum, minimum, and average spectral values recorded over the duration of the test. (Left) Sampled at 500 kS/s with 10 Hz resolution. (Right) Sampled at 10 MS/s with 200 Hz resolution.

The entire set of 1,999 spectra is then analyzed to obtain the maximum, minimum, and average at each frequency value. The maximum value at each frequency is recorded so that spectra containing the highest spectral components can be easily identified and retrieved for further analysis. The maximum, minimum, and average values are shown in Figure 22. The maximum curves below 200 kHz reflect a  $1/f^2$  power law relationship, which is reminiscent of arcing behavior. The data also show two peaks centered

around approximately 270 kHz and 580 kHz which were not observed during the 70°C testing. As the BMU and charging equipment was not present for the 70°C test, it is possible that these spectral components are attributable to this equipment. As this spectral content is present in spectra before nail penetration, it is part of the system and not attributable to battery failure.

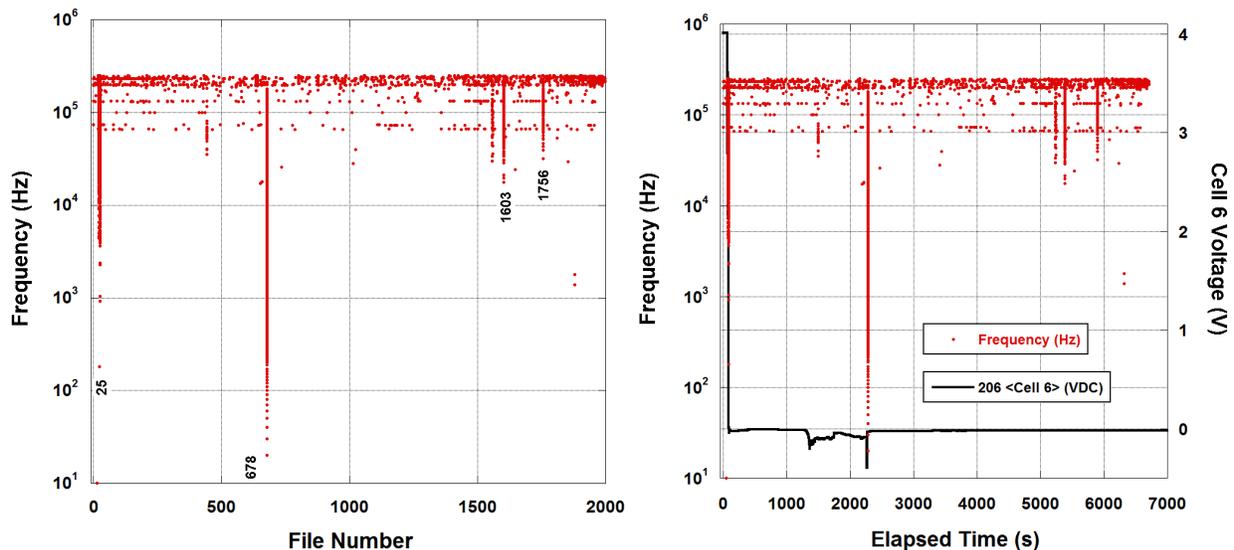
As Figure 22 is a composite graph capturing the maximum values from all 1,999 spectrum plots, it is desirable to identify which files captured the most significant events. This is achievable by plotting the file number for which each maximum frequency component was recorded, and then evaluate those files where the maximum values were recorded most. This is graphed in Figure 23. As can be seen, maximum values tend to be concentrated in a relatively small number of files, suggesting that relatively significant wideband events are occurring at these moments in time. Most notable are wideband events at the moment of Cell 6 failure (File 25) and during a timeframe of voltage noise, observable as drops below 0V across Cell 6 (File 678). This voltage noise is observed identically in the Cell 6 voltage data and that measured at the battery grounding terminal. As Cell 6 is no longer supplying power, this suggests power delivered from an adjacent cell (most likely from Cell 5, due to the negative bias observed across Cell 6) through Cell 6 and to the cell case. File 678 therefore records the spectral content during part of this event, specifically at the end.

Figure 23. Location with respect to (*left*) file number and (*right*) test time of maximum amplitude for each of the 50,000 frequencies tracked in each of the 1,999 spectral files. At right the data are superimposed onto Cell 6 voltage data. Left plot lists file numbers with the most significant number of recorded maxima.
