# **NTSB Battery Nail Penetration Tests**

## ***Final Report for 787 Battery (Asset 445) Tested at 15°C, Grounded***

J. Thomas Chapin, PhD  
Pravinray D. Gandhi, PhD, PE  
Paul W. Brazis, Jr., PhD  
May 29, 2014

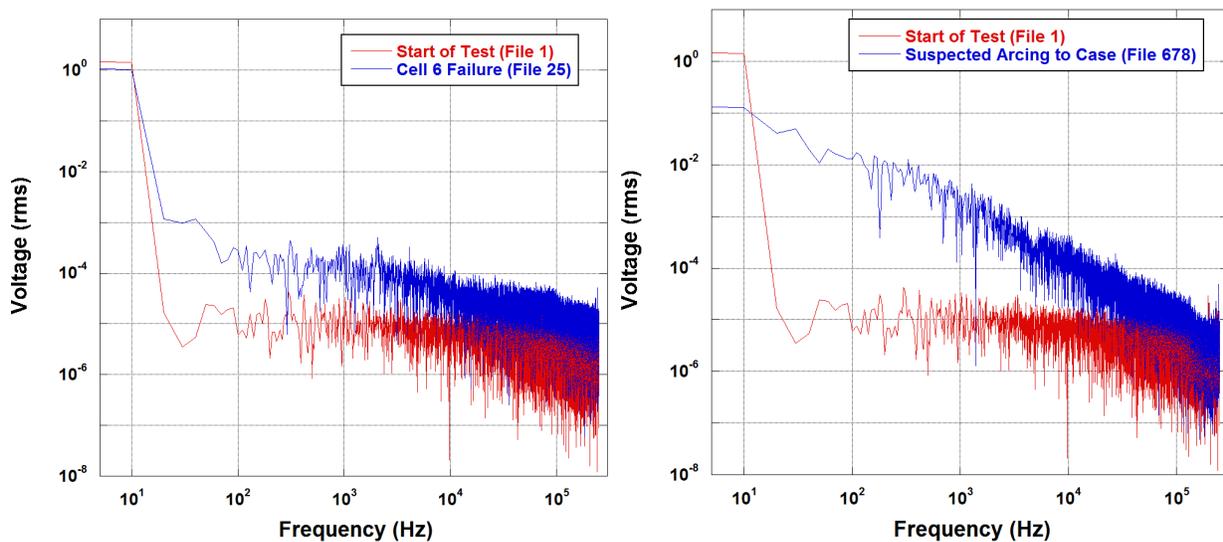
Figure 24 shows four example spectral plots from the two events containing the most significant spectral content. Figure 24 (*left*) shows the spectral content during failure of Cell 6, specifically, during the drop of

cell voltage to zero. Significant spectral content (similar in shape and magnitude to that shown for File 25) is also observed for Files 22 through 25, which spans the drop of Cell 6 voltage from 4V to zero. This spectral content does not appear to span to the failure of the ground wire. Spectral noise appears to increase by approximately one order of magnitude during the nail penetration event, possibly signifying the presence of electrical arcing. The  $1/f^{\beta}$  relationship above 1 kHz is consistent with previously observed arcing behavior; the flattened response below 1 kHz does suggest presence of wideband noise, but has more of a “white noise” characteristic which has not been observed in previously observed arcing behavior. However, shorting effects as the battery interior carbonizes may be a source of this lower-frequency suppression of expected arcing magnitude.

The most significant wideband noise was observed within File 678, captured during a suspected arcing event, most likely to the battery case through Cell 6, supplied by Cell 5 and/or Cell 7. Wideband noise is observable through this discharge event, though spectral noise is most significant at the start of the event and at the end. This suggests arc strike during formation of the arcing path, and the most significant arcing event (captured in File 678) occurring at the end of the event, likely providing sufficient arc energy to destroy the arcing path, as Cell 6 and grounding voltage return to 0V at this point in time.

Figure 24. Spectra identified to have significant maximum frequency components. (Left) Spectrum during Cell 6 failure (File 25). (Right) Spectrum during suspected arcing to case event (File 678). Start-of-test spectrum is also shown for comparison.

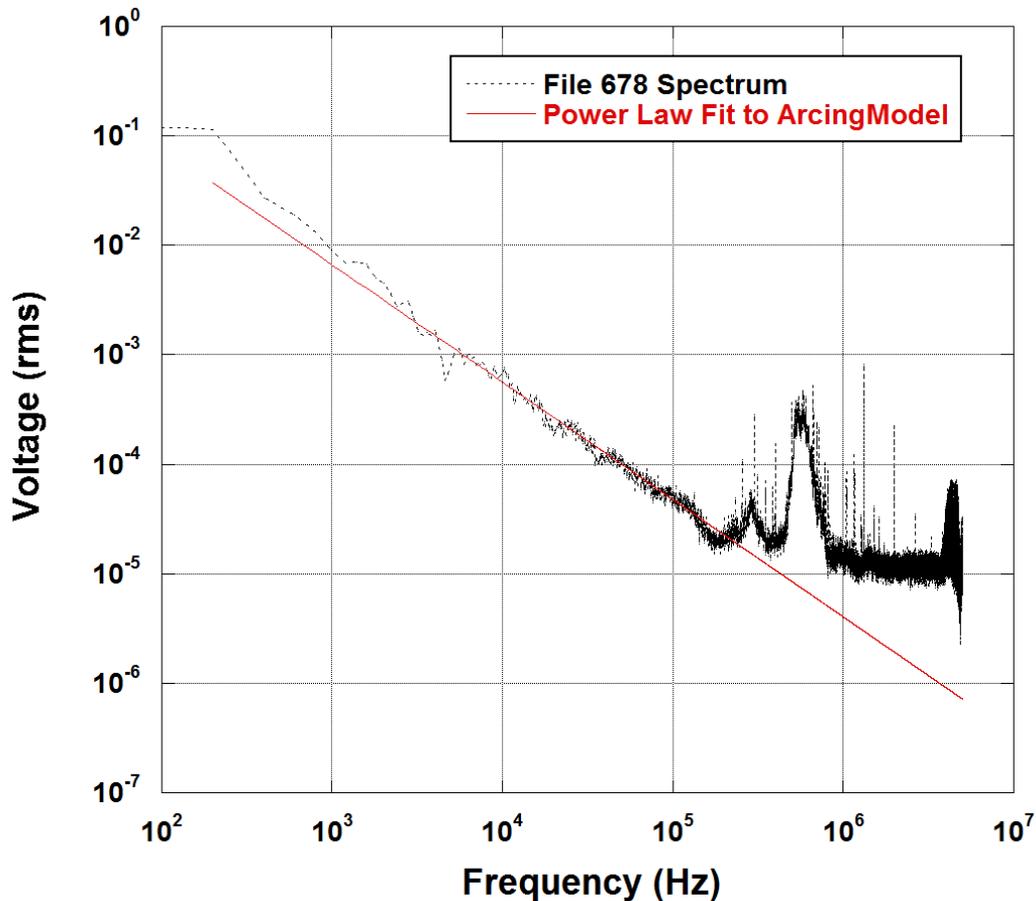
The spectrum above 250 kHz fell below the noise floor of the measurement and was subject to probable noise from the BMU and charging equipment, as well as instrument noise-related artifacts. However, prior characterization experience of electrical arcing events suggests that this  $1/f^p$  power law relationship would continue to represent spectral content of arcing at higher frequencies should measurement capabilities allow for its characterization.

Figure 25. Power law fit to spectral data observed during suspected arcing event (File 678), showing agreement with power law fit that is consistent with electrical arcing behavior. Flattening, peaks at 270 kHz and 580 kHz, and delta artifacts above 250 kHz are result of noise floor, (likely) charging equipment, and equipment noise, respectively.

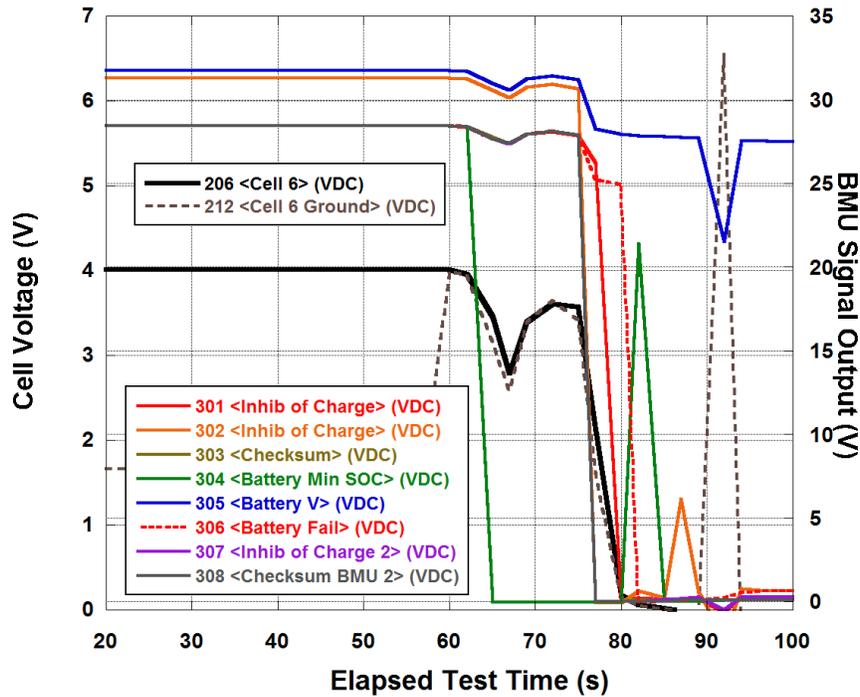
The BMU signal outputs recorded during the test are shown in Figure 26 and Figure 27. The voltage outputs before and after the Cell 6 venting event are listed in Table 3. The values show that the signals are all “high”, mostly referenced near or slightly below the battery voltage at the start of the test. The signal “Battery Min SOC” goes “low” first, at the time of the first drop in cell voltage (when the first sub-cell exhibits an internal short circuit). Except for the “Battery Fail” and one of the “Inhib of Charge” signals, the rest of the signals go “low” at the onset of Cell 6 dropping to zero volts. The “Battery Fail” signal then goes “low” during the transition of Cell 6 to zero or at the moment Cell 6 reaches zero volts. The “Battery V” signal follows the battery output voltage through the first 2500 seconds of the test, with roughly a 0.4V drop from the voltage at the positive terminal of the battery.

Figure 26. Signal outputs of BMU in the vicinity of venting of Cell 6.

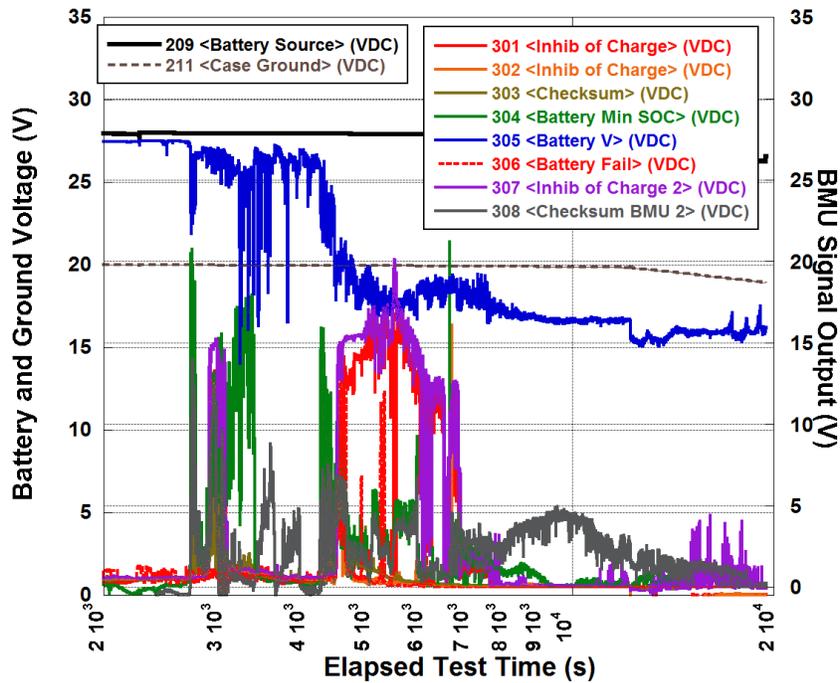
These values attained after venting of Cell 6 hold stable until 2600 seconds into the test, where signals from the BMU become noisy and erratic (Figure 27). The exact reason for this change is not clear, but it is possible that this originates from some mechanism of electrical failure in the control circuitry inside the battery, which could be triggered from the exposure to high temperature and/or smoke contaminants from the Cell 6 venting event.

Figure 27. Signal outputs of BMU, 2000 to 10000 seconds into the test, showing erratic voltage output of BMU.

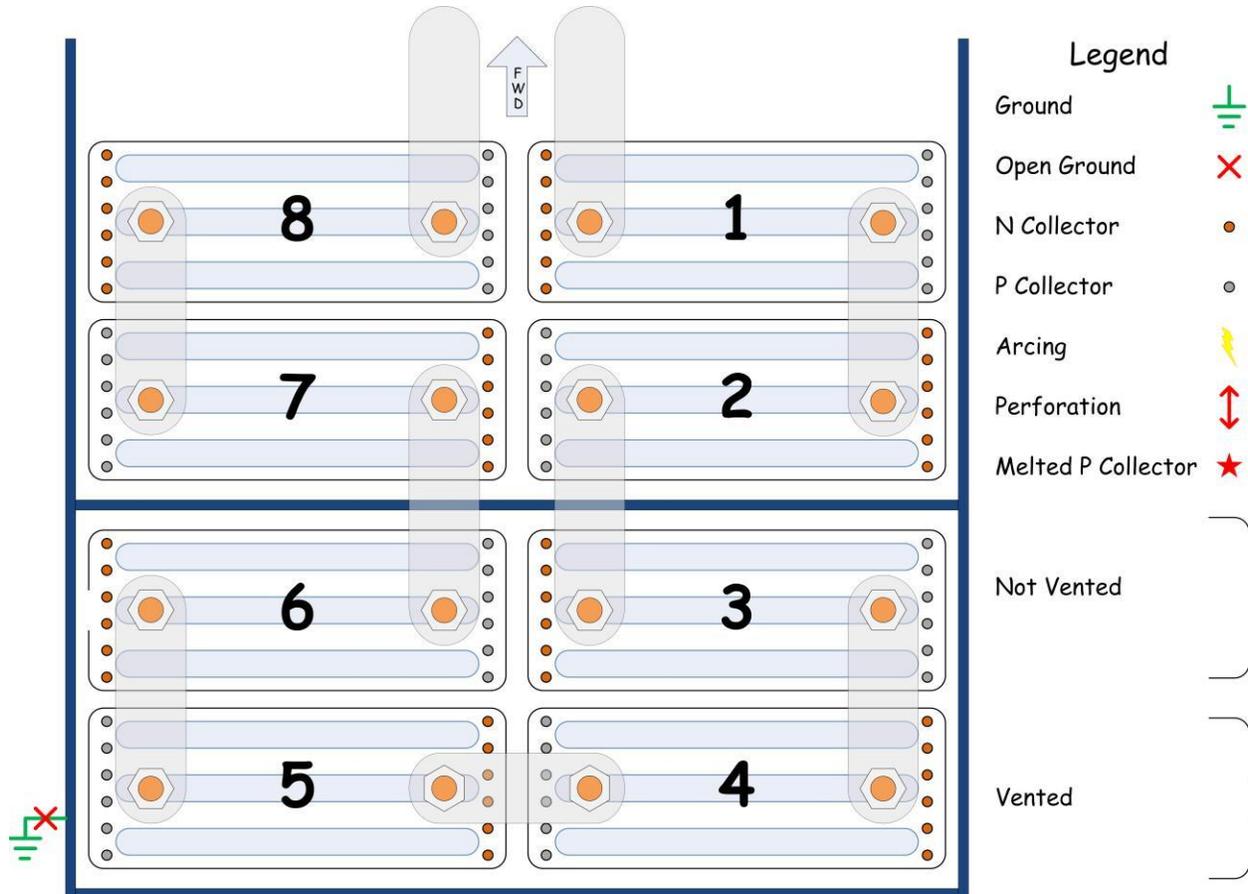
The battery was disassembled after discharging the cells. The photographic documentation of the disassembled battery is presented in Appendix A. Figure 28 shows the potential locations of each melted/open collector within each cell. For this test, no such melting/opening was observed.

Figure 28. Locations of melted/open collectors inside each battery cell.

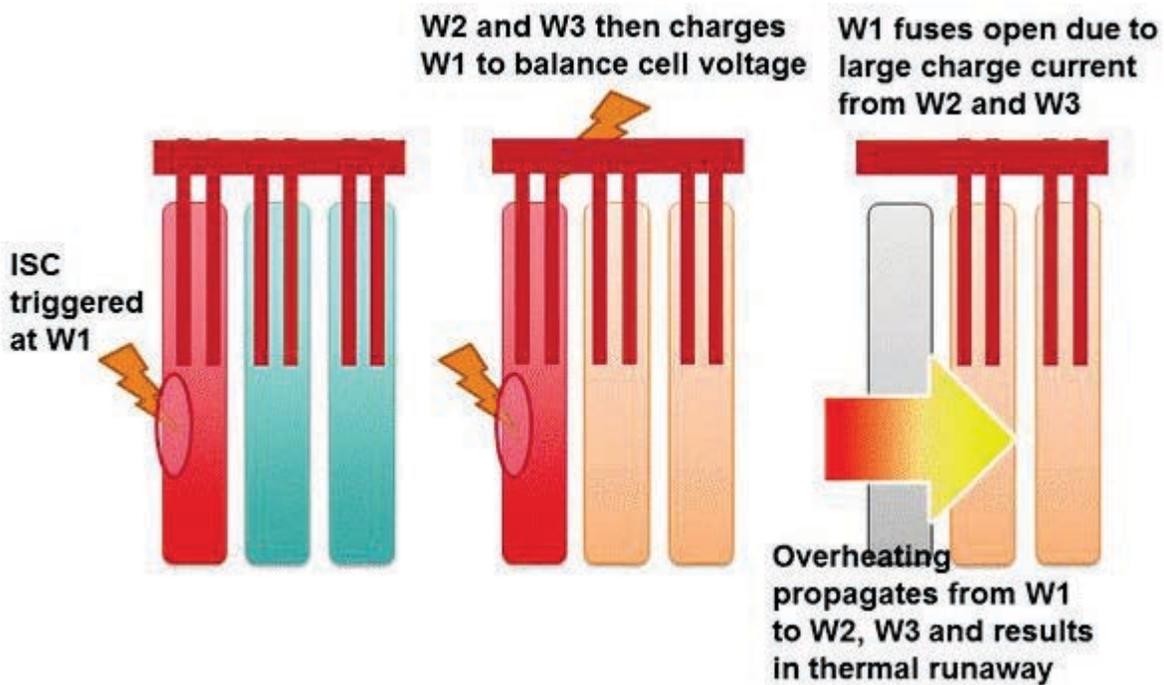
The pattern of failure from other tests suggests the failure mechanism as shown in Figure 29, and the corresponding voltage behavior is shown in Figure 30. In this model, heat transferred to the cell (e.g., from a previously vented cell) causes one of the three sub-cells to short circuit and draw large current from the rest of the cell. This causes the aluminum electrodes to overheat and open on the cell which is in a short-circuit condition. During short-circuit the voltage of the cell drops, but then recovers once the

shorted cell is removed from the circuit. The heat from the failed sub-cell then transfers to the other two sub-cells, causing thermal runaway for the rest of the cell and drop of the cell voltage to zero. This failure model suggests that the electrodes that fused open will denote the sub-cell which failed first, and is expected to help in determining the sequence of cell failure by signaling the direction of heat flow into the cell which caused failure. This also suggests that open electrodes at the center sub-cell suggests that heating originated from within the cell rather than from an adjacent cell, increasing the probability that the cell showing open electrodes at the center sub-cell only was the cell that was first to fail and triggered the entire failure event.

Figure 29. Proposed failure mechanism for cells.

Since no propagation of cell venting was observed in this test, nor were any electrodes observed to have failed open, the results were not able to be used to correlate this proposed failure mechanism.

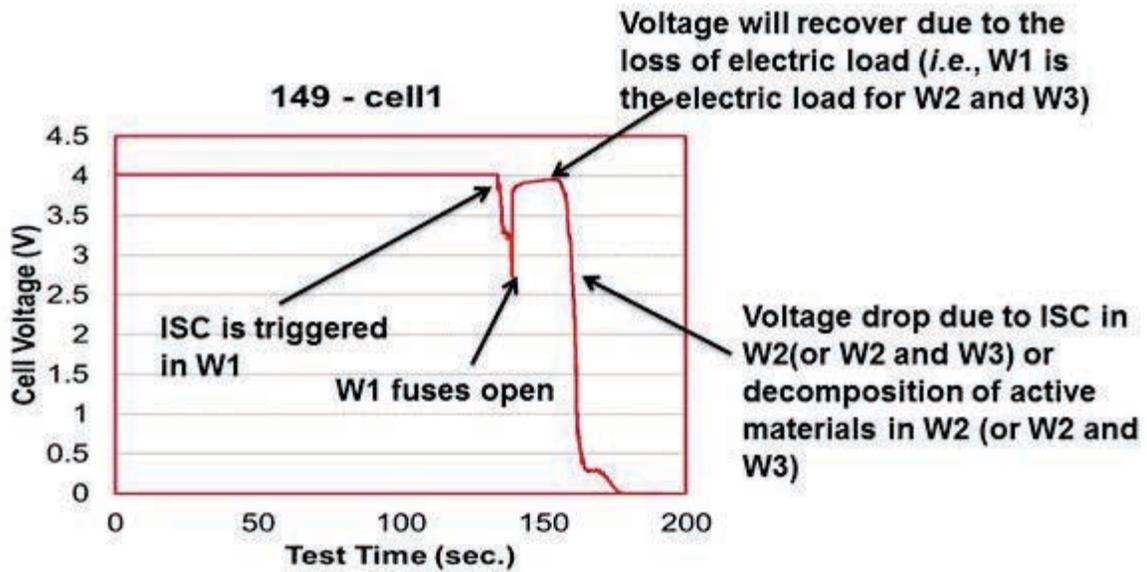
Figure 30. Cell voltage behavior during failure mechanism as shown in Figure 29.

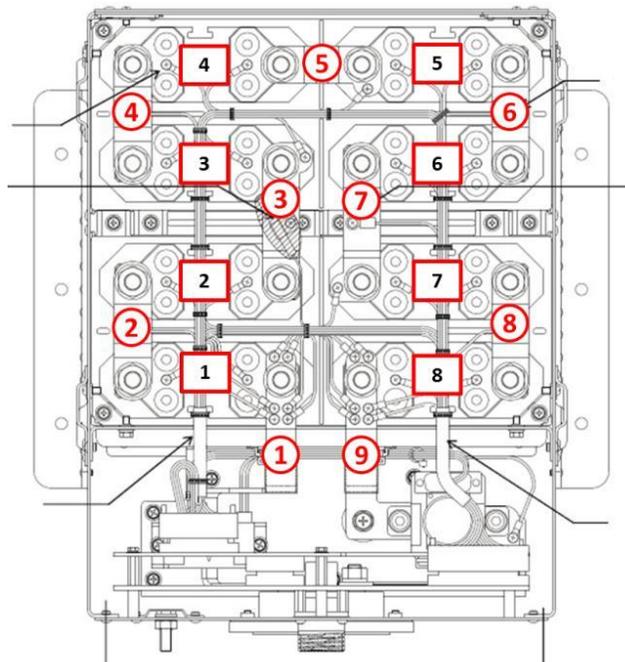
Remove the cover. Take picture of internal battery and record photo # 445\_0994.  
Tape the edge of box before start. Number the cells and bus bars in a clockwise direction.

Figure 31. Numbering of the cells and bus bar

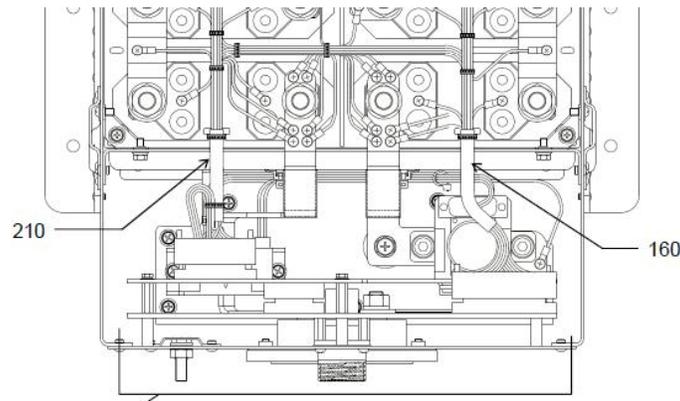
Put a sheet on cell and disconnect the Sub Harness (210), then disconnect the Main Harness (160). Cut the cable tie and tape the harness on the outside of box.

**Figure 33. Positions of Sub Harness (210) and Main Harness (160)**

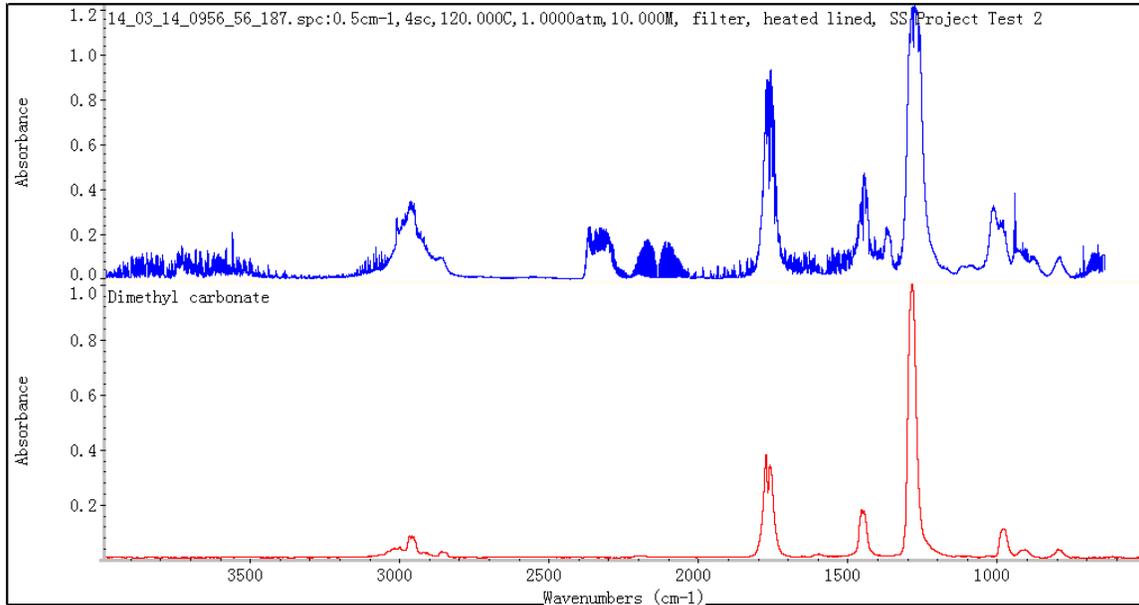
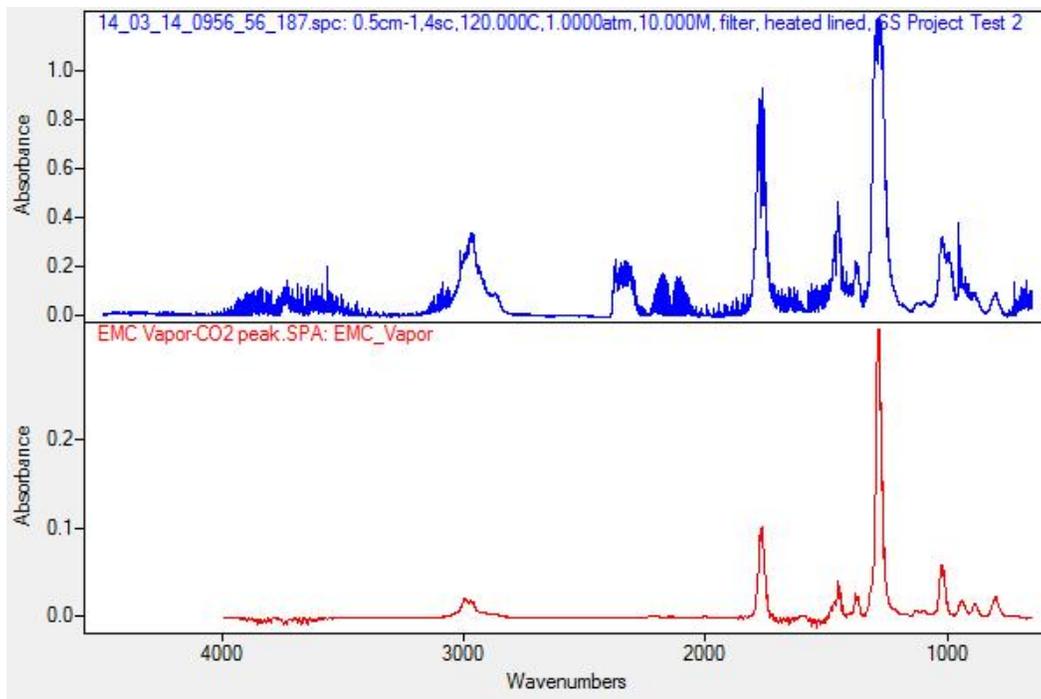
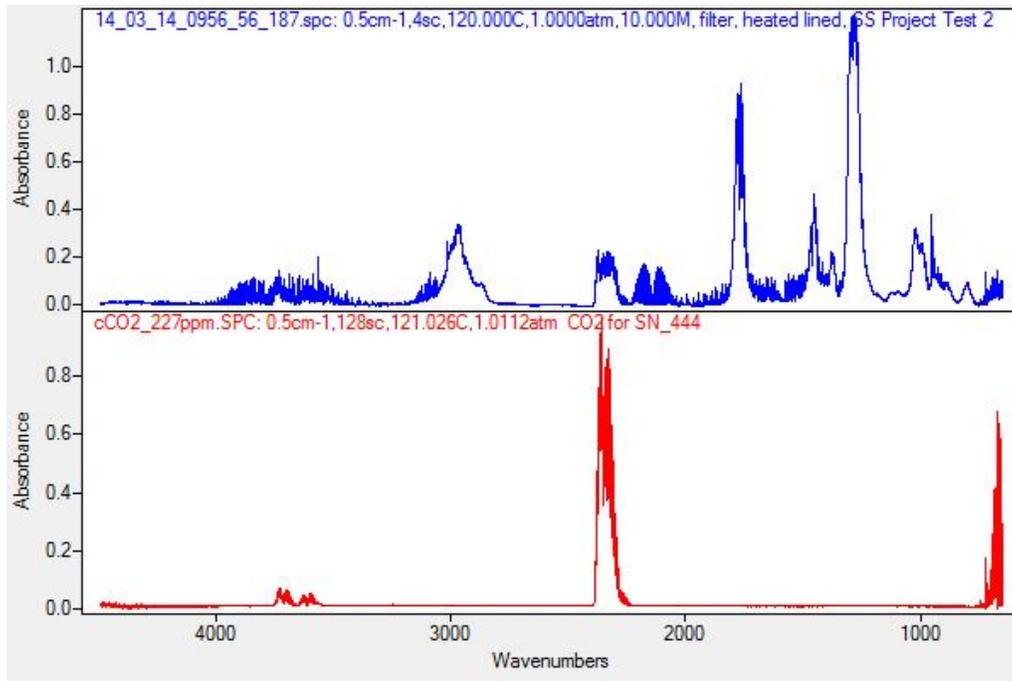
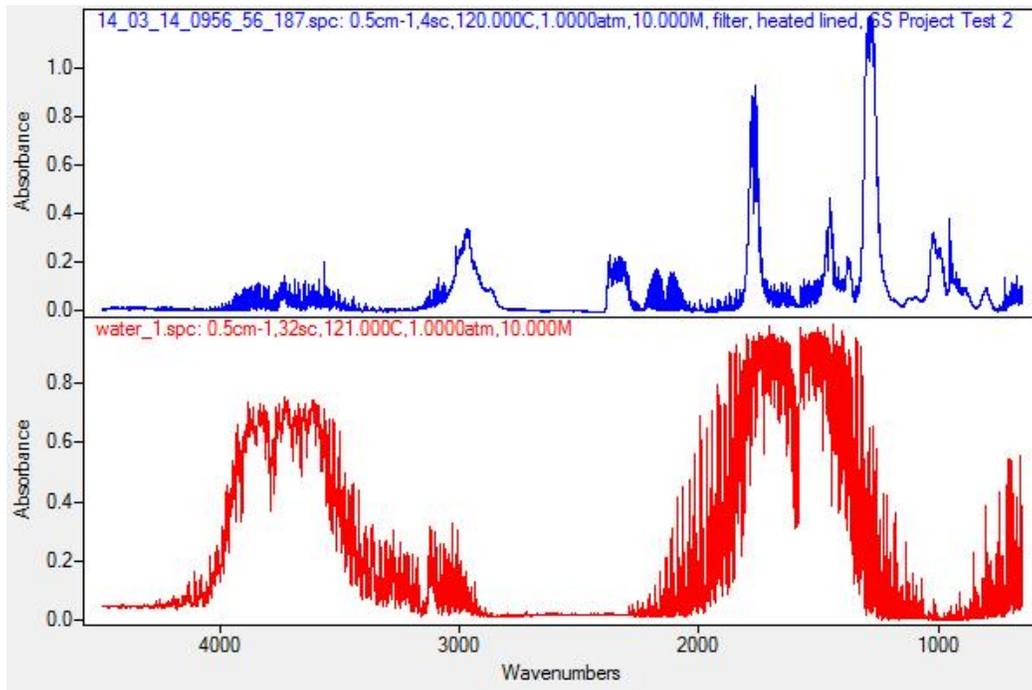
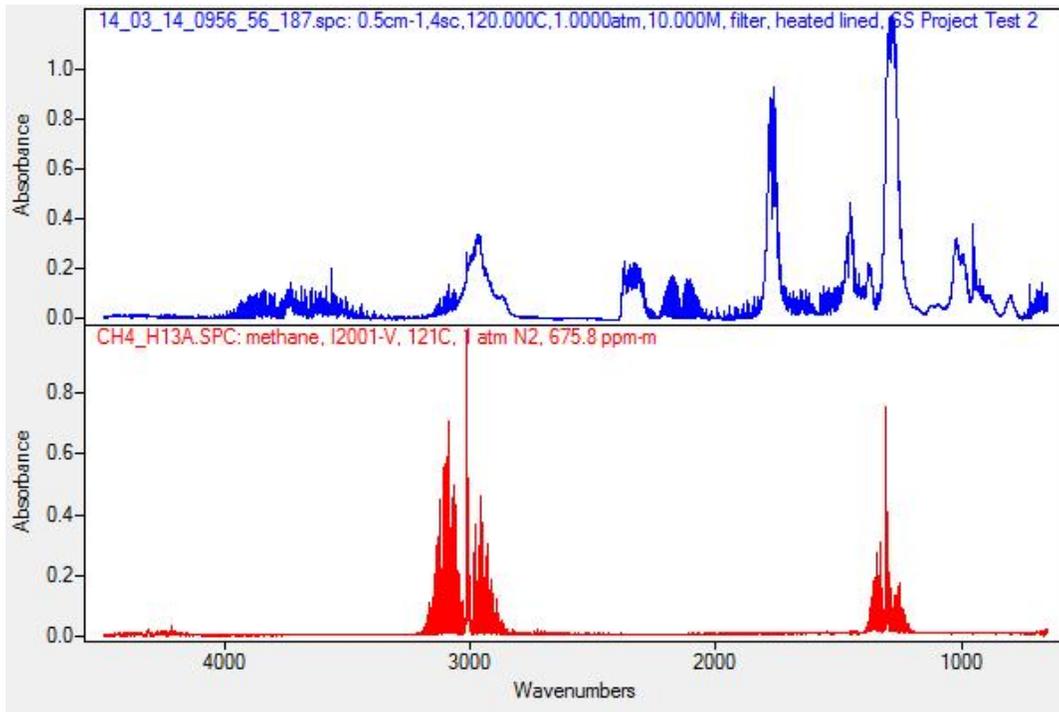
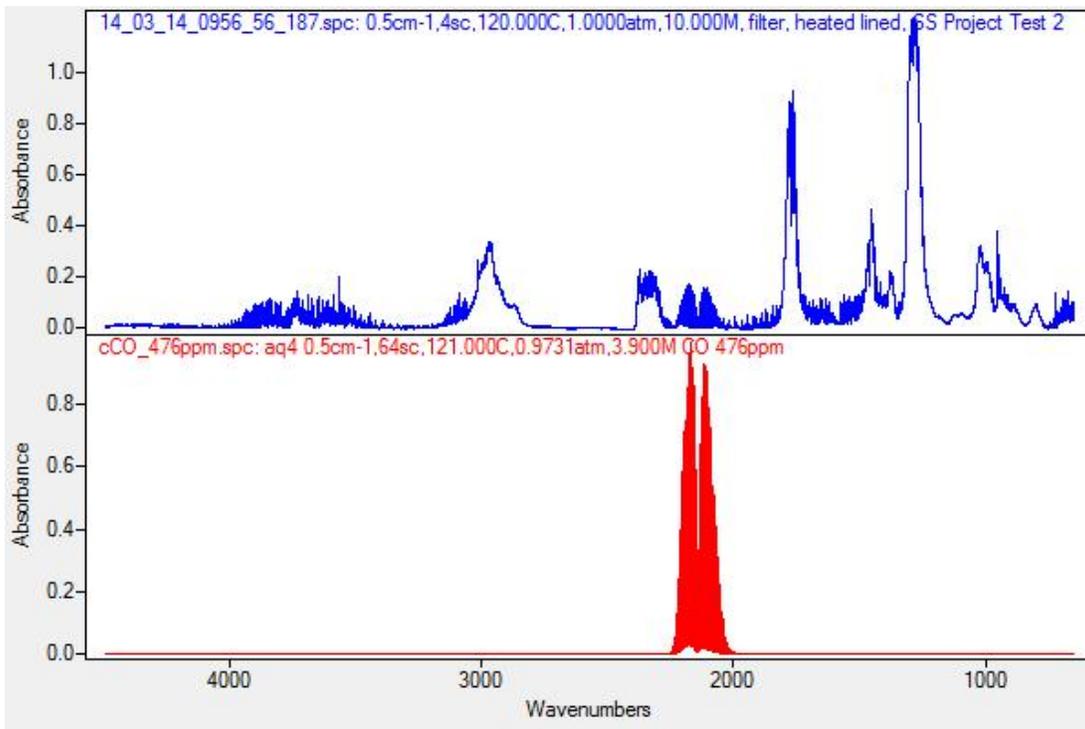
Figure 34. Spectrum of zone A compare to standard spectrum of Dimethyl Carbonate; DMC.

Figure 35. Spectrum of zone A compare to standard spectrum of Ethylmethyl Carbonate; EMC

Figure 36. Spectrum of zone A compare to standard spectrum of Carbon dioxide; CO<sub>2</sub>.

Figure 37. Spectrum of zone A compare to standard spectrum of Water; H<sub>2</sub>O.

Figure 38. Spectrum of zone A compare to standard spectrum of Methane; CH<sub>4</sub>.

Figure 39. Spectrum of zone A compare to standard spectrum of Carbon monoxide; CO.

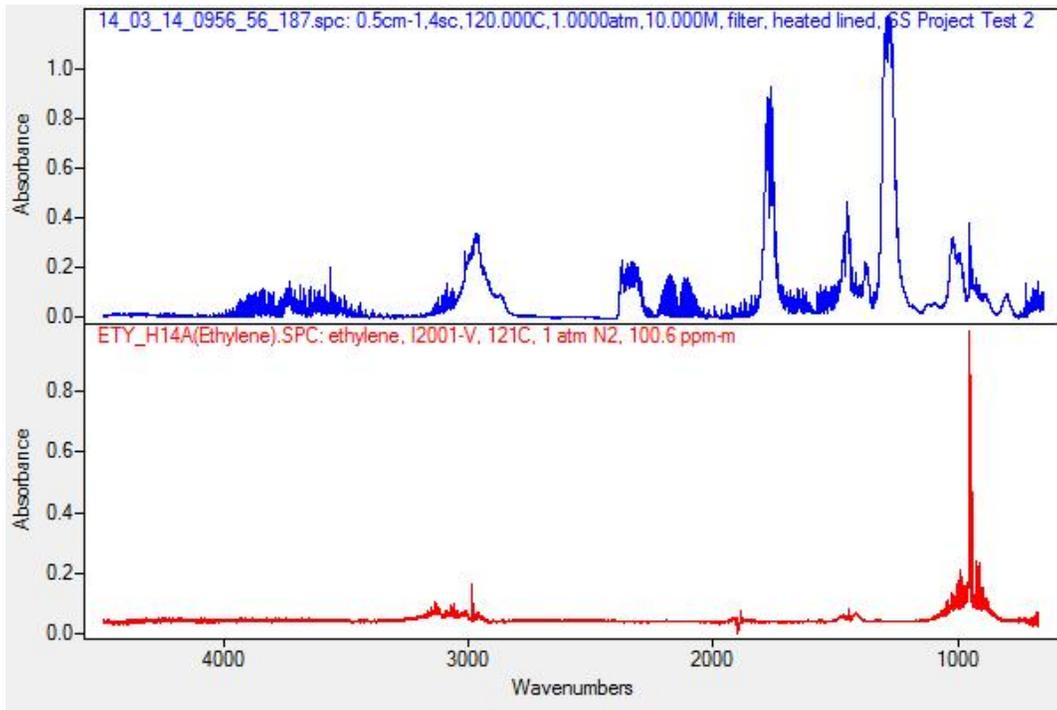
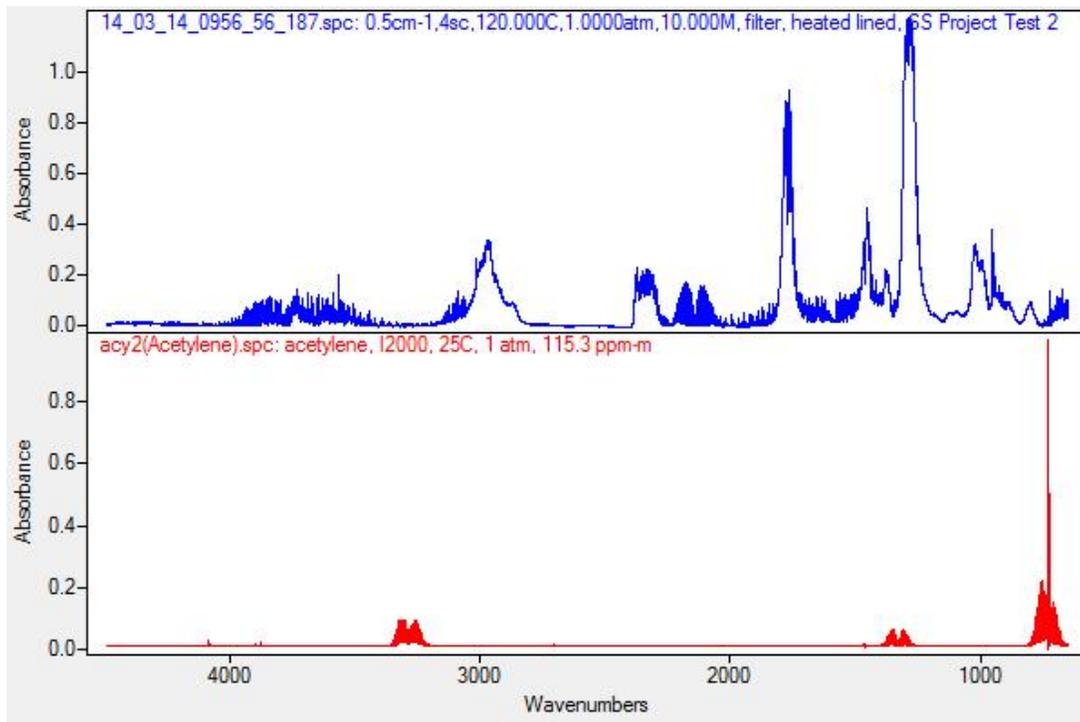
Figure 40. Spectrum of zone A compare to standard spectrum of Ethylene,  $C_2H_4$ .

Figure 41. Spectrum of zone A compare to standard spectrum of Acetylene,  $C_2H_2$ .
