PRELIMINARY REPORT

RAILROAD

DCA16FR007

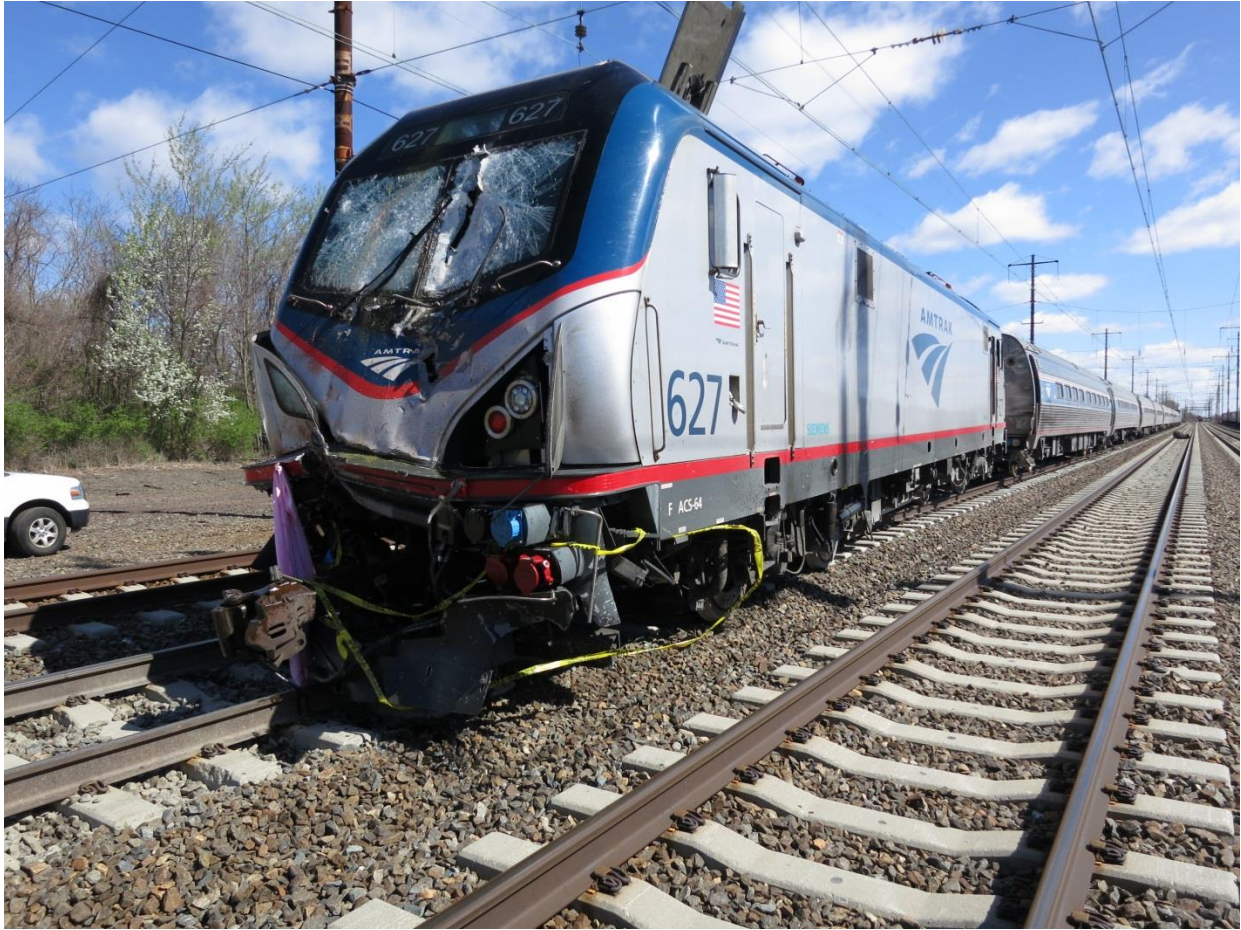
Figure 1. Damage to Amtrak passenger train 89.
