## **PRELIMINARY REPORT**

### **HIGHWAY**

### **HWY14MH014**

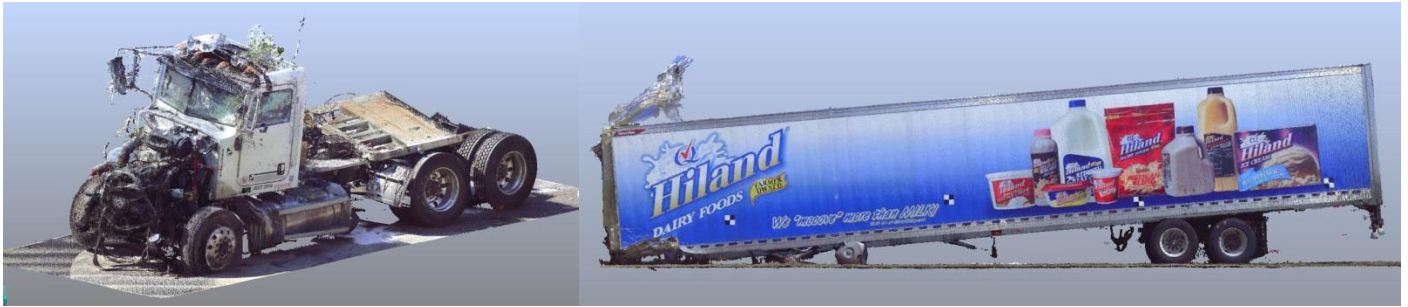
**Figure 1.** Image from 3D scans of the 2013 Peterbilt truck-tractor and 2014 Great Dane semitrailer combination vehicle.

Using three-dimensional (3D) laser scanning technology, National Transportation Safety Board (NTSB) investigators documented the accident scene and the vehicles (see figures 1 and 2).

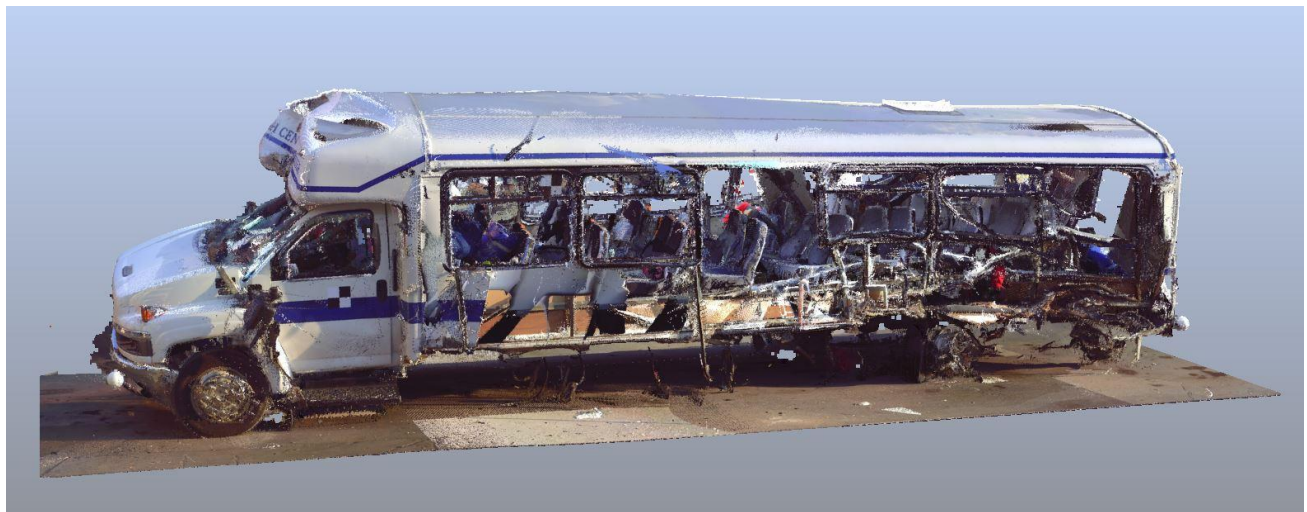
**Figure 2.** Image from 3D scan of the 2007 Chevrolet C5500 / 2008 Champion 32-passenger medium-size bus.
