National Transportation Safety Board  
Washington, D.C. 20594

Highway Accident Brief

**Accident No.:** HWY-03-MH-018  
**Accident Type:** Vehicle loss of control, followed by sideswipe collisions with tractor-semitrailer  
**Location:** Amsterdam Road (State Route 347), west of Belgrade, Montana  
**Date and Time:** January 23, 2003, 3:20 p.m.

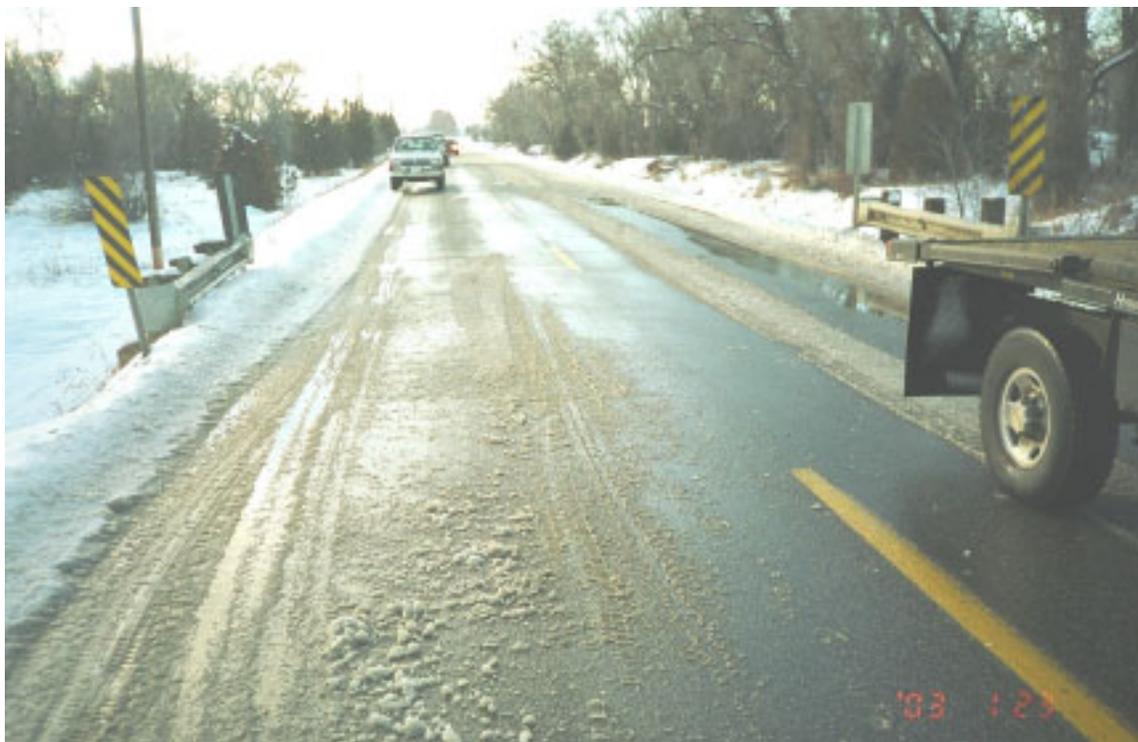
**Figure 2.** Roadway conditions at the accident scene. (Source: Montana Highway Patrol)

In the vicinity of the accident site, Amsterdam Road is a straight, level, undivided roadway consisting of two 11-foot-wide lanes, variable-width shoulders, and grassy ditches sloping away from the shoulders. The road was intermittently bordered on the south by tall trees that cast shadows on the roadway. The posted speed limit was 70 mph in the daytime and 65 mph at night. Approximately 60 feet west of the accident site was a short, 22-foot-wide bridge over a ditch. The sides of the bridge consisted of W-beam barriers marked by 12-inch object markers on each end; each marker extended about 6 inches into the roadway (see figure 2).

Time sheets for the Gallatin County Road and Bridge Department, which is responsible for snow removal, included several entries on January 23 for Amsterdam Road, indicating “Scrape Ice” and “Plow and Sand.” The time of day for these entries was not noted. Postaccident photographs show an accumulation of ice, snow, and slush on the pavement edges and two clear tire ruts in the slush in each lane, slightly offset toward the center of the roadway (see figure 2). Some standing water had accumulated in puddles along the south side of the roadway.

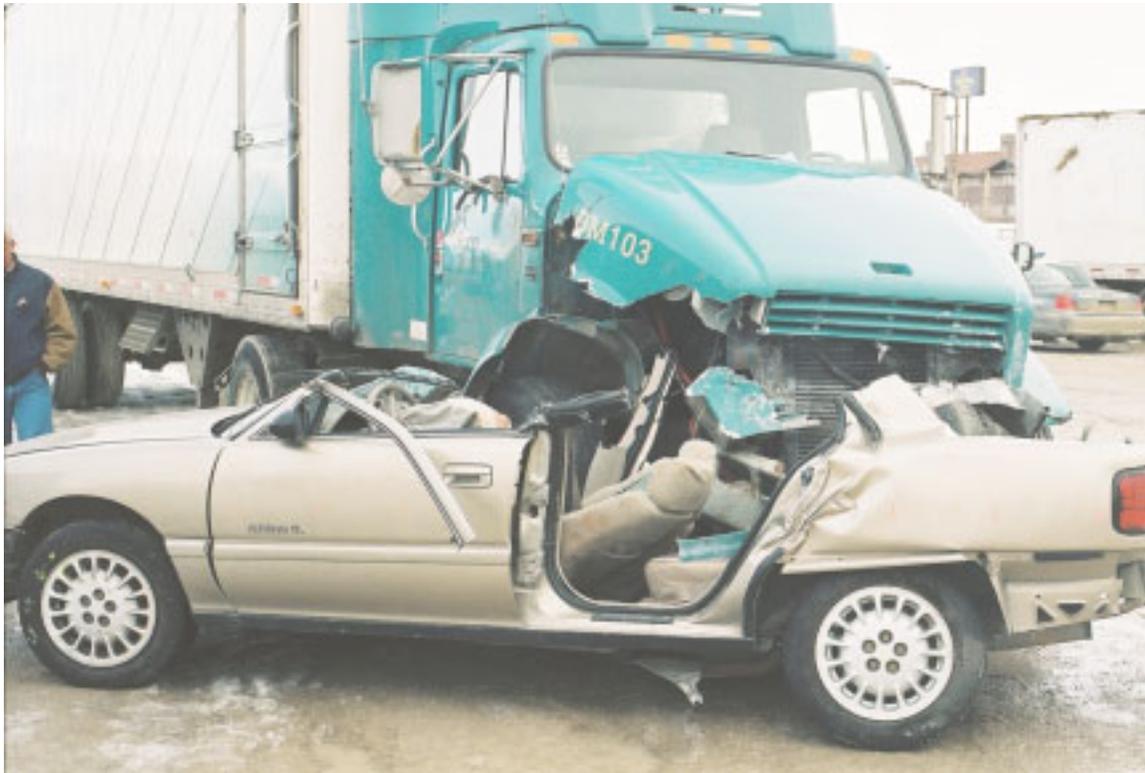
**Figure 3.** Vehicles aligned postcollision during accident reconstruction.

The Oldsmobile rotated counterclockwise and slid sideways across the centerline, where it was struck by the front of the tractor-semitrailer, and then rotated clockwise and impacted the right-front side of the tractor. The Oldsmobile sustained severe damage to its right side and the tractor-semitrailer sustained minor front-end damage. Intrusion into the Oldsmobile's passenger compartment was 24 inches extending along the right side. All of the passengers were wearing their lap/shoulder belts, and the driver and front passenger airbag deployed. Full autopsies were not conducted, but the coroner determined that all four Oldsmobile passengers sustained fatal injuries from massive blunt force trauma and flail chest<sup>4</sup> wounds.

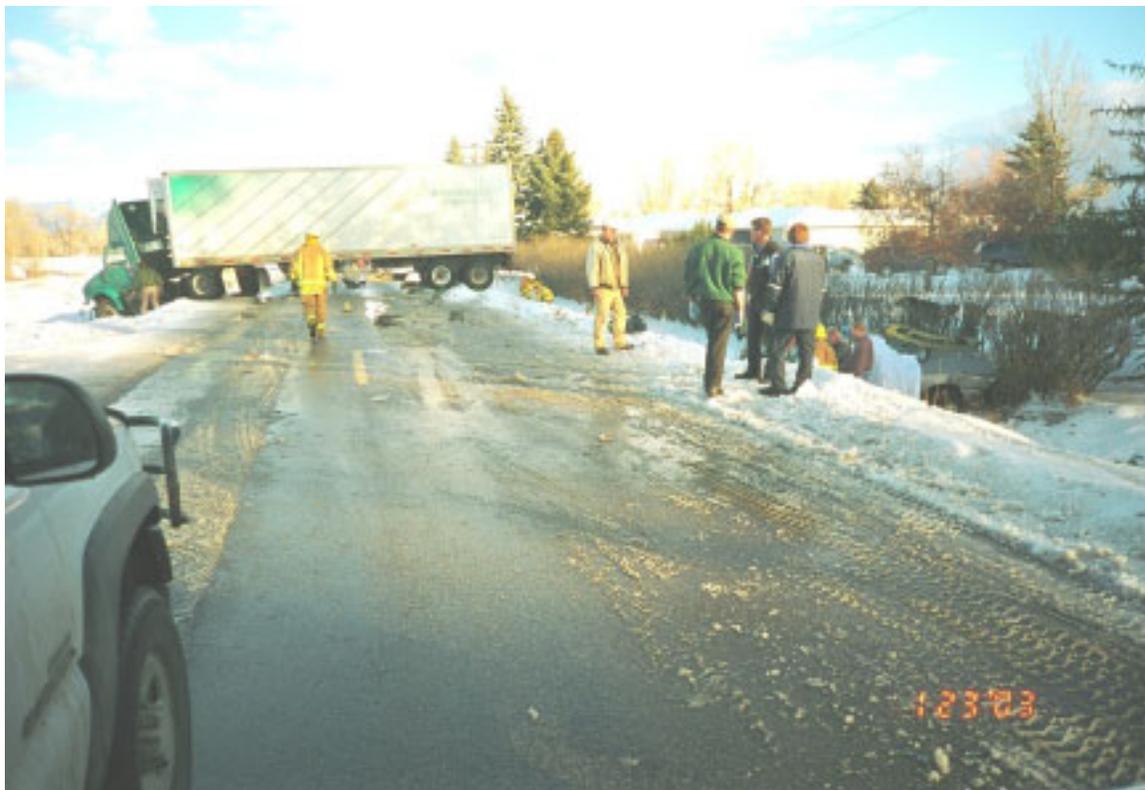
**Figure 4.** Vehicles at final rest. (Source: Montana Highway Patrol)

About 3:20 p.m. on January 23, 2003, a 1997 Oldsmobile Achieva driver education vehicle was westbound on Amsterdam Road near Belgrade, Montana (see figure 1). A driver education student, age 14 years, 8 months, was driving; an instructor was in the right-front passenger seat, and two other students were seated in the rear seat. About the same time, a 1991 International Truck and Engine Corporation truck tractor with a 1998 Utility Trailer Manufacturing Company semitrailer was eastbound on Amsterdam Road. The weather was clear. Snow earlier in the day had resulted in an accumulation of slush on the roadway in places shaded by patches of trees (see figure 2). The truck driver estimated that his vehicle and the Oldsmobile were traveling 35 to 45 mph. He stated that he saw the oncoming automobile from a distance of more than 100 yards and noticed no indication of a problem. Just after the tractor-semitrailer crossed a short bridge over a ditch, the truck driver said the Oldsmobile began to fishtail and veered into the eastbound lane in front of the tractor-semitrailer. The tractor-semitrailer driver said that he tried to avoid the collision by steering left, but he struck the Oldsmobile on the right side (see figure 3), causing the Oldsmobile to rotate clockwise, strike the right side of the tractor, and then slide down an embankment on the south side of the roadway. The tractor came to rest facing north, blocking both lanes of traffic (see figure 4).
