# National Transportation Safety Board

## Highway Accident Brief

### Fatal Pedestrian Collision with Sport Utility Vehicle Falls Church, Virginia, May 18, 2016

<b>Accident Number:</b>	HWY16SH012
<b>Accident Type:</b>	Fatal pedestrian collision with sport utility vehicle
<b>Location:</b>	Leesburg Pike (State Route 7) at Glen Carlyn Drive, Falls Church, Virginia
<b>Date and Time:</b>	May 18, 2016, about 3:40 p.m. eastern daylight time
<b>Vehicle:</b>	2012 Jeep Wrangler
<b>Driver:</b>	51-year-old male
<b>Pedestrian:</b>	71-year-old male
<b>Fatalities:</b>	1

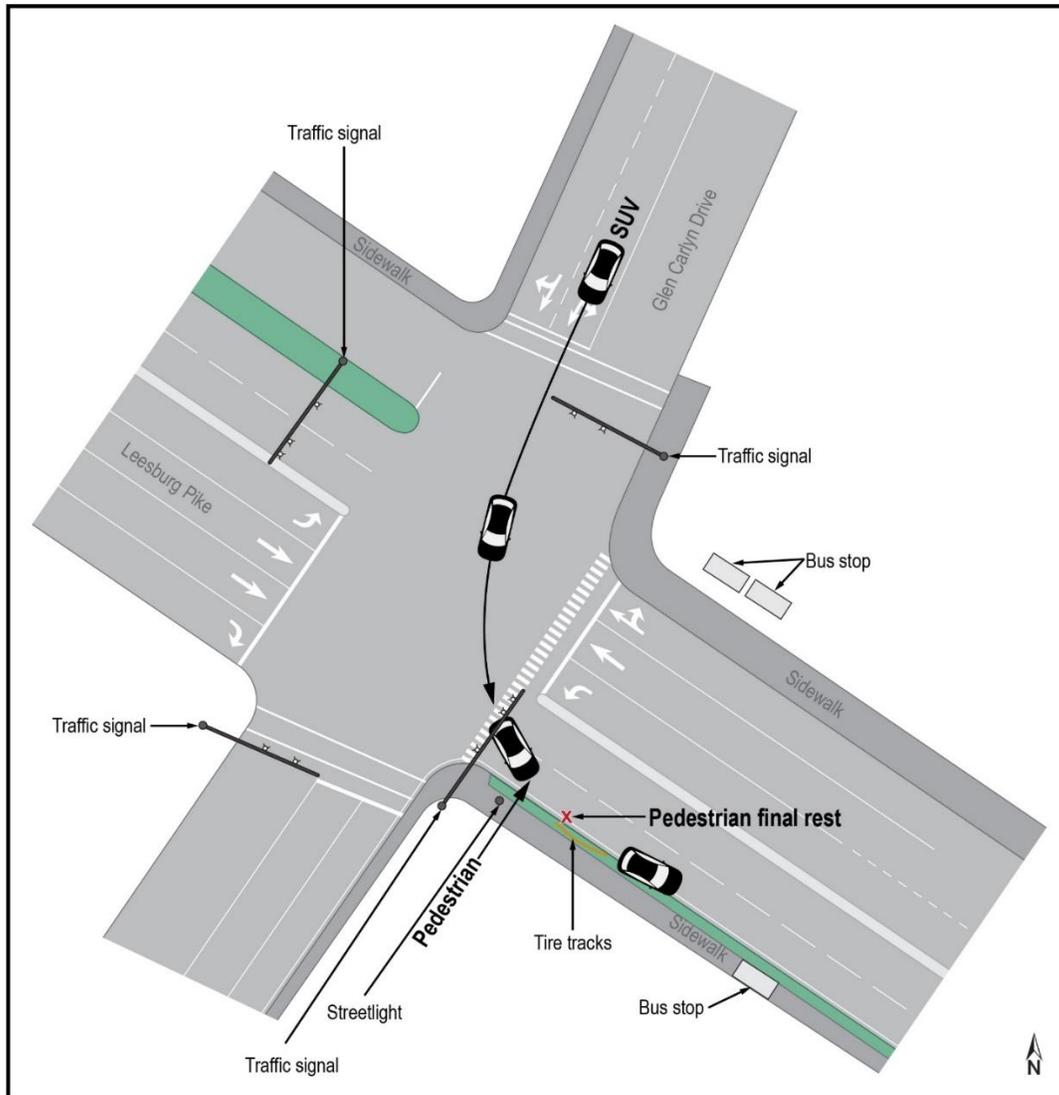
**Figure 1.** Diagram of crash site showing path of SUV as it traveled through intersection to collide with pedestrian, final rest positions of pedestrian and SUV, and location of crosswalks, bus stops, traffic signals, and streetlight near collision point.

About 3:40 p.m. on Wednesday, May 18, 2016, a 2012 Jeep Wrangler sport utility vehicle (SUV) was making a left turn from the left-turn lane on southbound Glen Carlyn Drive onto eastbound Leesburg Pike (State Route 7) in Falls Church, Virginia.<sup>1</sup> The SUV had a green left-turn arrow and was the first vehicle in a queue. As the 51-year-old male driver turned, a 71-year-old male pedestrian tried to cross Leesburg Pike from south to north, in front of the turning vehicle. According to a witness, the pedestrian was outside the crosswalk, the traffic signal facing him was red, and the pedestrian control signal indicated not to walk.

The driver steered right in an effort to go behind the pedestrian, but the left front corner of the vehicle struck him. The pedestrian was thrown to the ground and run over by the SUV's left tires. After the collision, the driver steered off the roadway, over the curb, and onto the grass next to the curb. (No skid marks were found, but the SUV's tire tracks went from the curb onto the grass.) The pedestrian came to rest in the right eastbound lane of Leesburg Pike near the curb, approximately 15 feet from the point of impact (figure 1). The temperature at the time of the accident was 66°F, winds were variable at 5.8 mph, and skies were overcast.<sup>2</sup>

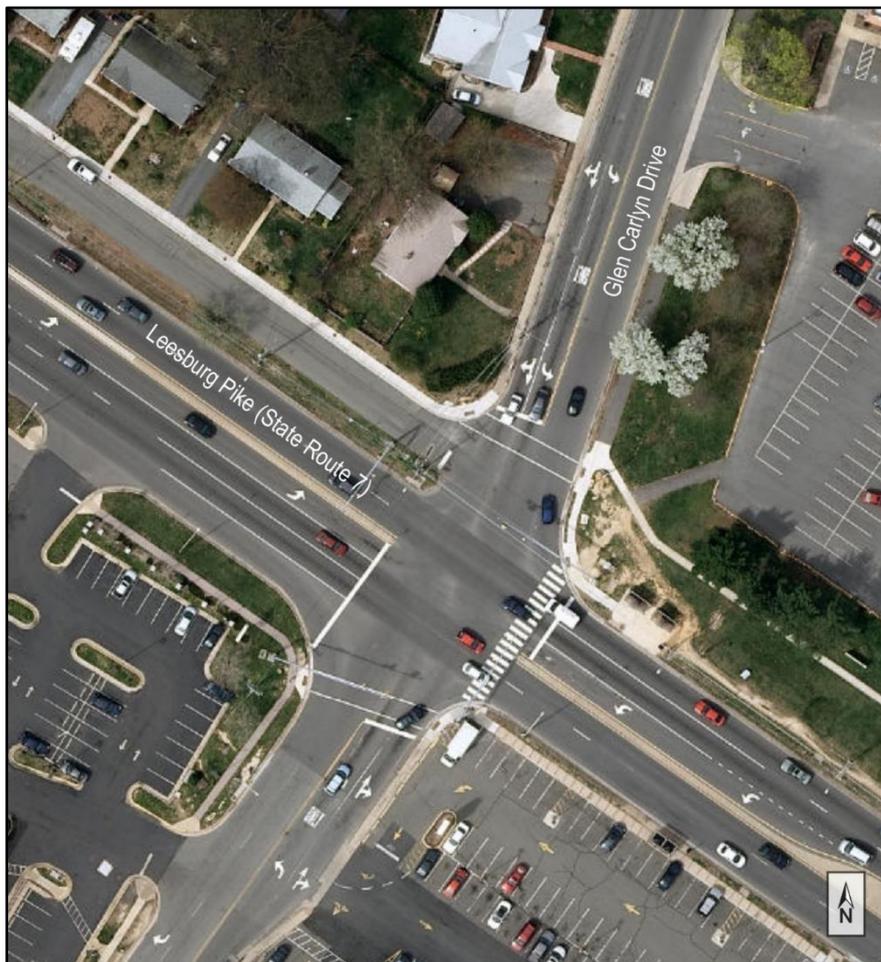
**Figure 2.** Aerial view of crash location showing intersecting roadways, crosswalk, and surrounding businesses. (Base map by Google Earth)

The area around the intersection includes sidewalks for pedestrians as well as marked pedestrian crosswalks (figure 2). Pedestrian-walk phases are incorporated in the timing sequence for the traffic lights at the intersection. A shopping center is located on the south side of Leesburg Pike. Metrobus stops and shelters are found on both sides of the highway—two shelters near the northeast corner of the intersection, and a smaller shelter in the middle of the block on the south side of Leesburg Pike (refer to figure 1). Local residents and law enforcement officers told investigators that pedestrian and bus traffic in the area is heavy.

The crash occurred during daylight hours. The roadway was dry, and the sky was overcast. Possible sight obstructions included a streetlight post on the southeast corner of the intersection near where the pedestrian would have stepped off the curb. The large post would have been between the driver and the pedestrian and might have momentarily obstructed their views of each other as the pedestrian walked behind it.

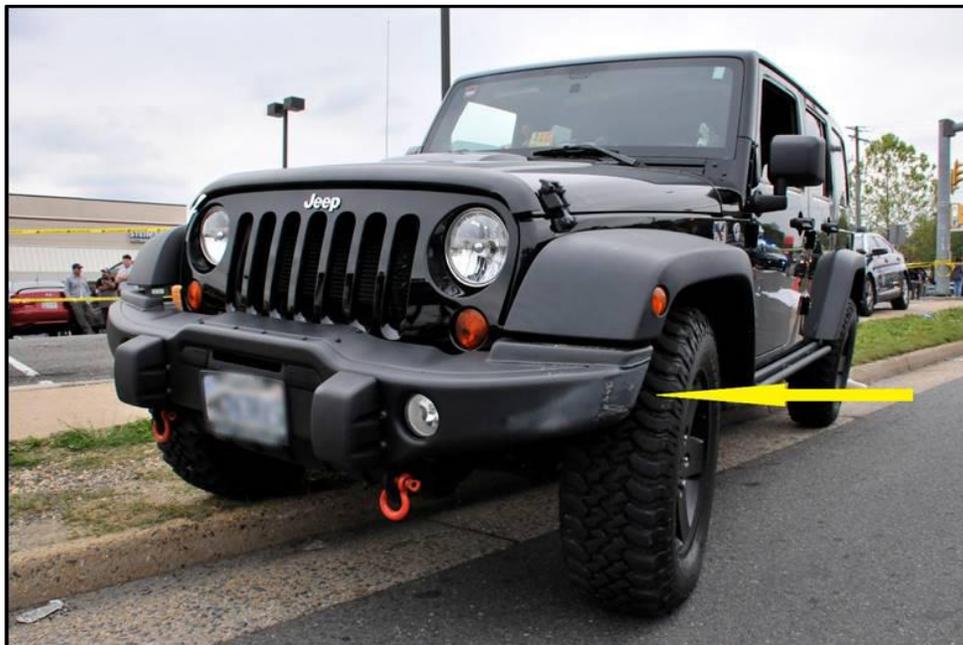
**Figure 3.** Photograph showing minor contact damage (arrow) to left front bumper of SUV.

The crash vehicle was a 2012 Jeep Wrangler SUV. The owner purchased the vehicle in 2012 and was familiar with its operation. He stated that the SUV had no mechanical problems and had been in only one other collision, a minor one in 2012. The SUV was examined on the scene by law enforcement officers and NTSB investigators, who observed minor damage to the area of the left front bumper (figure 3).
