Highway Investigation Report HIR-24-08

Box Truck Centerline Crossover Collision with Bus

Louisville, New York
January 28, 2023

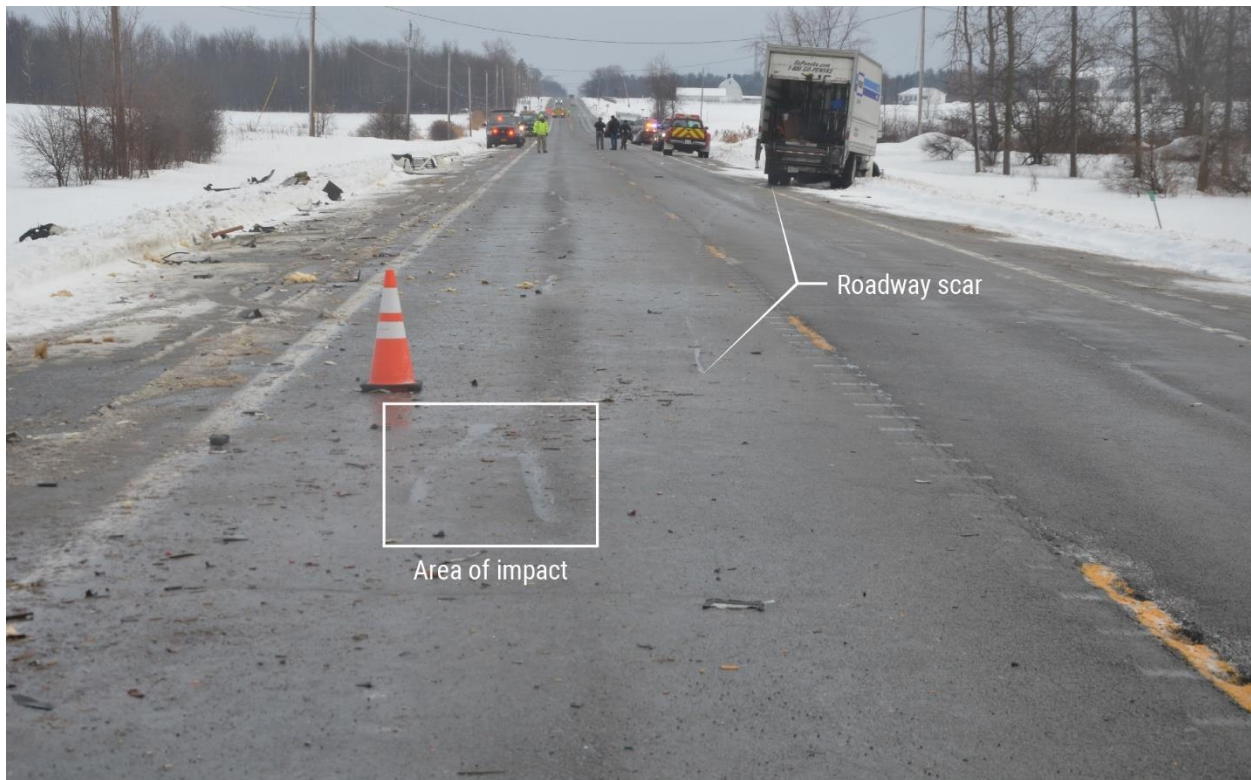
Figure 3. Eastbound SR-37 showing area of impact and roadway scar extending to truck's damaged left front wheel assembly. (Source: New York State Police; annotated by National Transportation Safety Board)

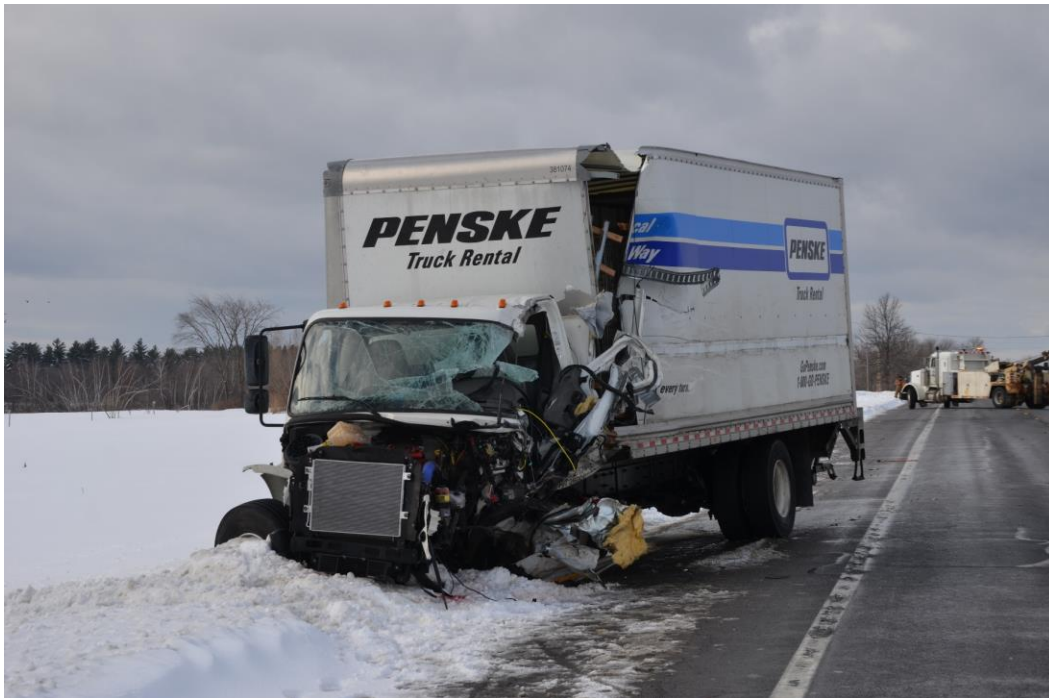
Figure 4. Truck at rest off eastbound shoulder of SR-37. (Source: New York State Police)

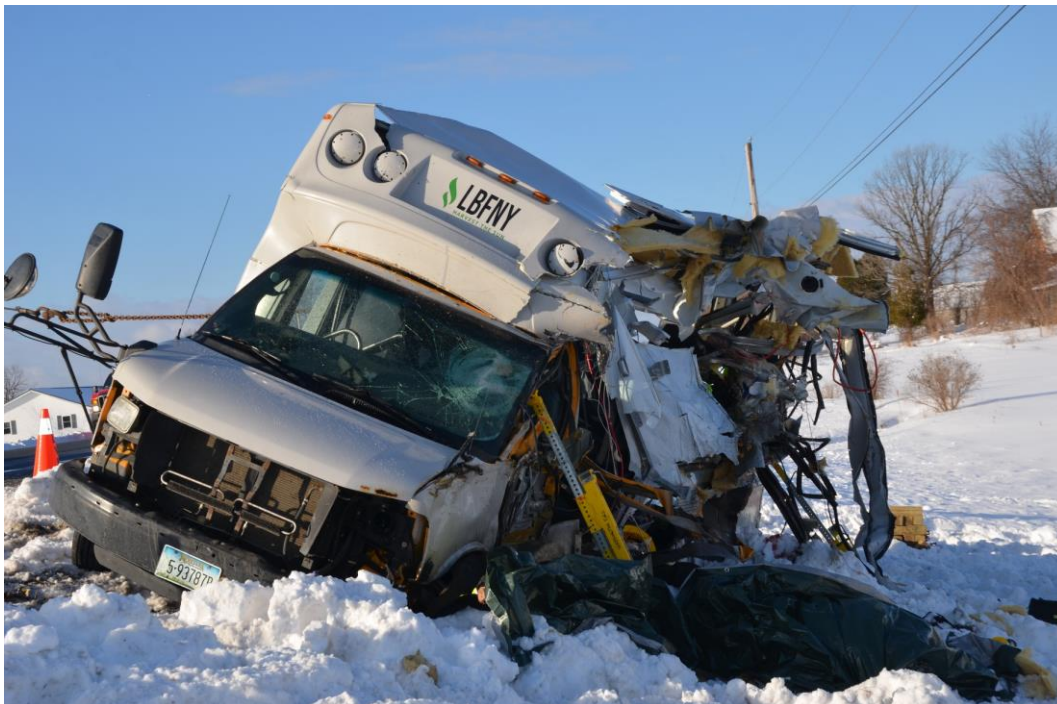
Figure 5. Bus at rest off westbound shoulder of SR-37, facing east. (Source: New York State Police)

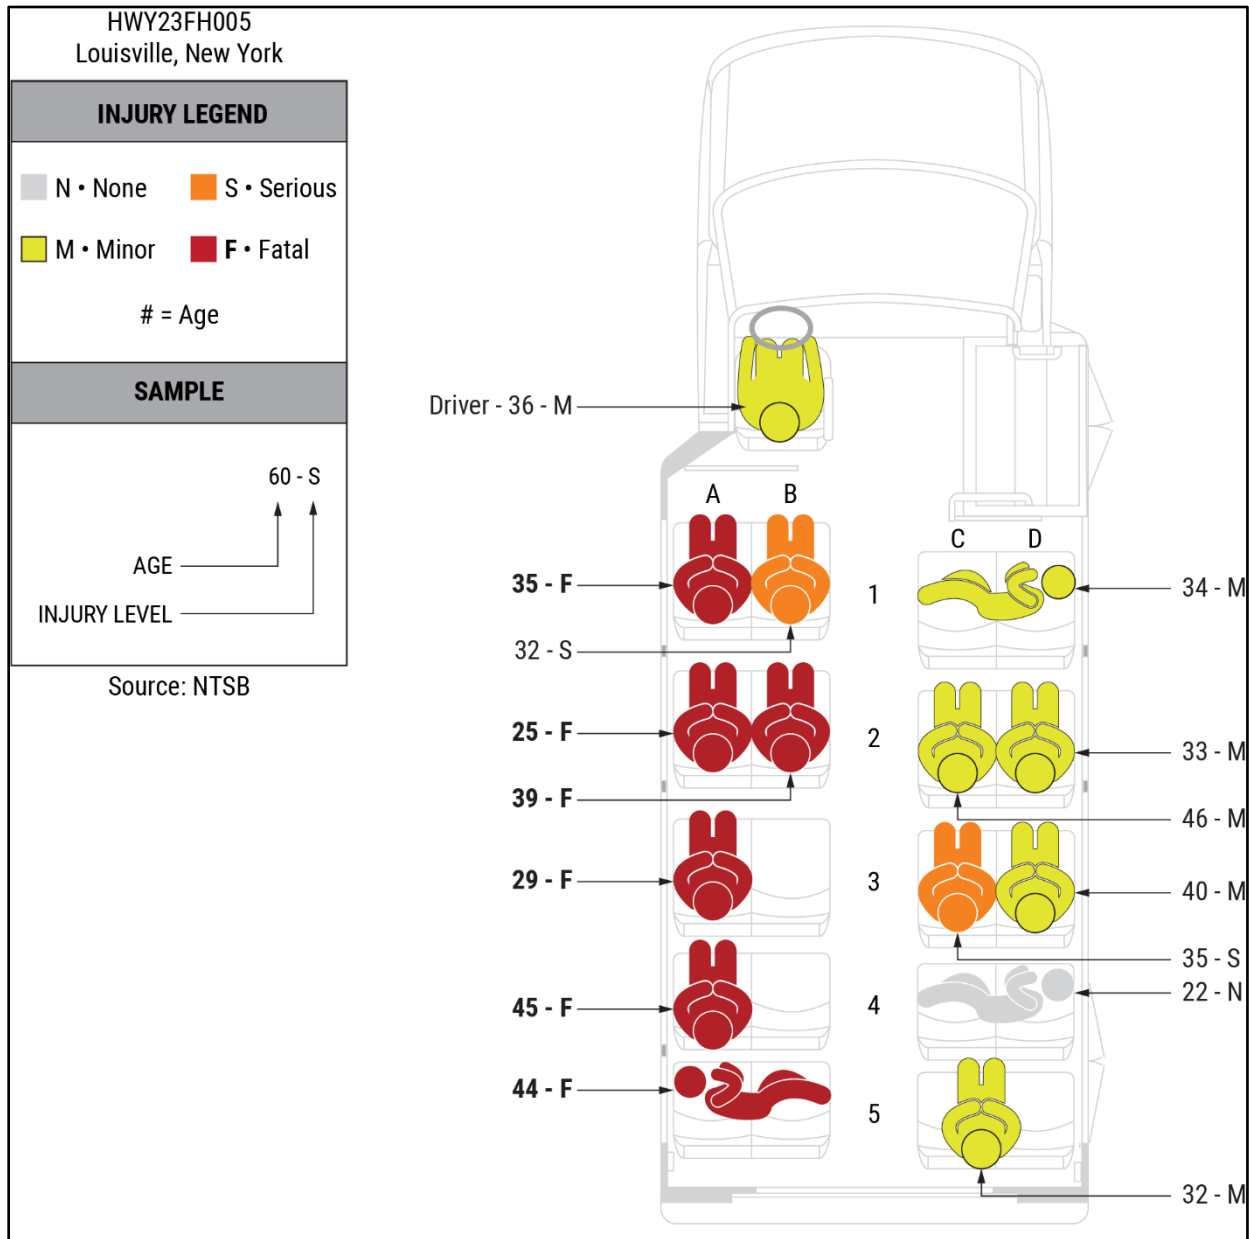
Figure 6. Seating locations and injury severity sustained by bus occupants.

The bus was equipped with three lap belts in all bus passenger seat rows except for the two rows added by the LBFNY mechanics at the right rear of the bus, which did not have any lap belts. Examination of the seat belts found that most of the belts were pushed between the seat pans and the seatbacks, limiting their accessibility to bus passengers. Only one lap belt—located in the aisle seat of row 1 behind the driver (seat 1B)—showed evidence of usage. Emergency personnel extricated the occupant of this seat, who was unconscious, by removing the entangled seat and cutting the lap belt.

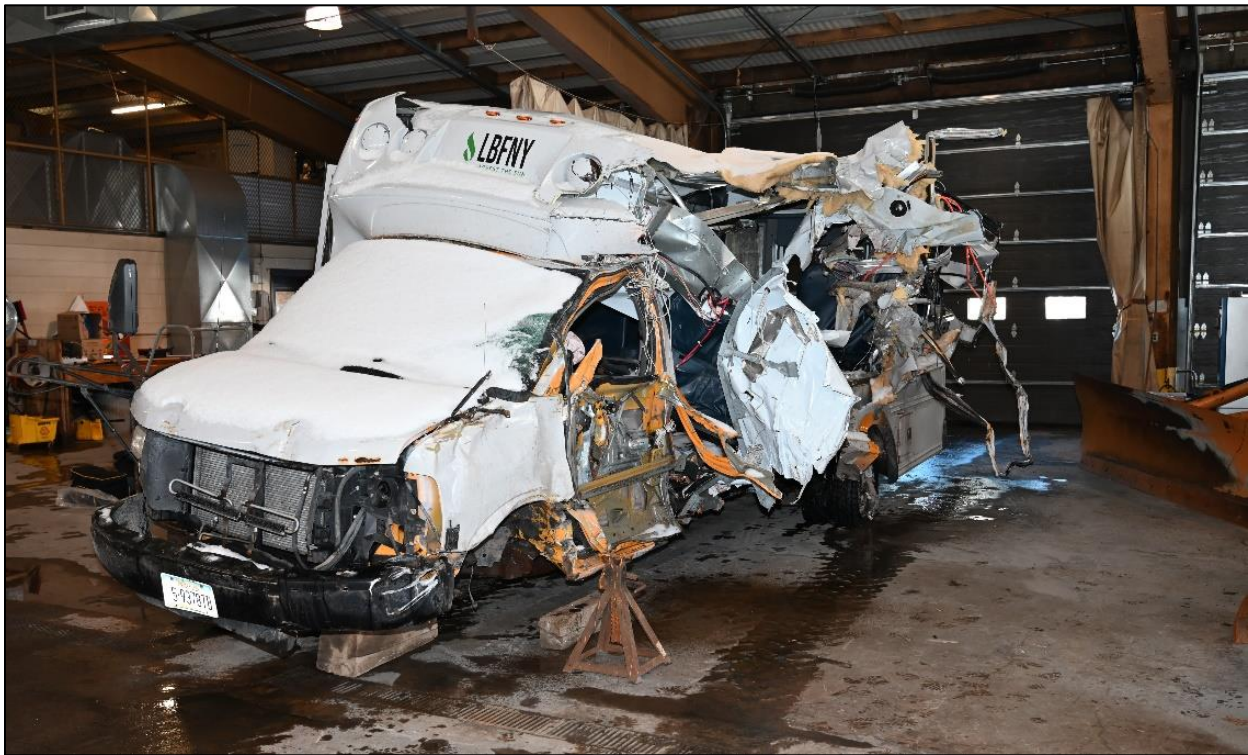
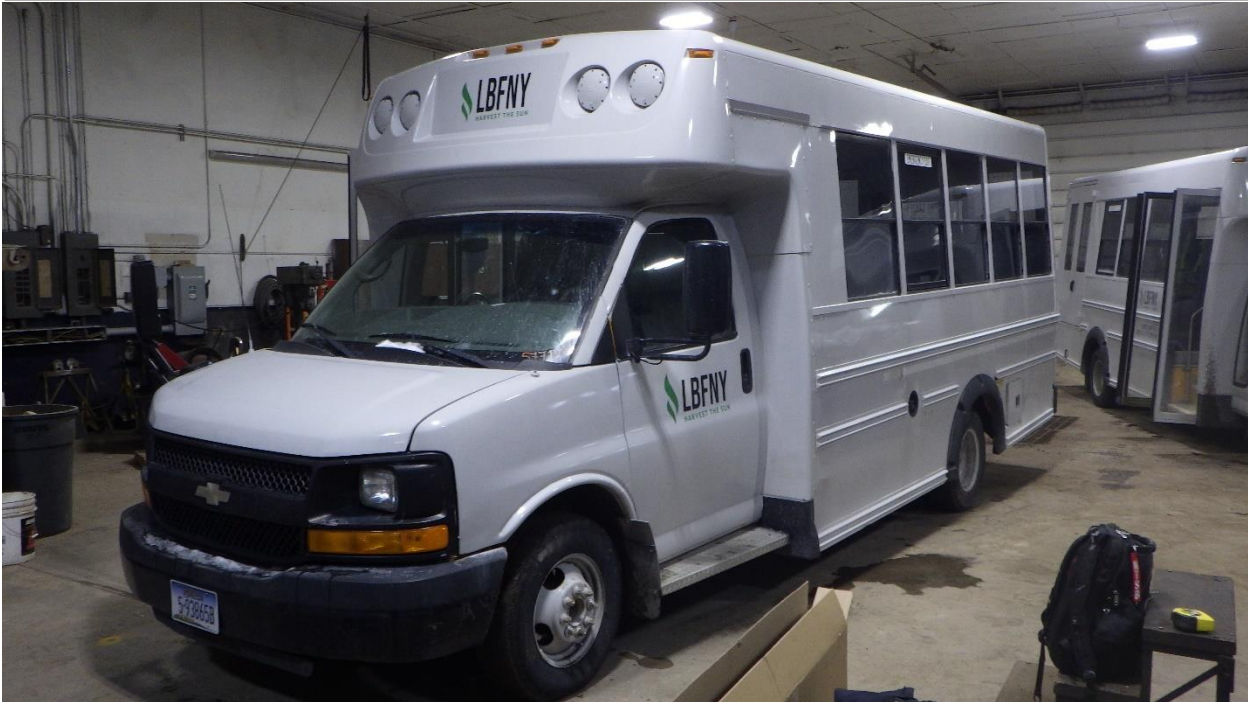
The bus sustained significant contact damage to its entire left side (see figure 8). The bus's front grille, left headlight, trim, and turn signal covering all separated from the vehicle. The leading edge of the hood was dented rearward in two distinct locations. The windshield was cracked and significantly damaged on the left side. Both left-side mirrors separated from the vehicle. The left fender was dented inward. The front left wheel assembly separated from the vehicle and the rear left tires were flat. The outer siding of the driver-side door peeled away from the vehicle, exposing the door mechanisms and interior siding.

Figure 8. Damage to front and left side of bus (top) and example of undamaged bus for comparison (bottom).

The upper-front portion of the bus body sustained contact damage on the left side, which compromised several vertical pillars and horizontal rails. On the right side

of the upper-front portion of the bus, the NTSB observed crash-induced damage in the form of tearing. The left side of the bus sustained contact damage that compromised the waist rail, seat rail, window rail, and other horizontal rails. All left-side vertical pillars behind the B-pillar of the bus were significantly damaged during the collision. The compromised pillars resulted in a large opening on the left side of the bus.

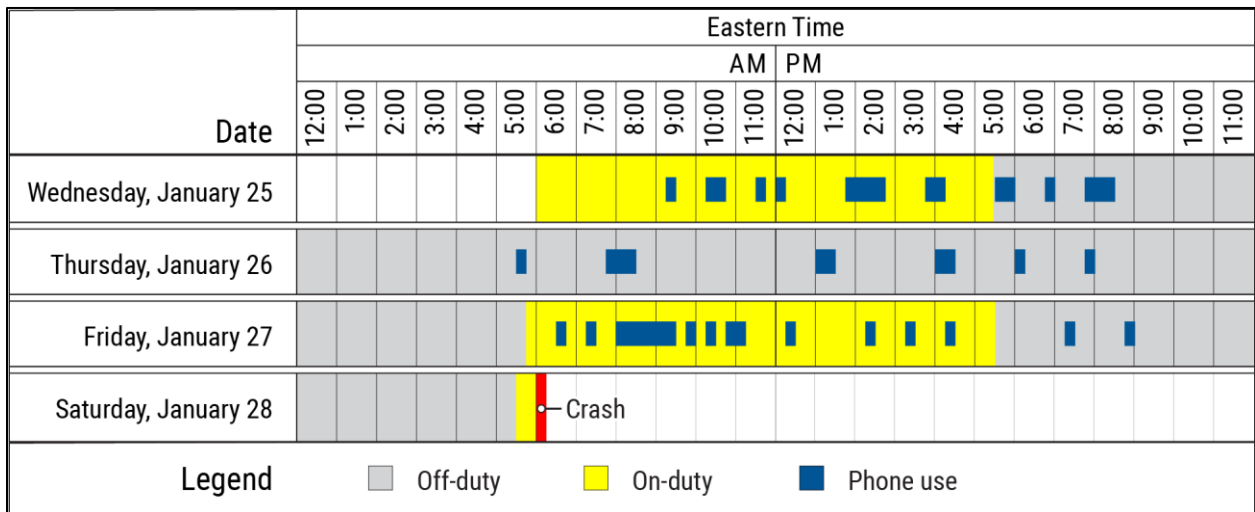
According to the bus driver, he never used his phone when driving. A review of records of the bus driver’s phone service provider showed no calls or texts at the time of the crash. Figure 10 provides an illustration of the bus driver’s phone use.

Figure 10. Graphical representation of the bus driver’s cell phone use and on-duty times during the 72 hours before the crash. Phone use is based on the bus driver’s cell phone records and is shown as a contiguous block if the time between outgoing texts or phone calls was less than 15 minutes.

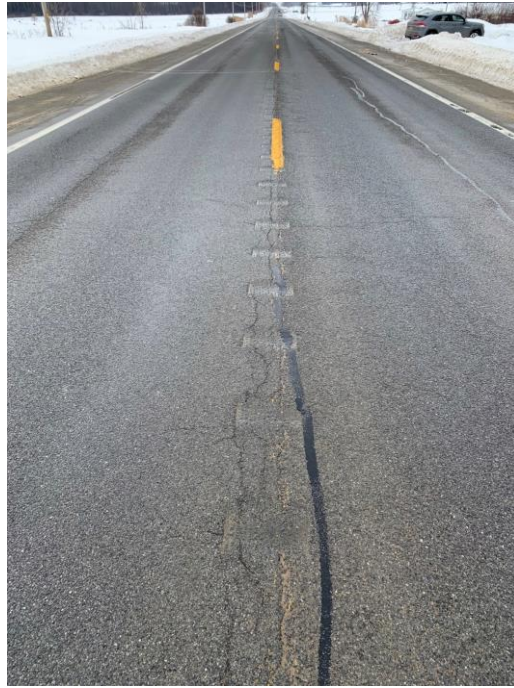
Centerline rumble strips spaced about 24 inches apart were positioned on SR-37 in the vicinity of the crash location. Figure 13 illustrates the centerline rumble strips, which were 7 inches wide by 12 inches long with a depth of one-half inch.⁵⁸

Figure 13. East-looking view of SR-37 centerline rumble strips.
