## PRELIMINARY REPORT

## Collapse of Pedestrian Bridge Under Construction Miami, Florida (HWY18MH009)

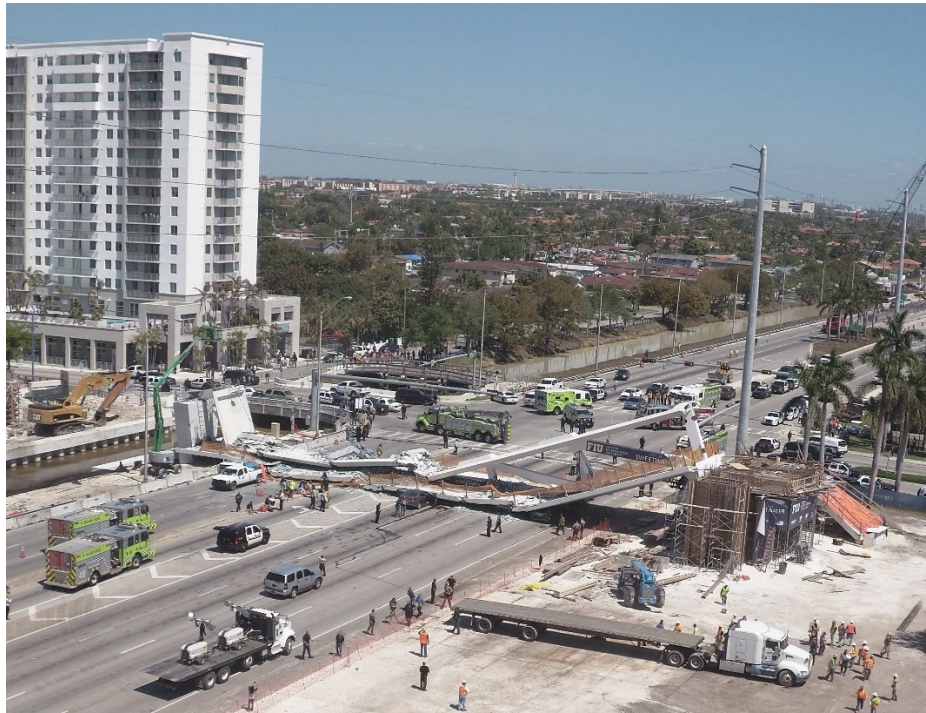
On Thursday, March 15, 2018, about 1:47 p.m. eastern daylight time, a partially constructed pedestrian bridge crossing SW 8th Street—an eight-lane roadway—in Miami, Florida, experienced a structural failure.<sup>1</sup> As a result, the 174-foot-long bridge fell about 18.5 feet onto SW 8th Street (figure 1). Eight vehicles that were stopped below the bridge at the time of the collapse were fully or partially crushed; seven of those vehicles were occupied. As a result of the bridge collapse, one bridge worker and five vehicle occupants died. Four bridge workers and four other people were injured.

**Figure 1.** View of collapsed pedestrian bridge. (Source: Florida International University)

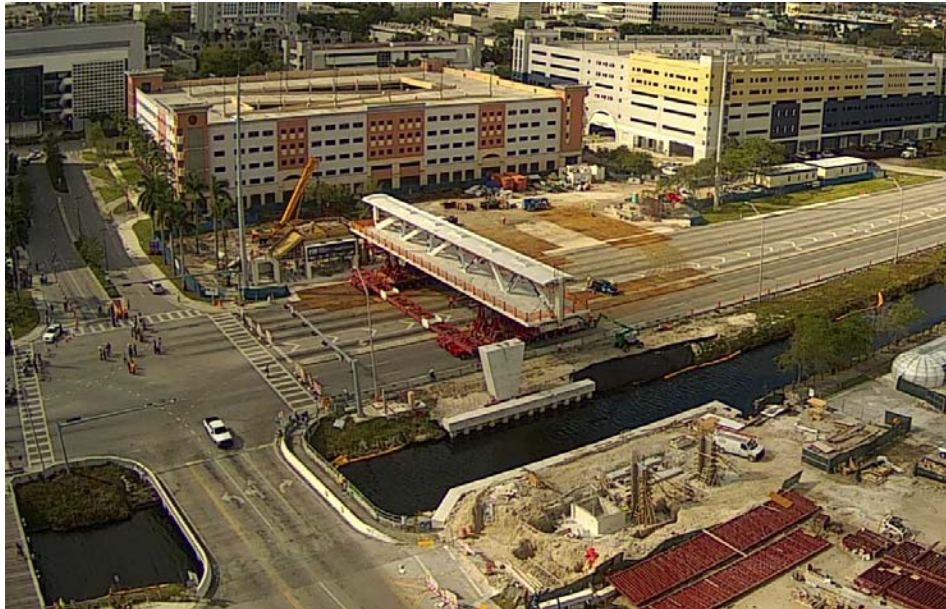
The bridge was to be completed by early 2019 and was built using an accelerated bridge construction method—a technique intended to minimize disruption of traffic. On March 10, 2018, the walkway, diagonals, and canopy comprising the bridge, which had been built in a lot adjacent to SW 8th Street, was moved from the lot, using transporters, into position across the roadway and then lowered onto bridge piers on either side of the roadway (figure 2).<sup>2</sup> Traffic on SW 8th Street was detoured during the installation period, and the entire roadway was closed to facilitate movement of the structure.

**Figure 2.** View of transporters moving the pedestrian bridge into place on the bridge piers. (Source: Florida International University)

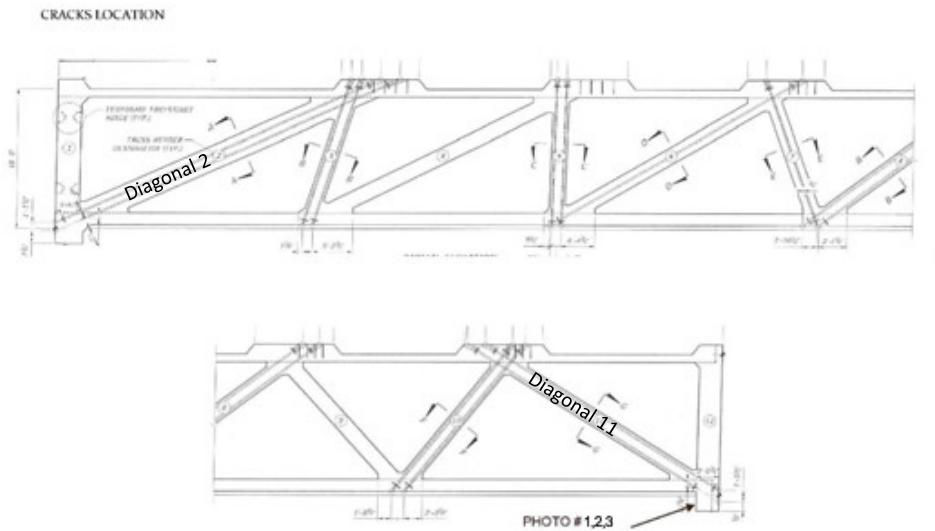
The NTSB is evaluating the bridge design, the construction process, and the construction materials. In addition, the NTSB is evaluating the emergence of cracks in the region of diagonal members 2 (south end of the bridge) and 11 (north end of bridge), see figure 3, and the propagation of cracks in the region of diagonal member 11. Photographic documentation from February 24, 2018 shows cracks in the region of diagonal member 11 (figure 4).

**Figure 3.** Elevation view of the pedestrian bridge. (Source: Bolton-Perez and Associates Consulting Engineers)

On March 10 per the bridge design plans, construction crew members de-tensioned the bridge diagonal members on the north and south ends of the bridge. When the collapse occurred on March 15, a construction crew was positioned on the structure working on re-tensioning the number 11 diagonal member connecting the canopy and the deck at the north end of the bridge. Because a crane was being used for this work, two of the three westbound lanes below the north end of the bridge were closed to traffic; however, the five eastbound lanes remained open, and eastbound traffic was not detoured.

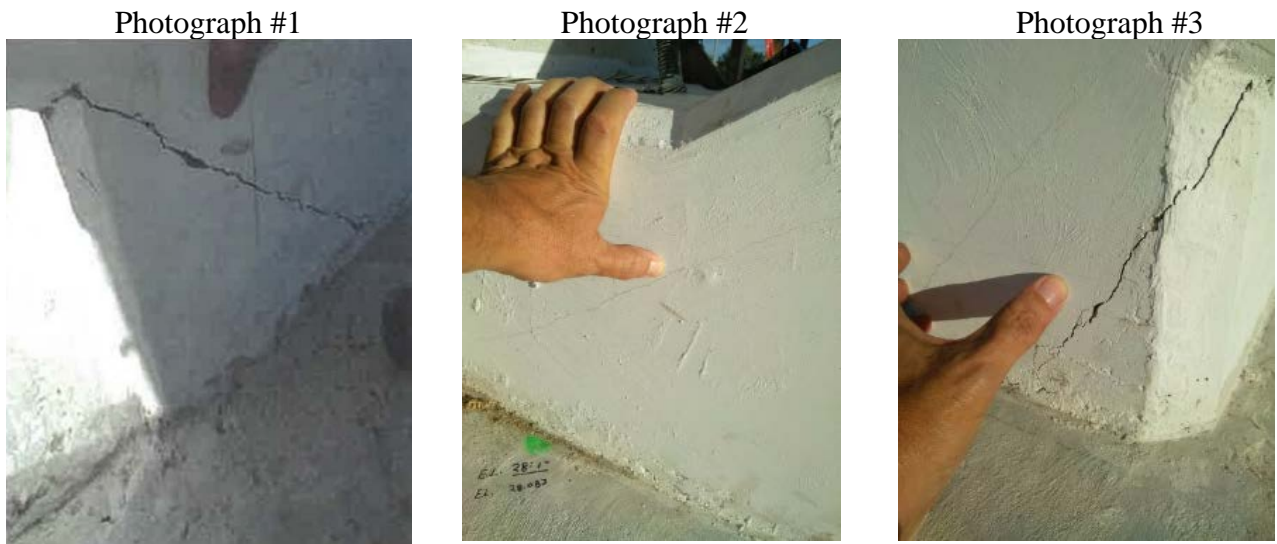
**Figure 4.** Photographic documentation of the crack in the region of bridge diagonal 11. (Source: Bolton-Perez and Associates Consulting Engineers)
