# National Transportation Safety Board

## Railroad Accident Brief

<b>Accident No.:</b>	DCA-07-FR-001
<b>Location:</b>	Pajaro, California
<b>Date:</b>	October 13, 2006
<b>Time:</b>	9:20 a.m., Pacific daylight time <sup>1</sup>
<b>Railroad:</b>	Union Pacific Railroad
<b>Property Damage:</b>	None
<b>Fatalities:</b>	1
<b>Injuries:</b>	None
<b>Type of Accident:</b>	Yard switching operations

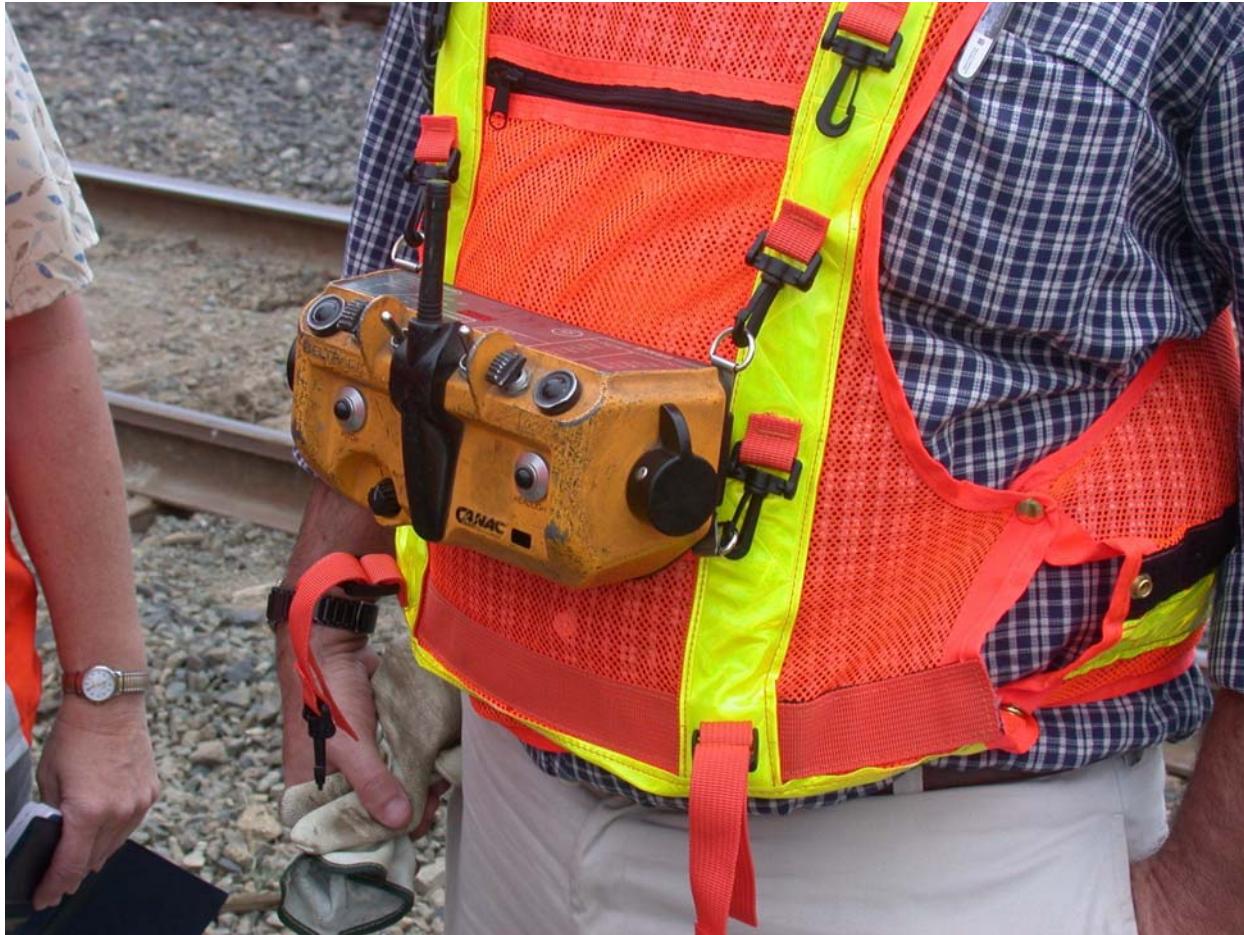
**Figure 1.** Operator Control Unit.

This crew was the only one working in the yard. The conductor was using an Operator Control Unit (OCU) to remotely control a locomotive that was used to switch railroad cars onto various yard tracks. (See figure 1.) The brakeman was to (1) ensure that the car couplings were successfully completed, (2) set the hand brakes, as needed, and (3) connect the air hoses.

The locomotive's event recorder indicated that the brakeman's OCU transmitted a tilt warning<sup>4</sup> at 9:20 a.m. One second later, the OCU transmitted an emergency brake command. The tilt warning continued for 4 more seconds, and then the OCU transmitted an automated "man down."
