National Transportation Safety Board

Railroad Accident Brief

Collision of Two Chicago Transit Authority Trains

Accident No.:	DCA13FR014
Location:	Forest Park, Illinois
Date:	September 30, 2013
Time:	7:42 a.m. central daylight time
Train:	Unoccupied equipment and southbound train No. 110
Railroad:	Chicago Transit Authority
Property Damage:	\$6.4 million
Injuries:	34
Fatalities:	0
Type of Accident:	Collision

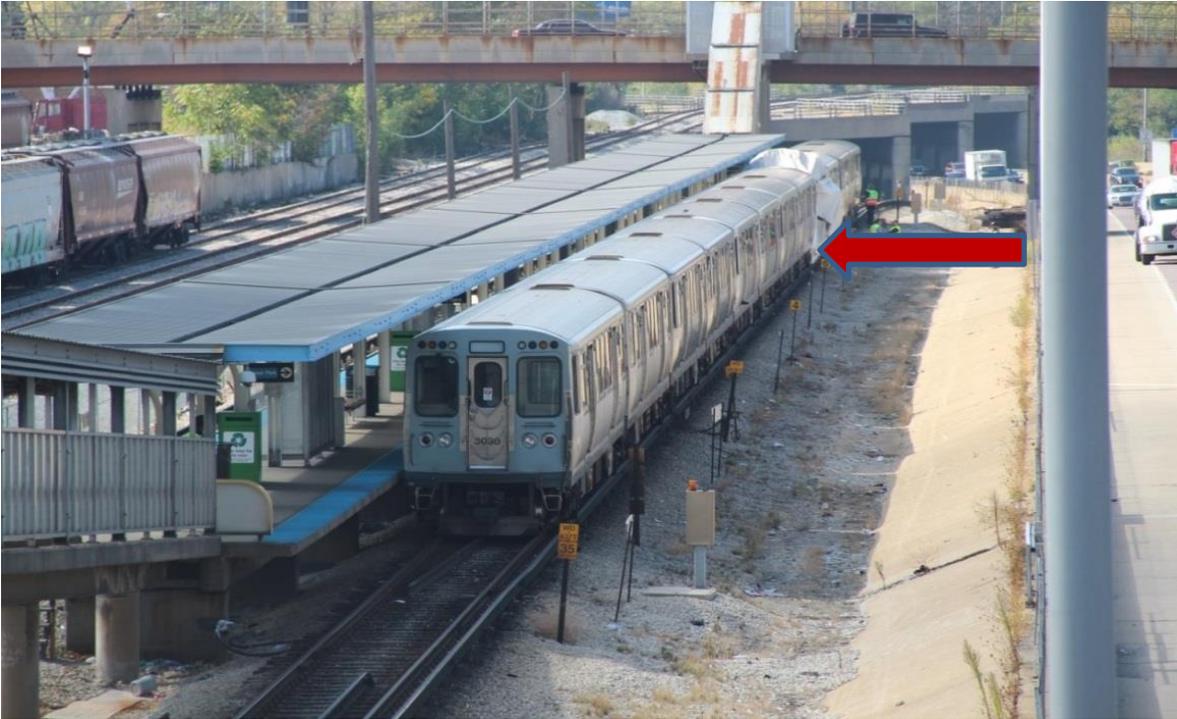
Figure 1: Arrow points to the damaged lead car of passenger train 110.

On Monday, September 30, 2013, at 7:42 a.m. central daylight time, a set of unoccupied Chicago Transit Authority (CTA) passenger cars collided with CTA passenger train 110 at the Harlem-Congress passenger station in Forest Park, Illinois (See figure 1.). The unoccupied cars were moving about 24 miles per hour when they struck the stopped train. Thirty-three passengers and the train operator were taken to local hospitals and later released. CTA estimated the property damage to be \$6.4 million.

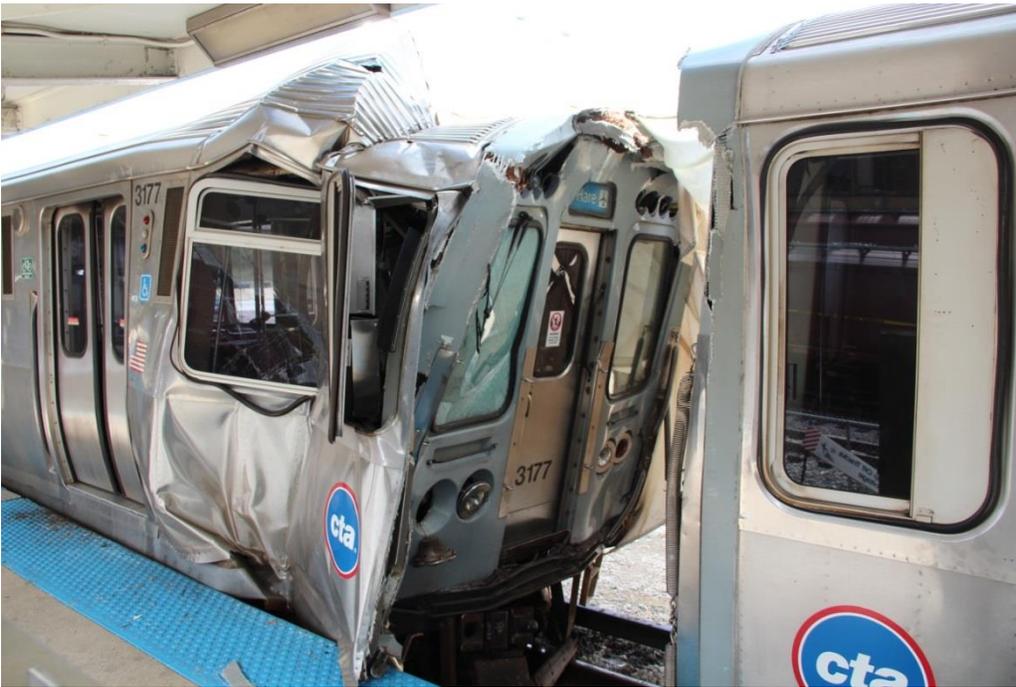
Figure 2: Crumpled lead car of passenger train 110 and minimally damaged striking car.

The lead cars of both the unoccupied cars and the passenger train were damaged (See figure 2.); the wheel of one car derailed (See figure 3.). As a result of the accident, CTA suspended all passenger operations north of the Harlem-Congress Station.

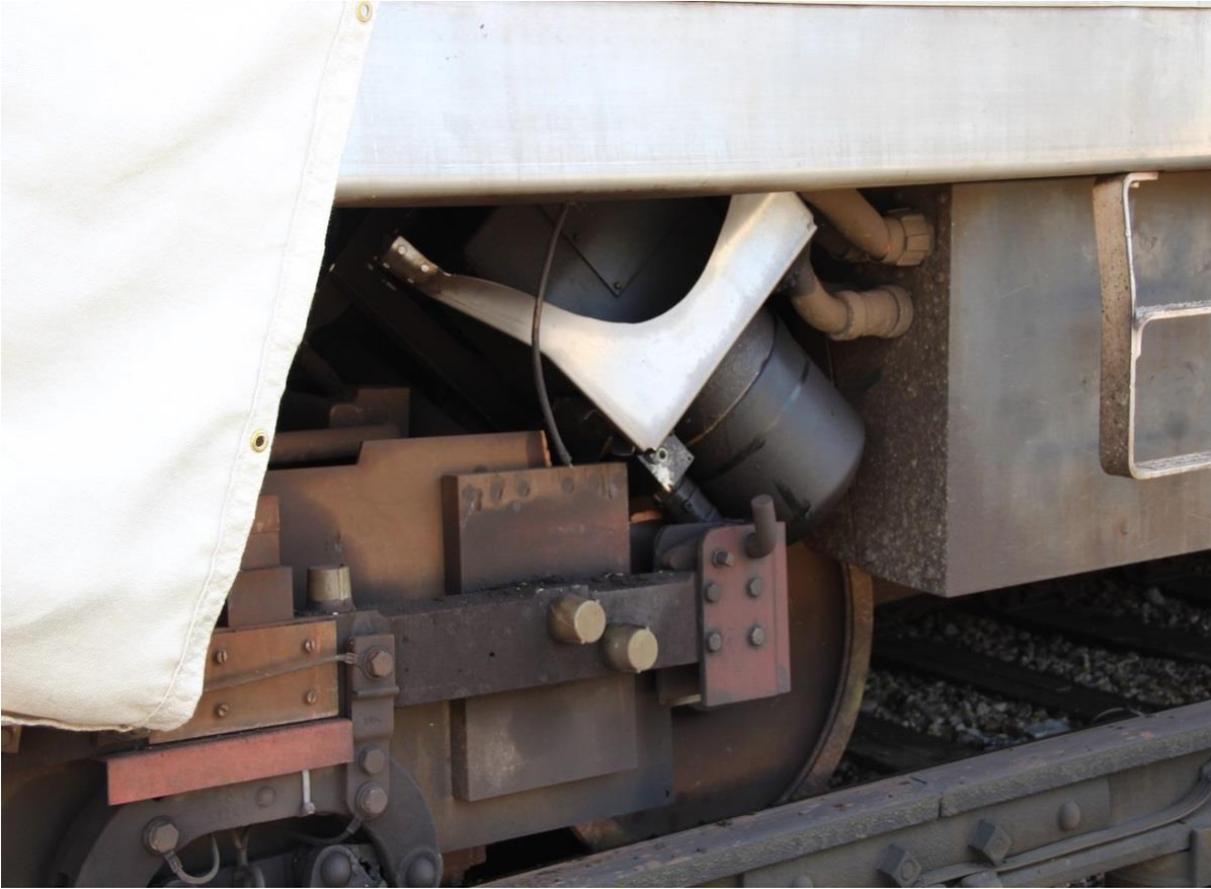
Figure 3: Derailed wheel and axle of the lead truck on the lead car.

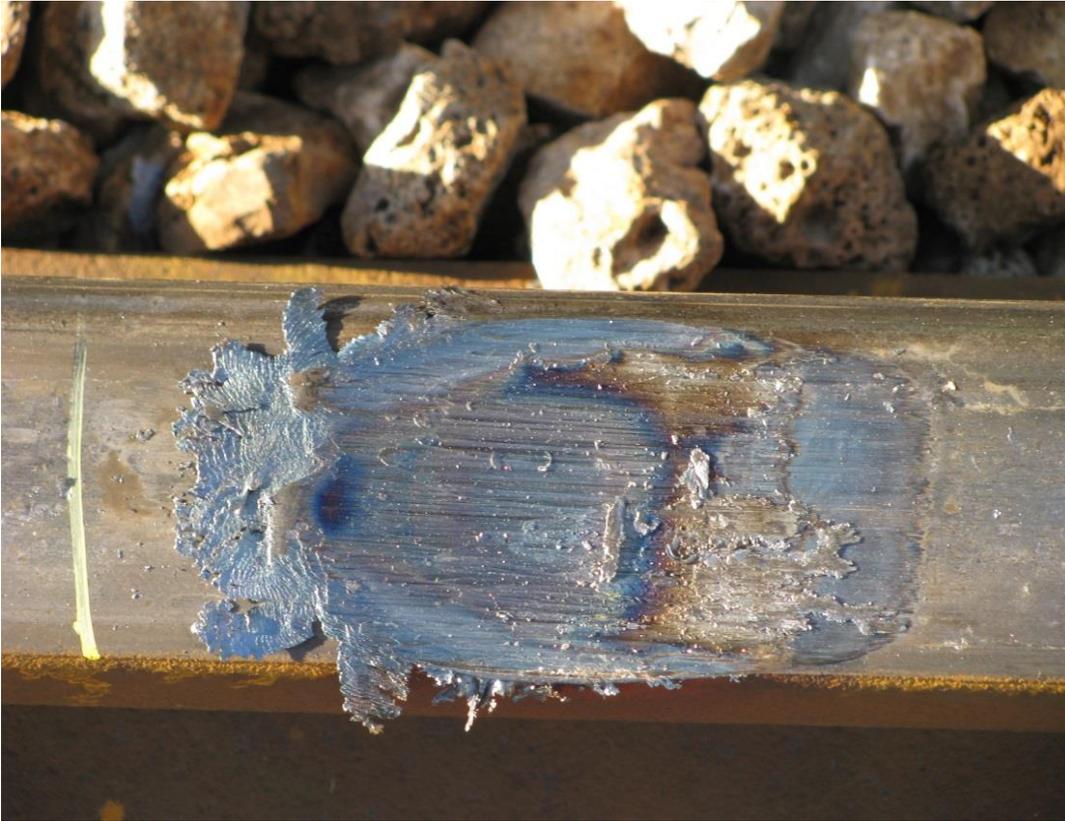
NTSB investigators determined that track conditions did not affect the operation of either the unoccupied cars or train 110. However, investigators found marks on the rails where the cars had been stored on the 1 West track. The marks showed that at least one of the unoccupied cars had been receiving power—causing the wheels to spin—before the cars rolled out of the Forest Park yard (See figure 4.).

Figure 4: Rail mark on 1 West track.

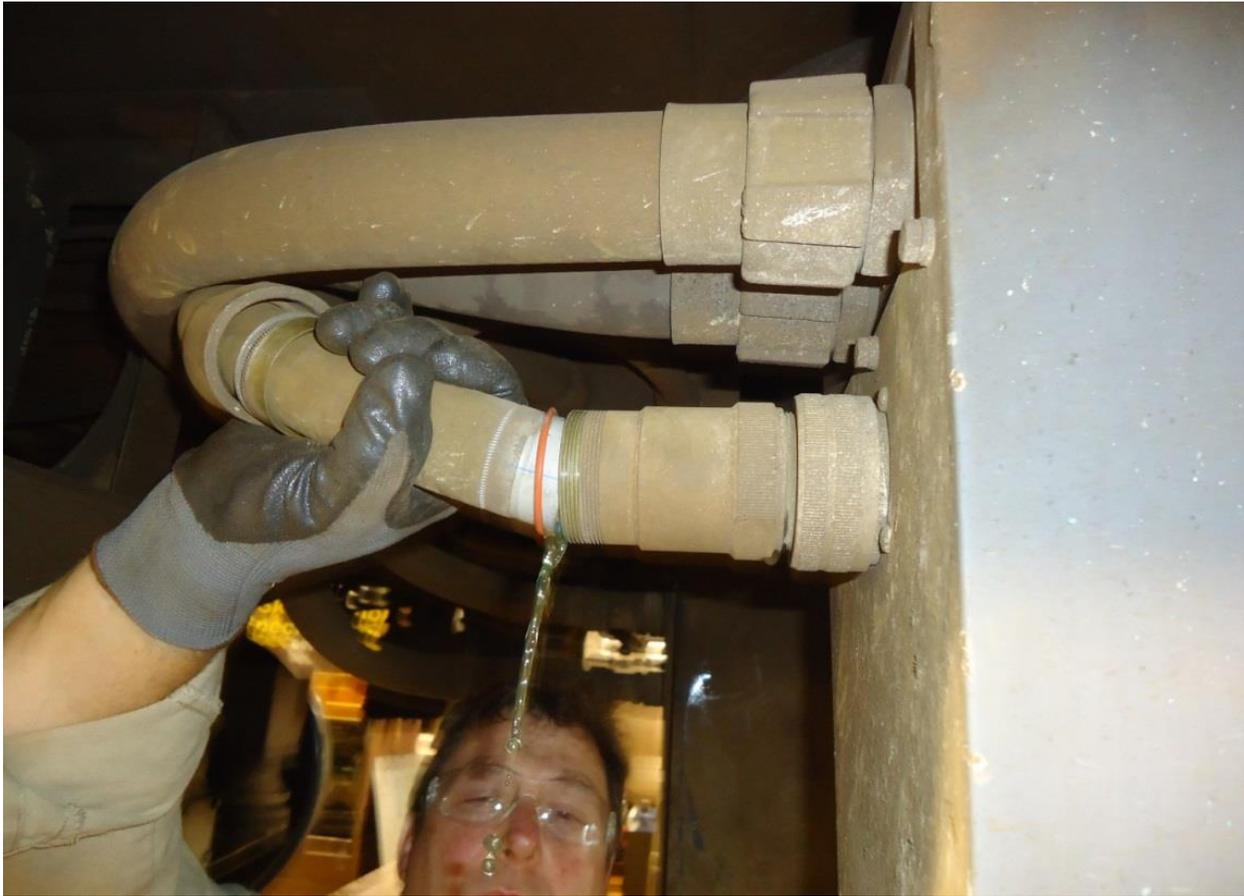
NTSB investigators examined all of the equipment involved in the accident at the accident scene. The unoccupied cars were then moved to a CTA maintenance facility and examined in more detail. After disassembling the control system, investigators found liquid in the control cables of two cars. (See figure 5.) An analysis determined the liquid to be primarily water with minute traces of other elements.

Investigators also examined the data from the data recorders on the unoccupied cars and found that errant control signals were being sent to the power systems of the two cars that had water in the control cables.² These errant control signals instructed the cars' power systems to apply power, move, and stop.

Figure 5: Liquid draining from control system cables of unoccupied car. (CTA)

Review your operating and maintenance procedures for stored unoccupied cars to ensure the propulsion and brake systems are left in a condition that would not facilitate unintended movement. (Urgent) (Closed—Acceptable Action)

Immediately implement redundant means of preventing unintended rail car movements, such as wheel chocks or a derail device. (Urgent) (Closed—Acceptable Action)

The National Transportation Safety Board determines that the probable cause of the accident was water in the control cables of two cars, which caused errant control signals to be sent to the cars' power systems. Contributing to the accident was the Chicago Transit Authority's practice of not securing unattended equipment.
