# National Transportation Safety Board

## Railroad Accident Brief

### National Passenger Rail Corporation Maintenance-of-Way Employee Fatality

<b>Accident No.:</b>	DCA14FR003
<b>Location:</b>	Clermont, New York
<b>Date:</b>	October 29, 2014
<b>Time:</b>	10:56 a.m. eastern daylight time
<b>Train:</b>	Amtrak A280
<b>Railroad:</b>	National Passenger Rail Corporation (Amtrak)
<b>Injuries:</b>	0
<b>Fatalities:</b>	1
<b>Type of Accident:</b>	Employee fatality

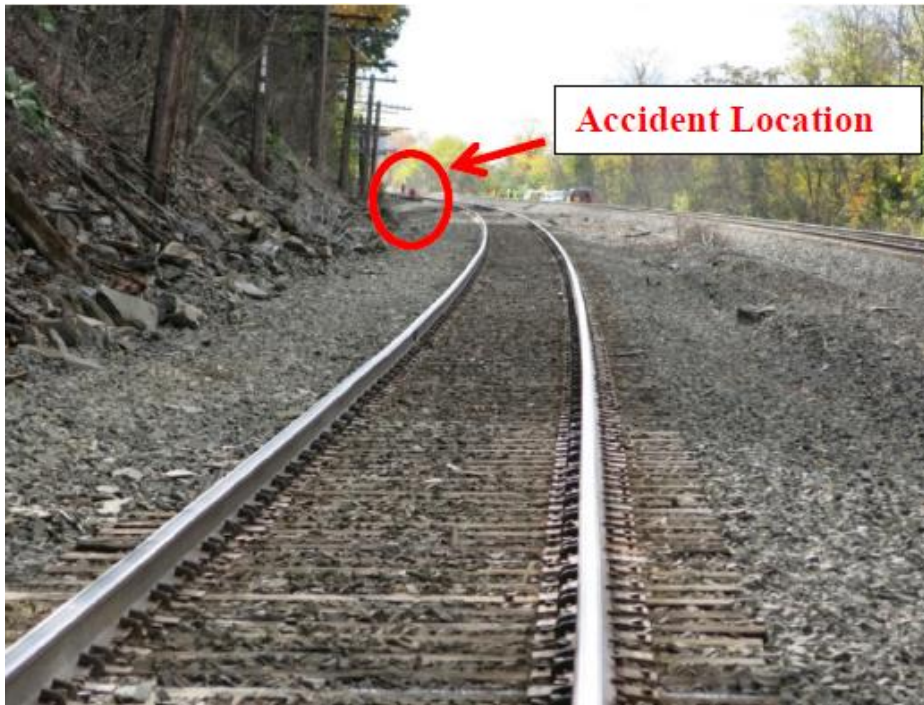
**Figure 1.** Recreation showing point where worker likely became visible to train crew—1,540 feet.

Train A280 consisted of one locomotive and five passenger coaches. As the southbound train was rounding a 1-degree curve, the engineer said he observed two orange objects in the distance at the far end of the curve where the track was straight. (See figure 1.) He thought they were workers and immediately began sounding the horn to alert them. The audio and video from the outward-facing camera and the data from the event recorder confirmed the horn sounded at 10:55:20 a.m.
