# PRELIMINARY REPORT

### Collision Between BNSF Intermodal Train and Rail Unloading Machine Vehicle at the Rear of a BNSF Work Train

near Kingman, Arizona

RRD18FR009

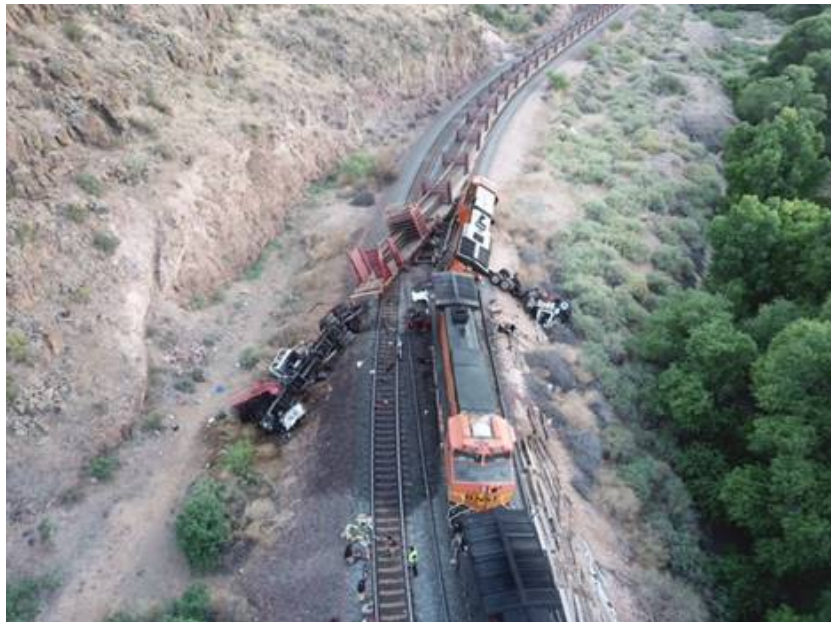
**Figure 1.** Accident scene. (Photograph courtesy of BNSF.)

On June 5, 2018, about 2:50 p.m. mountain standard time, a westbound BNSF Railway (BNSF) intermodal train, S MEMSCO1 02 (intermodal train), operating in double-track centralized traffic control (CTC) territory collided with a rail unloading machine (RUM) vehicle at the rear of a ribbon rail work train, W NEESGM1 05 (work train).<sup>1</sup> The accident occurred in Crozier Canyon, about 33 miles east of Kingman, Arizona. At the time of the accident, the sky was clear, the wind was from the southwest about 25 mph, and the temperature was 97°F. One Herzog Railroad Services, Inc. (Herzog) employee died and another was seriously injured.<sup>2</sup> Damages were estimated to be over \$1 million. Figure 1 shows the accident scene.

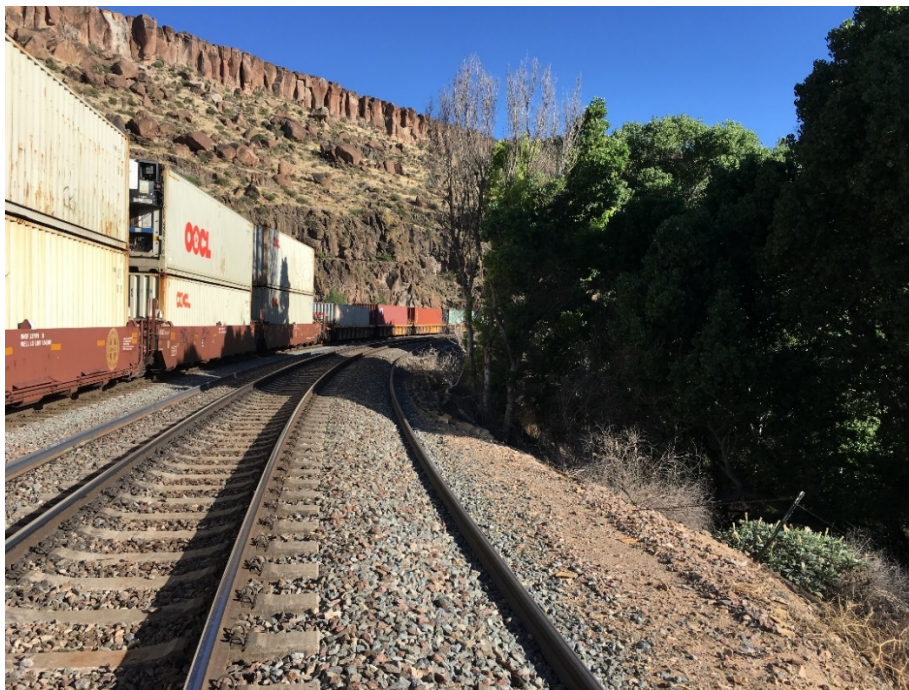
There were trees on the inside of the curve, causing a short line of sight distance. (See figure 2.) Because of this, the intermodal train descended the 1.5-percent grade using dynamic braking and reached a top speed of 15 mph before arriving at the curve in Crozier Canyon.

**Figure 2.** Viewpoint of the approaching intermodal train entering the 8° curve just before the point of collision.
