National Transportation Safety Board
Washington, DC 20594

Safety Recommendation Report
**Inward- and Outward-facing Audio and Image Recorders
as Investigative and Safety Tools**

Accident Number:	DCA17FR006
Operator:	Southeastern Pennsylvania Transportation Authority
Vehicle:	Light rail passenger car
Location:	Upper Darby, Pennsylvania
Date:	February 21, 2017
Recommendation Numbers:	R-17-013 through -15
Adopted:	August 24, 2017

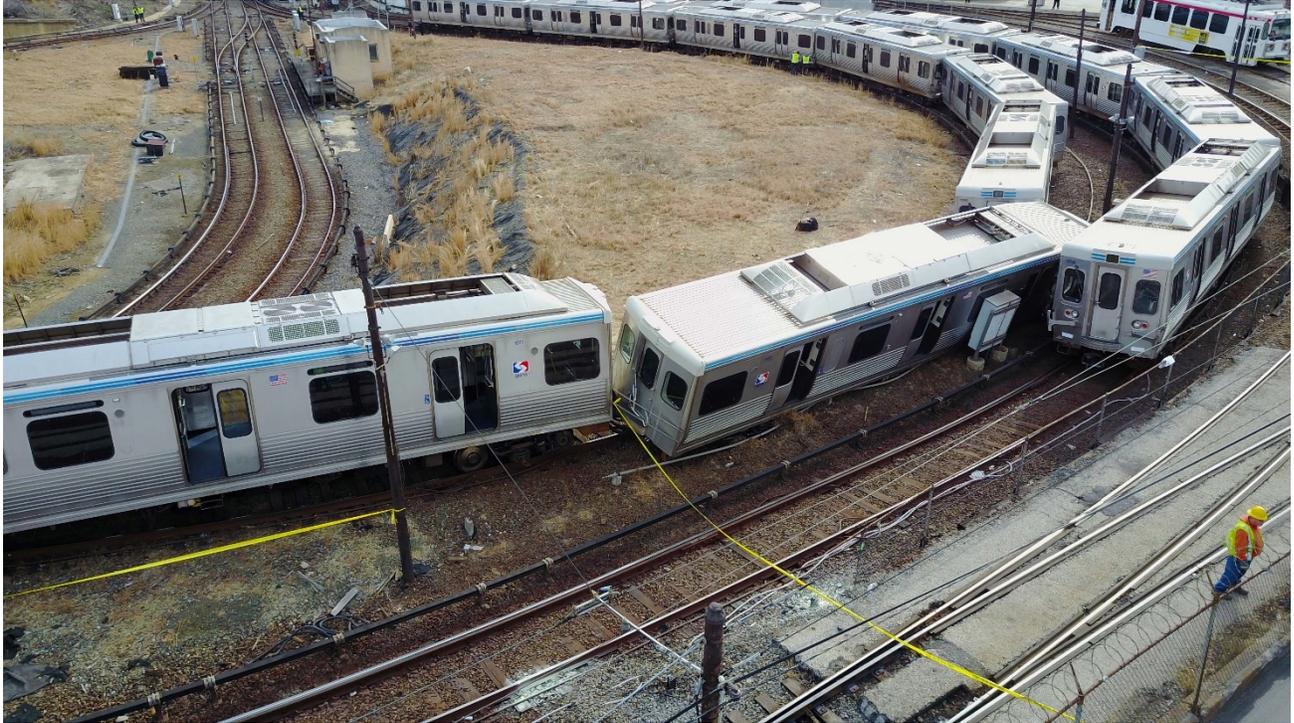
On February 21, 2017, at 8:10 a.m. eastern daylight time, SEPTA train 57 was traveling west at 10 mph when it collided with the rear of train 67, which had stopped on loop track 2 near the 69th Street station. The trains were not equipped with audio or image recorders in the operating cabs or forward-facing cameras, which would have proved invaluable in investigating this accident. Four cars derailed from train 57, and three derailed from train 67. The derailed cars from train 67 struck train 51 as it traveled in the opposite direction on loop track 1. (See figure 1.) A train operator in the control compartment of the lead car of each train operated the trains in manual mode. Each train included cars powered by an electrified third rail.

Two passengers were on board the striking train; no passengers were on trains 67 and 51. Both passengers and the operators of trains 57 and 67 were injured.

Figure 1. Accident site. (Photo: Upper Darby Police Department.)

Install crash- and fire-protected inward- and outward-facing audio and image recorders capable of recording operator actions in all rail transit vehicle operating compartments. The devices should have a minimum 12-hour continuous recording capability with recordings that are easily accessible for review for the investigation of accidents and as a tool to improve operational safety. (R-17-14)
