Safety Recommendation Report

Hazards of Moving Between Transit Railcars

Accident Number:	RRD18FR011
Operator:	Southeastern Pennsylvania Transportation Authority
Accident:	Passenger Fatality
Location:	Philadelphia, Pennsylvania
Date:	September 23, 2018
Recommendation Numbers:	R-19-39 and -40
Adopted:	August 27, 2019

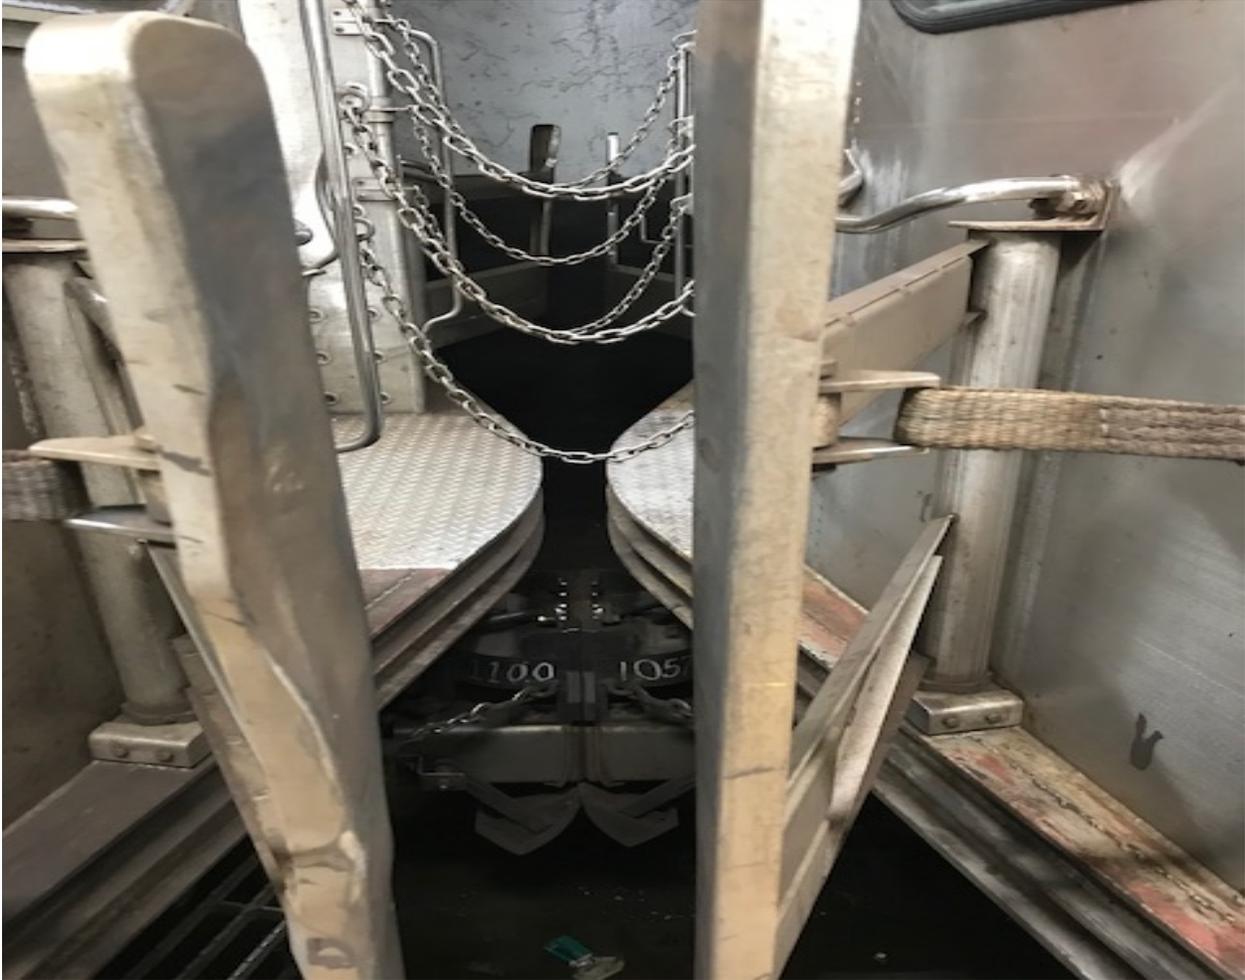
On September 23, 2018, about 5:35 p.m. local time, a Southeastern Pennsylvania Transportation Authority (SEPTA) subway train operator stopped a southbound train between the Alleghany Station and the North Philadelphia Station on the Broad Street Line when a passenger activated an emergency alert.¹ The train dispatcher instructed the train operator to perform a ground level inspection of the train. The operator found, between the running rails about 10 feet south of the Alleghany Station platform, a child that had been struck and killed by the train. According to witness statements provided to SEPTA officials, the child, a 7-year-old boy, was walking through the end-of-railcar doors from car 516 to car 536, when he fell between the railcars as the train moved out of the Alleghany Station. (See figure 1.)

Figure 1. Photograph of the area between SEPTA Broad Street Line subway railcars 516 and 536.

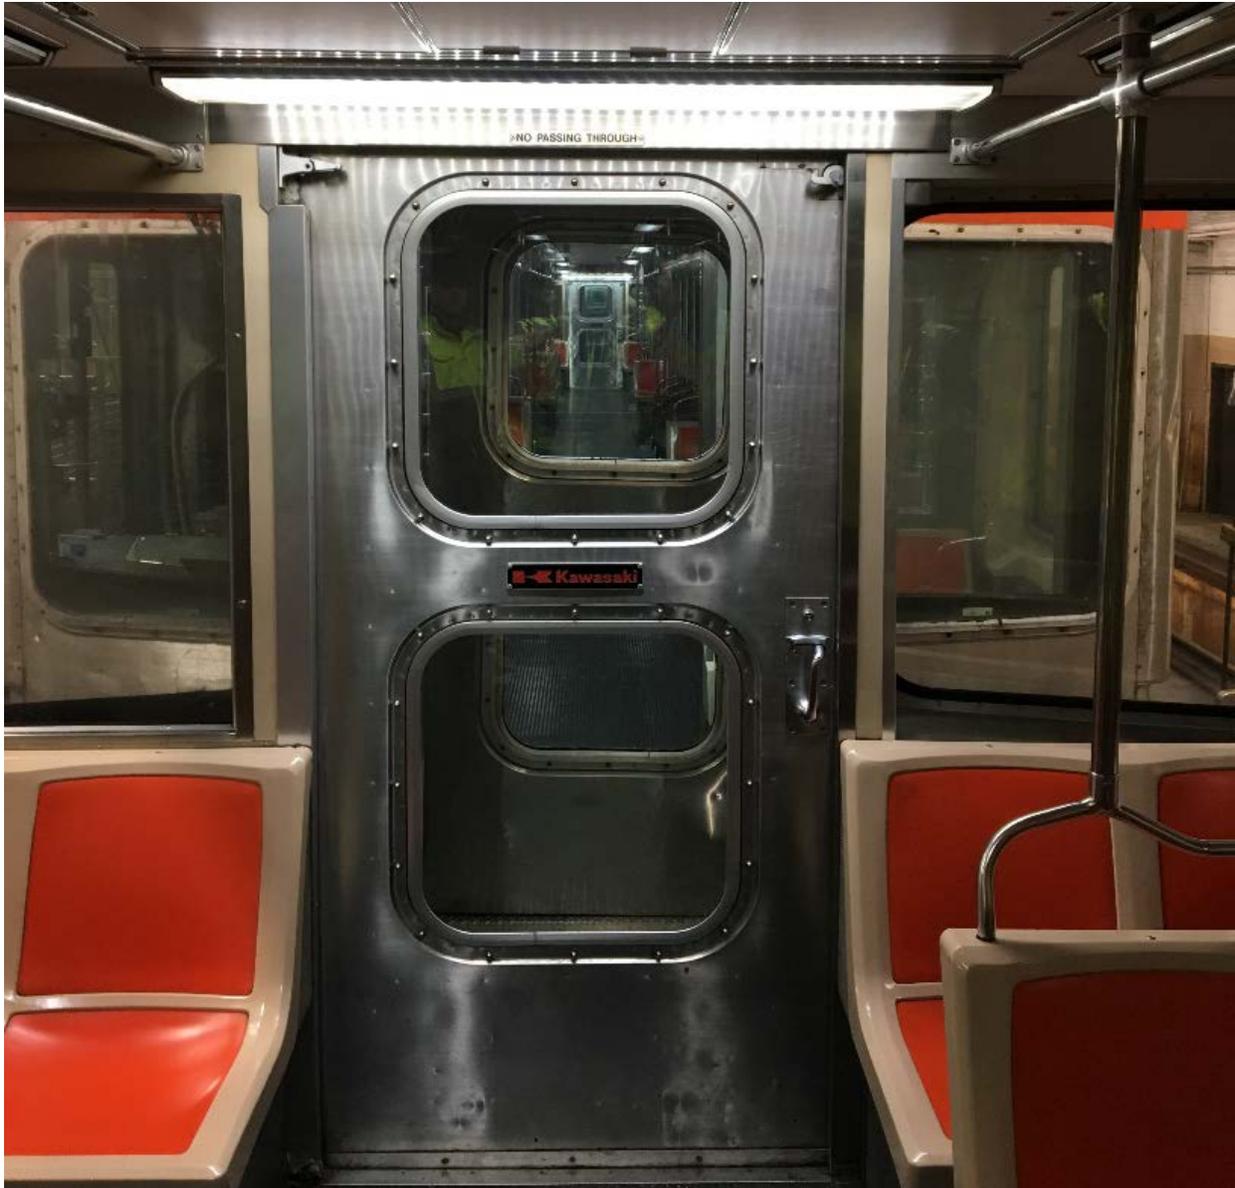
SEPTA and other rail transit operators use railcars with end-of-railcar doors.² The doors provide a pathway between two coupled railcars for use in emergency situations. However, because of gaps in the floor area between the coupled railcars, it can be dangerous to transit between railcars when the train is moving. Transit rail operators using railcars with end-of-railcar doors must ensure that passengers are informed about the dangers of walking between the railcars, especially when the train is moving. At the time of the accident, the only warning in SEPTA Broad Street Line subway cars was lettering on the door frame above the end-of-railcar doors stating, “NO PASSING THROUGH.” (See figure 2.)

Figure 2. End-of-railcar door on a SEPTA subway railcar, with “NO PASSING THROUGH” text above door.

Human factors engineering promotes the deliberate design and placement of warning signs that attract visual attention, are easily understood and interpreted, and provide clear guidance to avoid hazards.³ The warning over the end-of-railcar door in SEPTA’s Broad Street subway railcar does not meet human factors guidelines for effective warning signs. Specifically, the content of the warning fails to provide several essential elements of information, such as the nature of the hazard, what to do if the hazard is encountered, and whom to contact in case of an emergency. The warning lacks internationally recognized symbols, and the contents of the warning are written only

in English without conspicuous letter size, spacing, color, or contrast for readability. Additionally, the warning sign is not placed to attract visual attention.

Use your authority under Title 49 *United States Code* Part 5329 to develop standards for safety messaging for end-of-railcar doors, including appropriate sign location, text, and symbols to be placed on rolling stock. (R-19-39)

Once the messaging standards are successfully developed, use your authority under Title 49 *Code of Federal Regulations* 670.25 to immediately issue a general directive that would require all rail transit agencies to implement those standards on applicable rolling stock. (R-19-40)

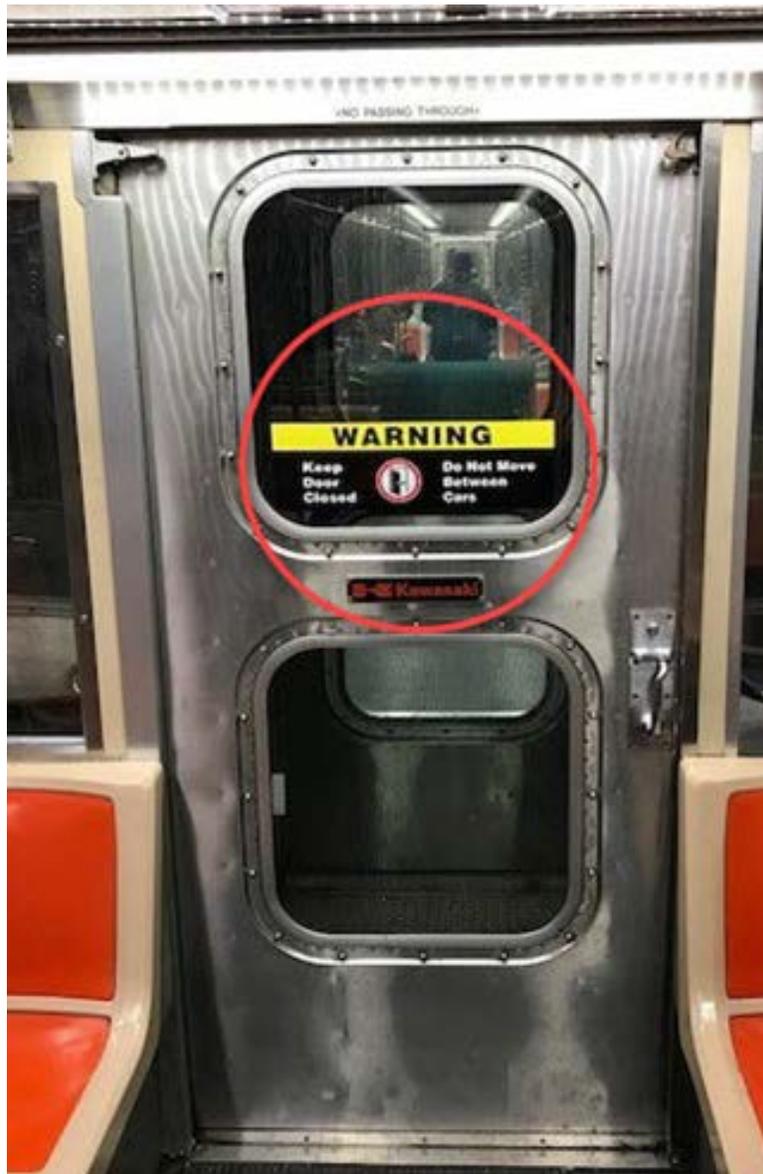
On September 24, 2018, SEPTA began placing new warning signs on the end-of-railcar doors for its subway fleet. (See figure 3.) The new warning signs use yellow and black coloring and state, “WARNING,” “Keep Door Closed,” and “Do Not Move Between Cars.” An internationally recognized symbol on the sign indicates the door should be kept closed. SEPTA also began making station and on-board train announcements to remind passengers that the end-of-railcar doors are for emergency use only.

Figure 3. An enhanced warning sign on a SEPTA subway end-of-railcar door.

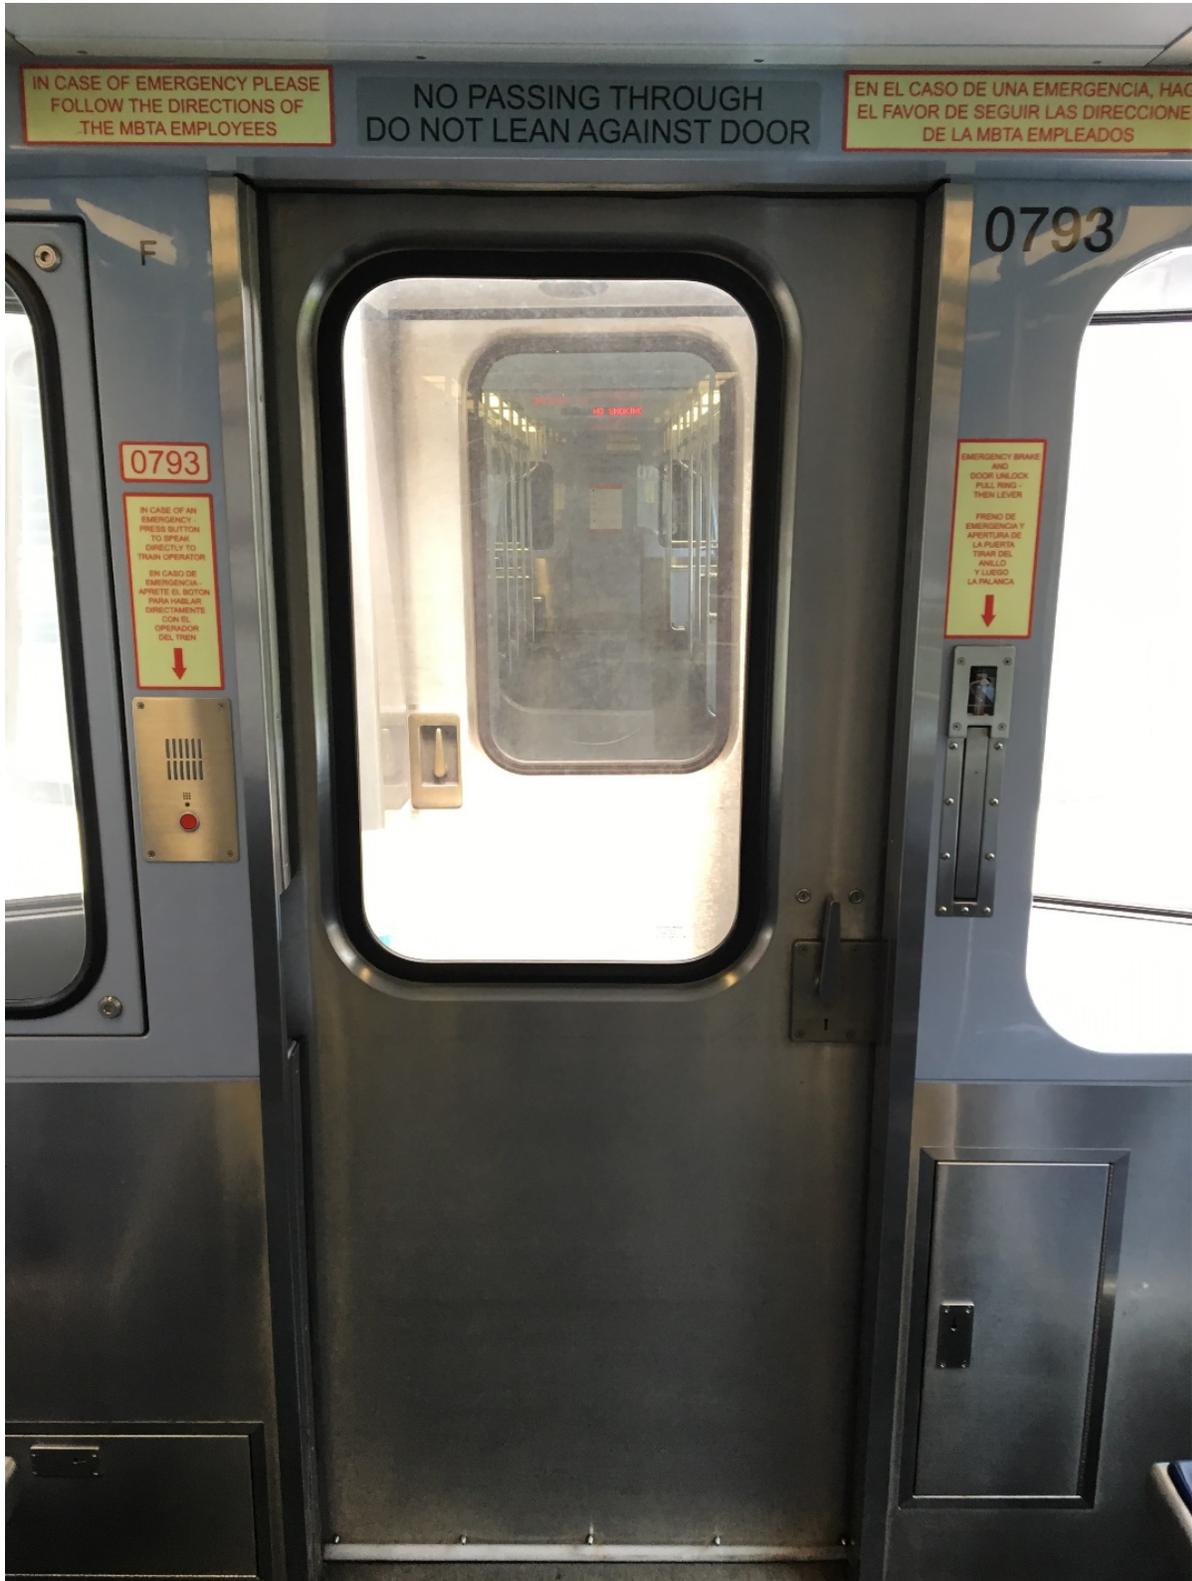
A practical means of emergency egress must be maintained with any new safety intervention because passengers and crewmembers need to be able to use the end-of-railcar doors in emergencies. The Massachusetts Bay Transportation Authority (MBTA) uses a locked end-of-railcar door that can be opened during emergency situations, which restricts access to the area between coupled cars while maintaining access during emergencies. (See figure 4.)

Figure 4. End-of-railcar door on an MBTA subway train, the door is locked and includes signage instructing customers how to unlock the door during emergencies.

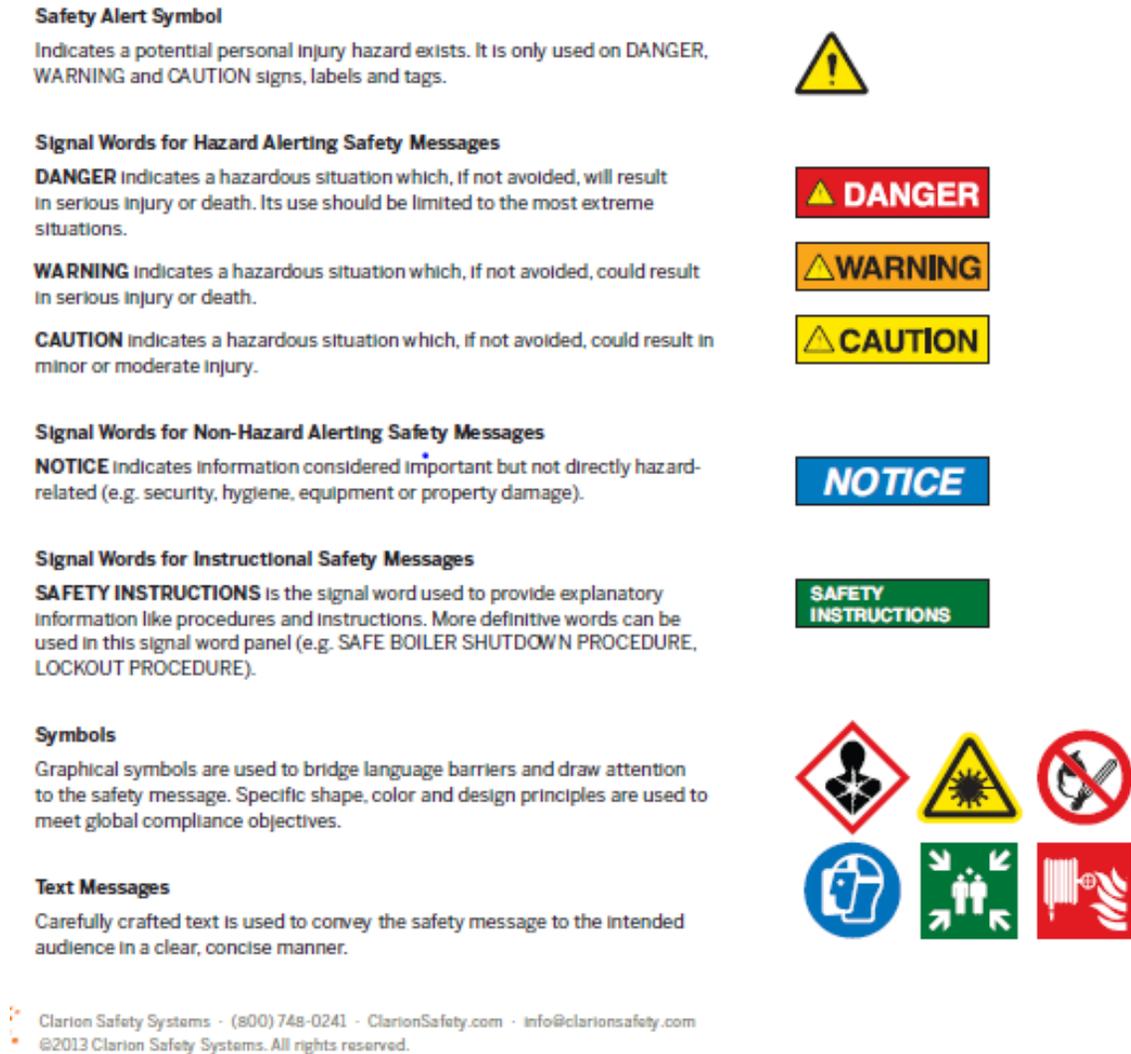
Alternatively, the hazard can be mitigated through safety education in the form of signage to deter passengers from moving between railcars while a train is moving. Visual signs and auditory messages are the primary methods to warn people about hazards. Safety messages must be properly designed and prominently presented, as discussed in the American National Standards Institute (ANSI) Z535 and Occupational Safety and Health Administration standards.⁴ Effective safety messaging uses internationally recognized symbols to convey the nature of the hazard, provides guidance on what to do if the hazard is encountered, and explains whom to contact when help is needed. (See figure 5.)

Figure 5. Illustration of safety message components in ANSI Z535 (effective 2013).

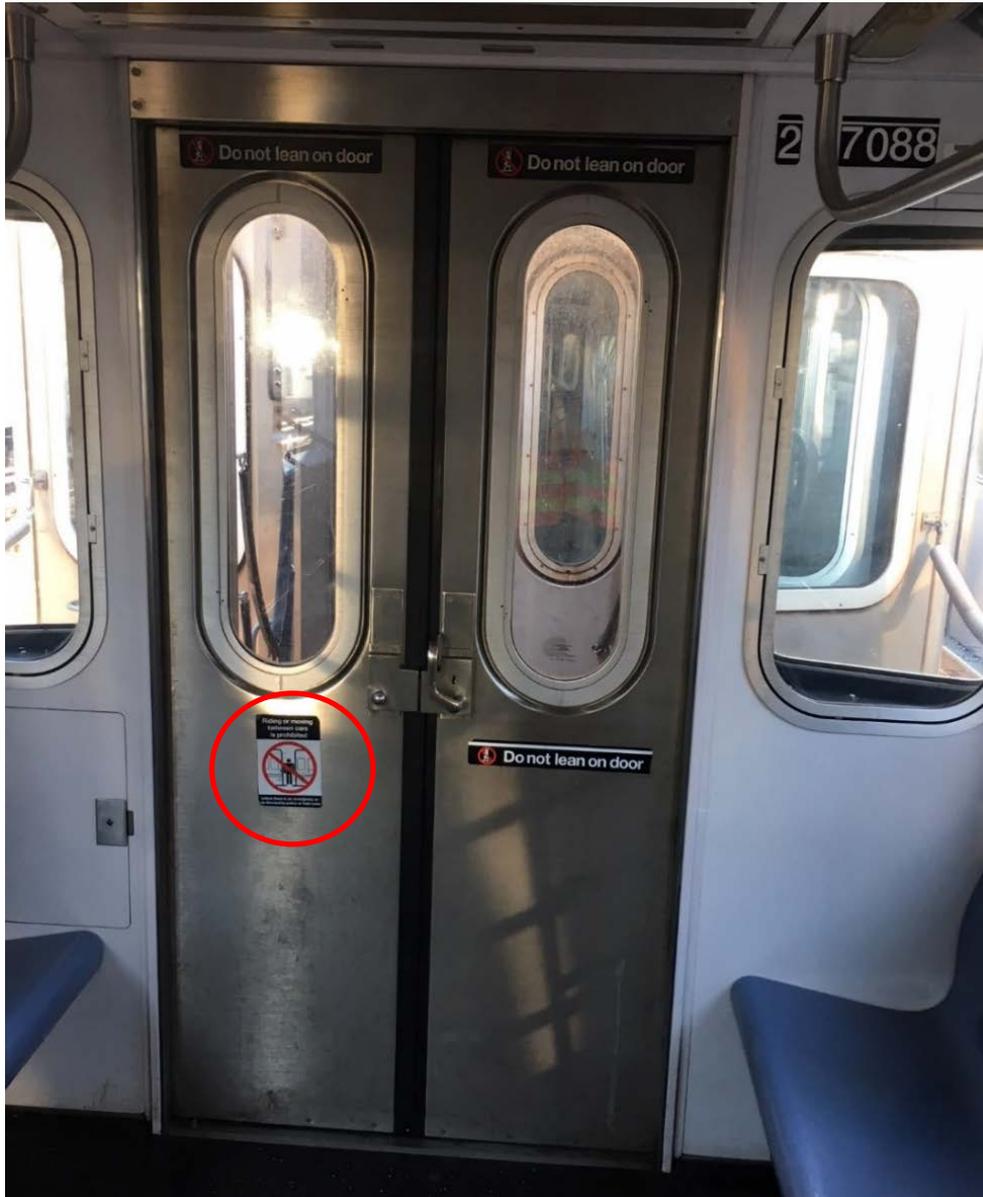
NTSB reviewed end-of-railcar door safety messaging in the railcars of several transit agencies. Most agencies use some form of visual sign on or near the end-of-railcar doors, warning that the door should not be opened. However, NTSB investigators found that these signs are not standardized or uniformly designed across transit properties. NTSB investigators also found that the size, shape, and content of warning signs varied between railcar types and routes even within the same transit agency. Figures 6 and 7 show additional examples of visual signs on end-of-railcar doors.

Figure 6. End-of-railcar door on New York City Transit car with warning sign circled in red.

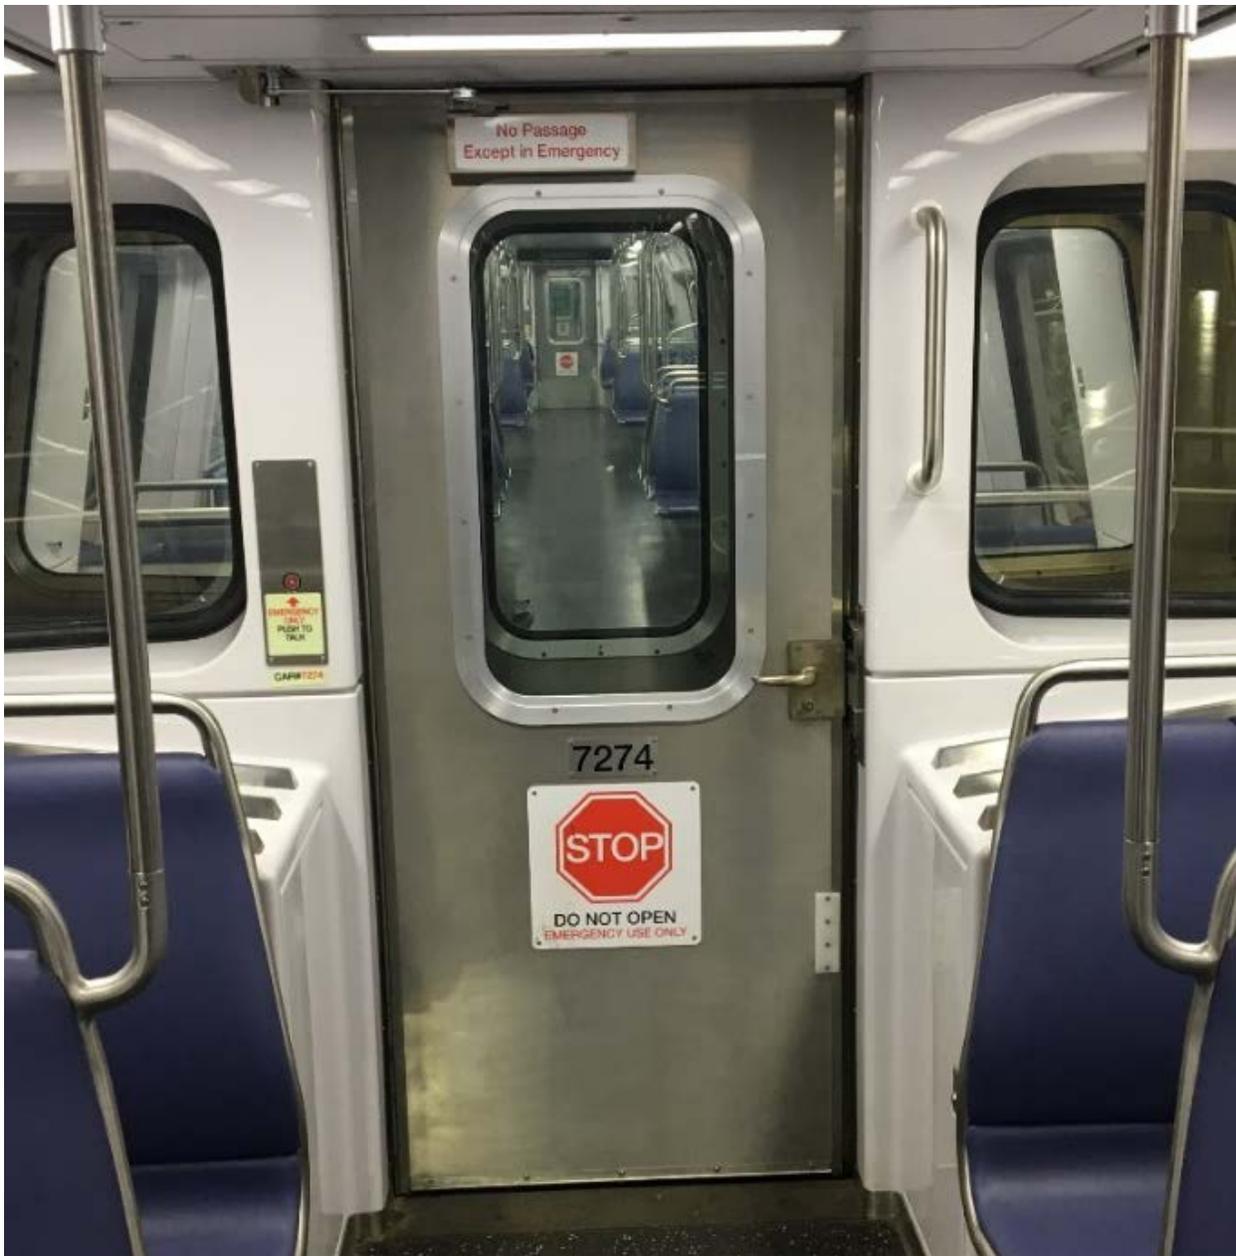
Figure 7. End-of-railcar door with red octagon universal stop sign on a Washington Metropolitan Area Transit Authority railcar.
