# National Transportation Safety Board

## Operational Issues

Georgia Struhsaker,  
Operations Group Chairman

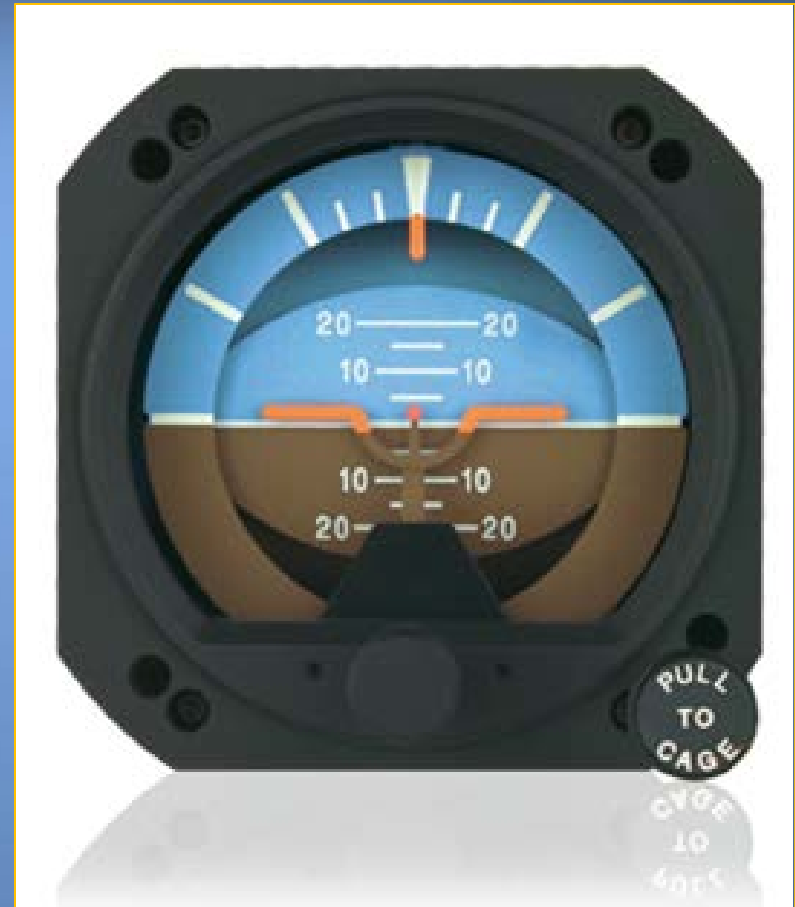
# Attitude Indicator Limitations

Attitude indicator  
met  $\pm 25^\circ$  pitch  
indication range  
requirement of  
TSO-C4c

Possible reasons for caging:

- Distrust of attitude display due to spatial disorientation
- Attitude indicator reached pitch indicating limit and stopped moving, which pilot interpreted as malfunction

- FAA handbooks do not inform pilots about pitch indicating limits
- *Pilot's Handbook of Aeronautical Knowledge* contains unclear, misleading information about limitations
- Unknown whether knowledge of limitations would have changed pilot's actions in this accident
