**Collision of Metrolink Train 111
with Union Pacific Train LOF65-12
Chatsworth, California
September 12, 2008**

Operations Presentation

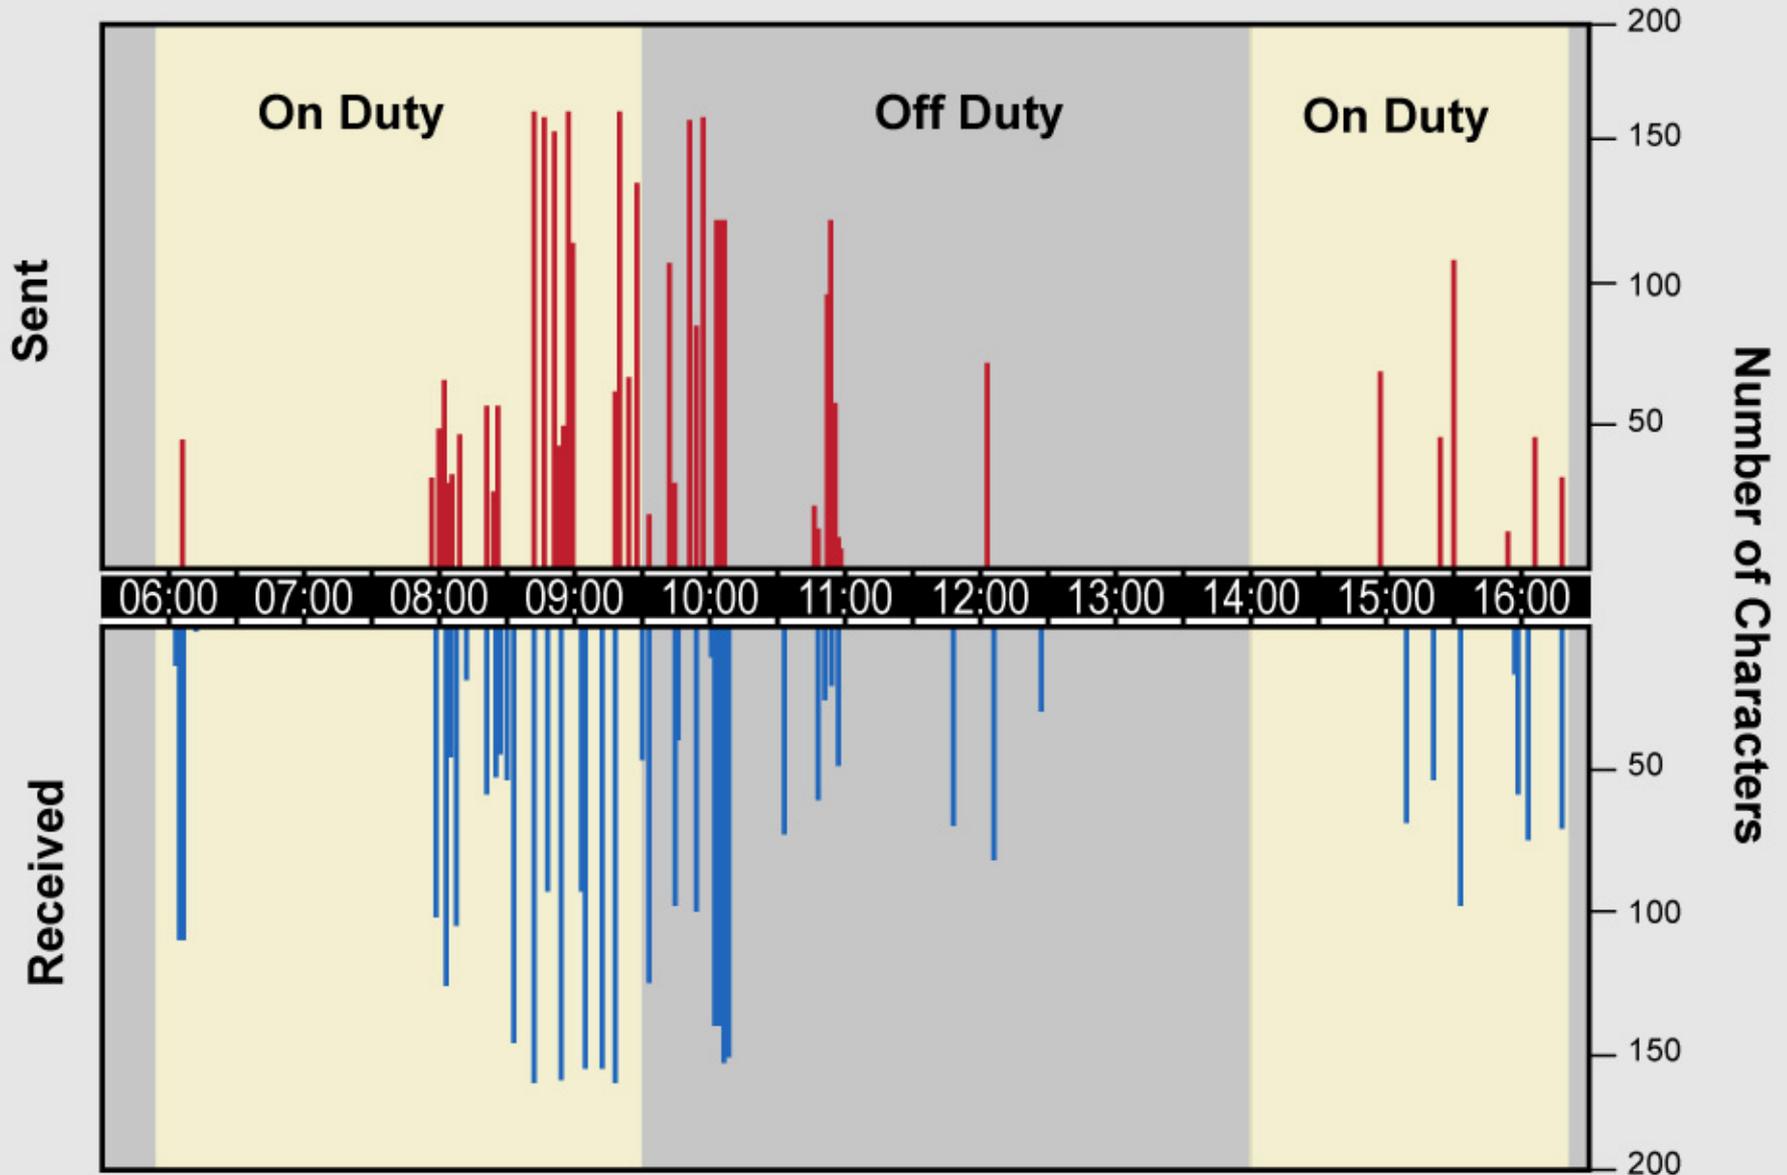
Metrolink Engineer's Text Messages

- Metrolink engineer's cell phone calls and text messages collected from the service provider
- Records show the Metrolink engineer sent and received numerous text messages while on duty
- Metrolink engineer's last text message was sent shortly before the accident while the train was in motion

Engineer's Cell Phone Activity (On Duty)

Weekday	Total Messages Sent	Total Messages Received
Tuesday	19	13
Wednesday	67	59
Thursday	50	42
Total	136	114

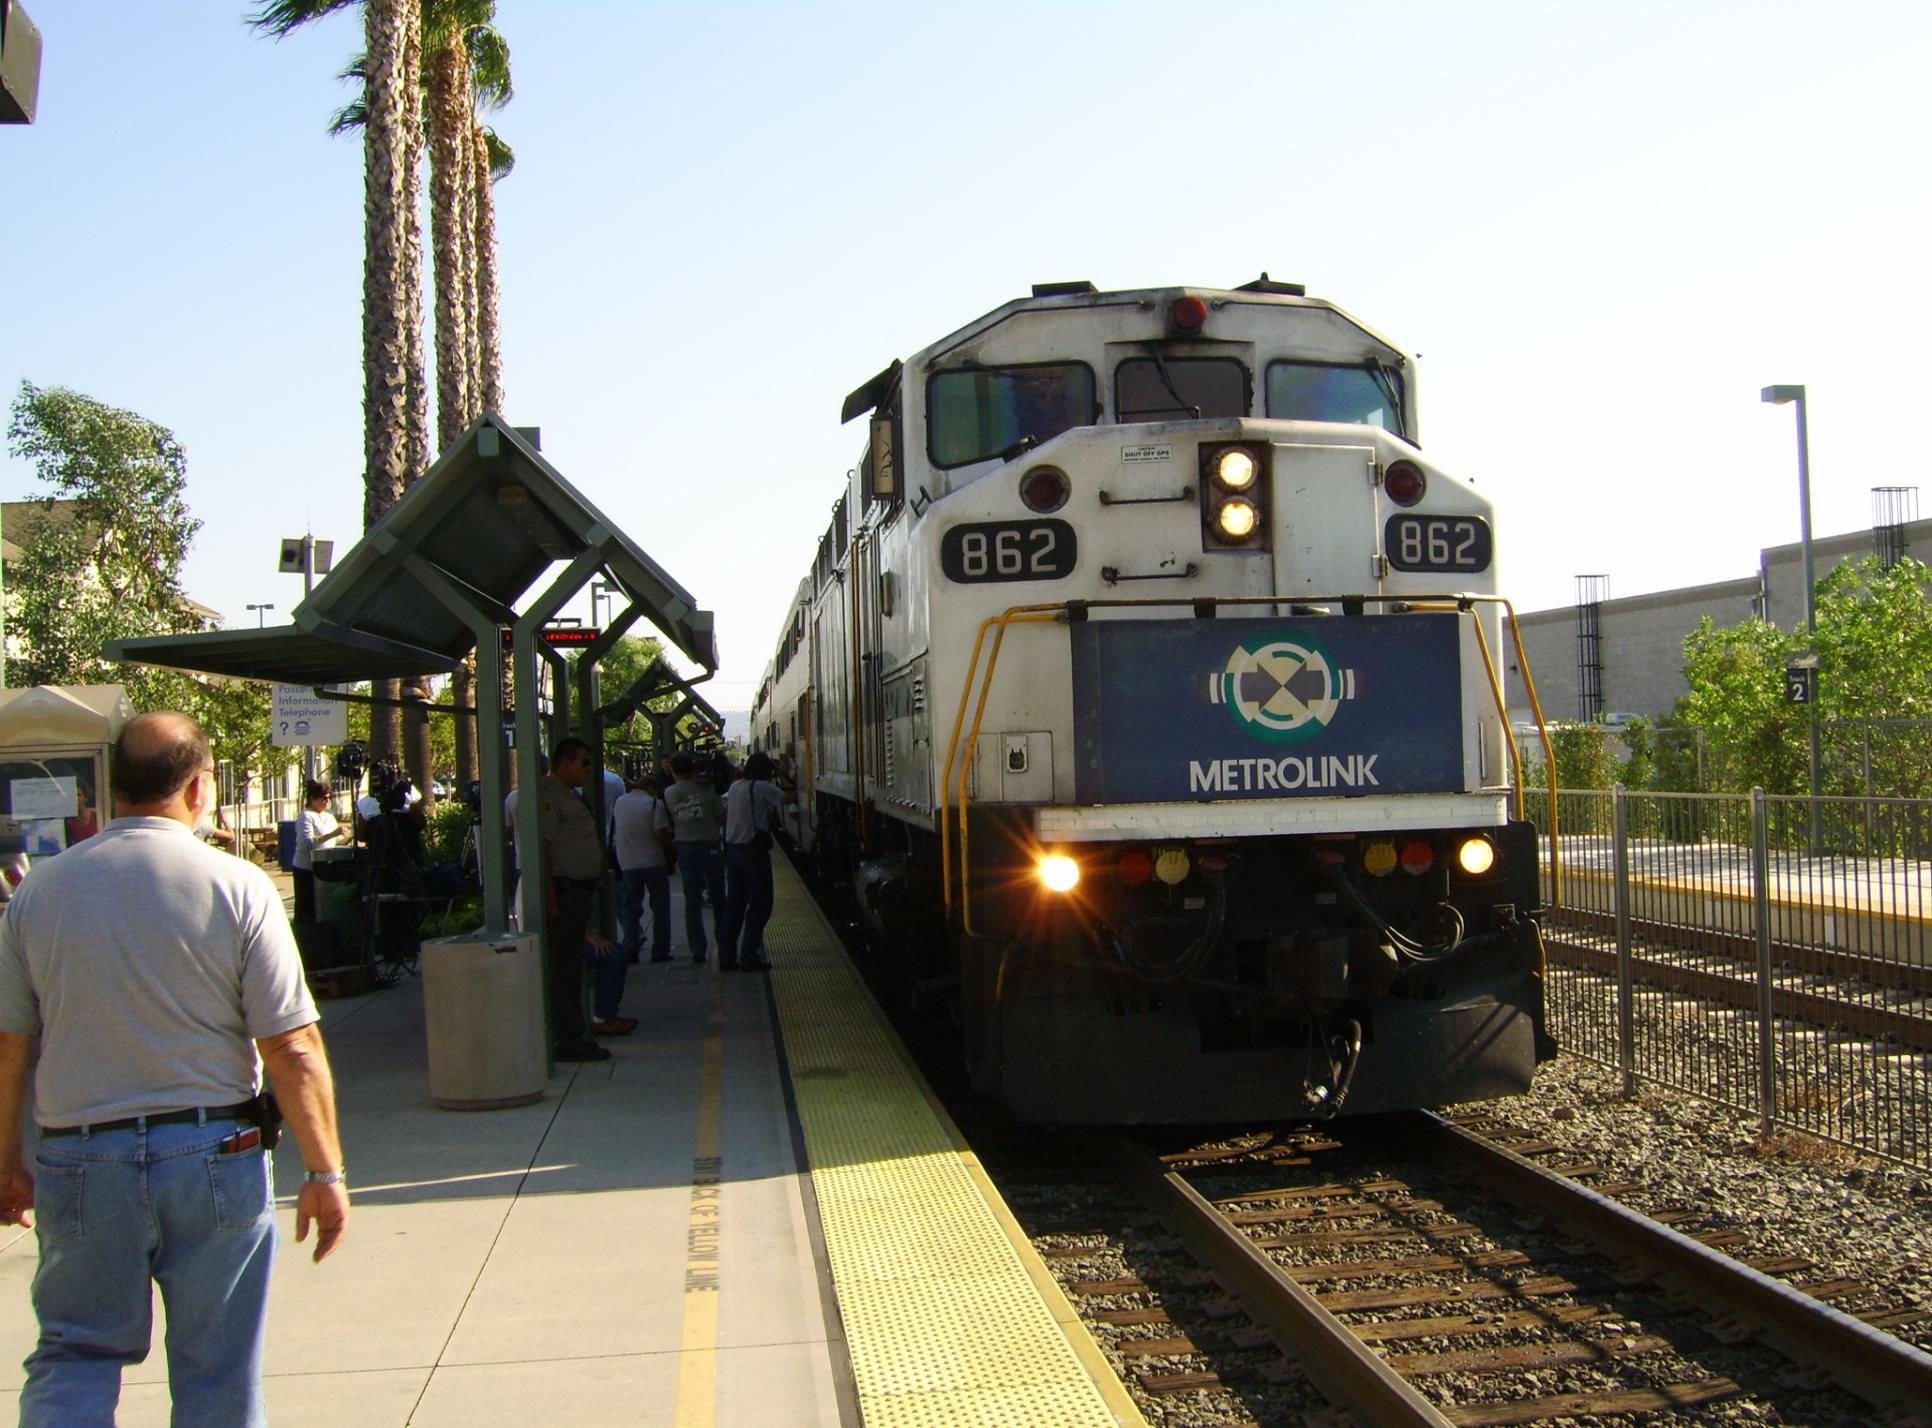
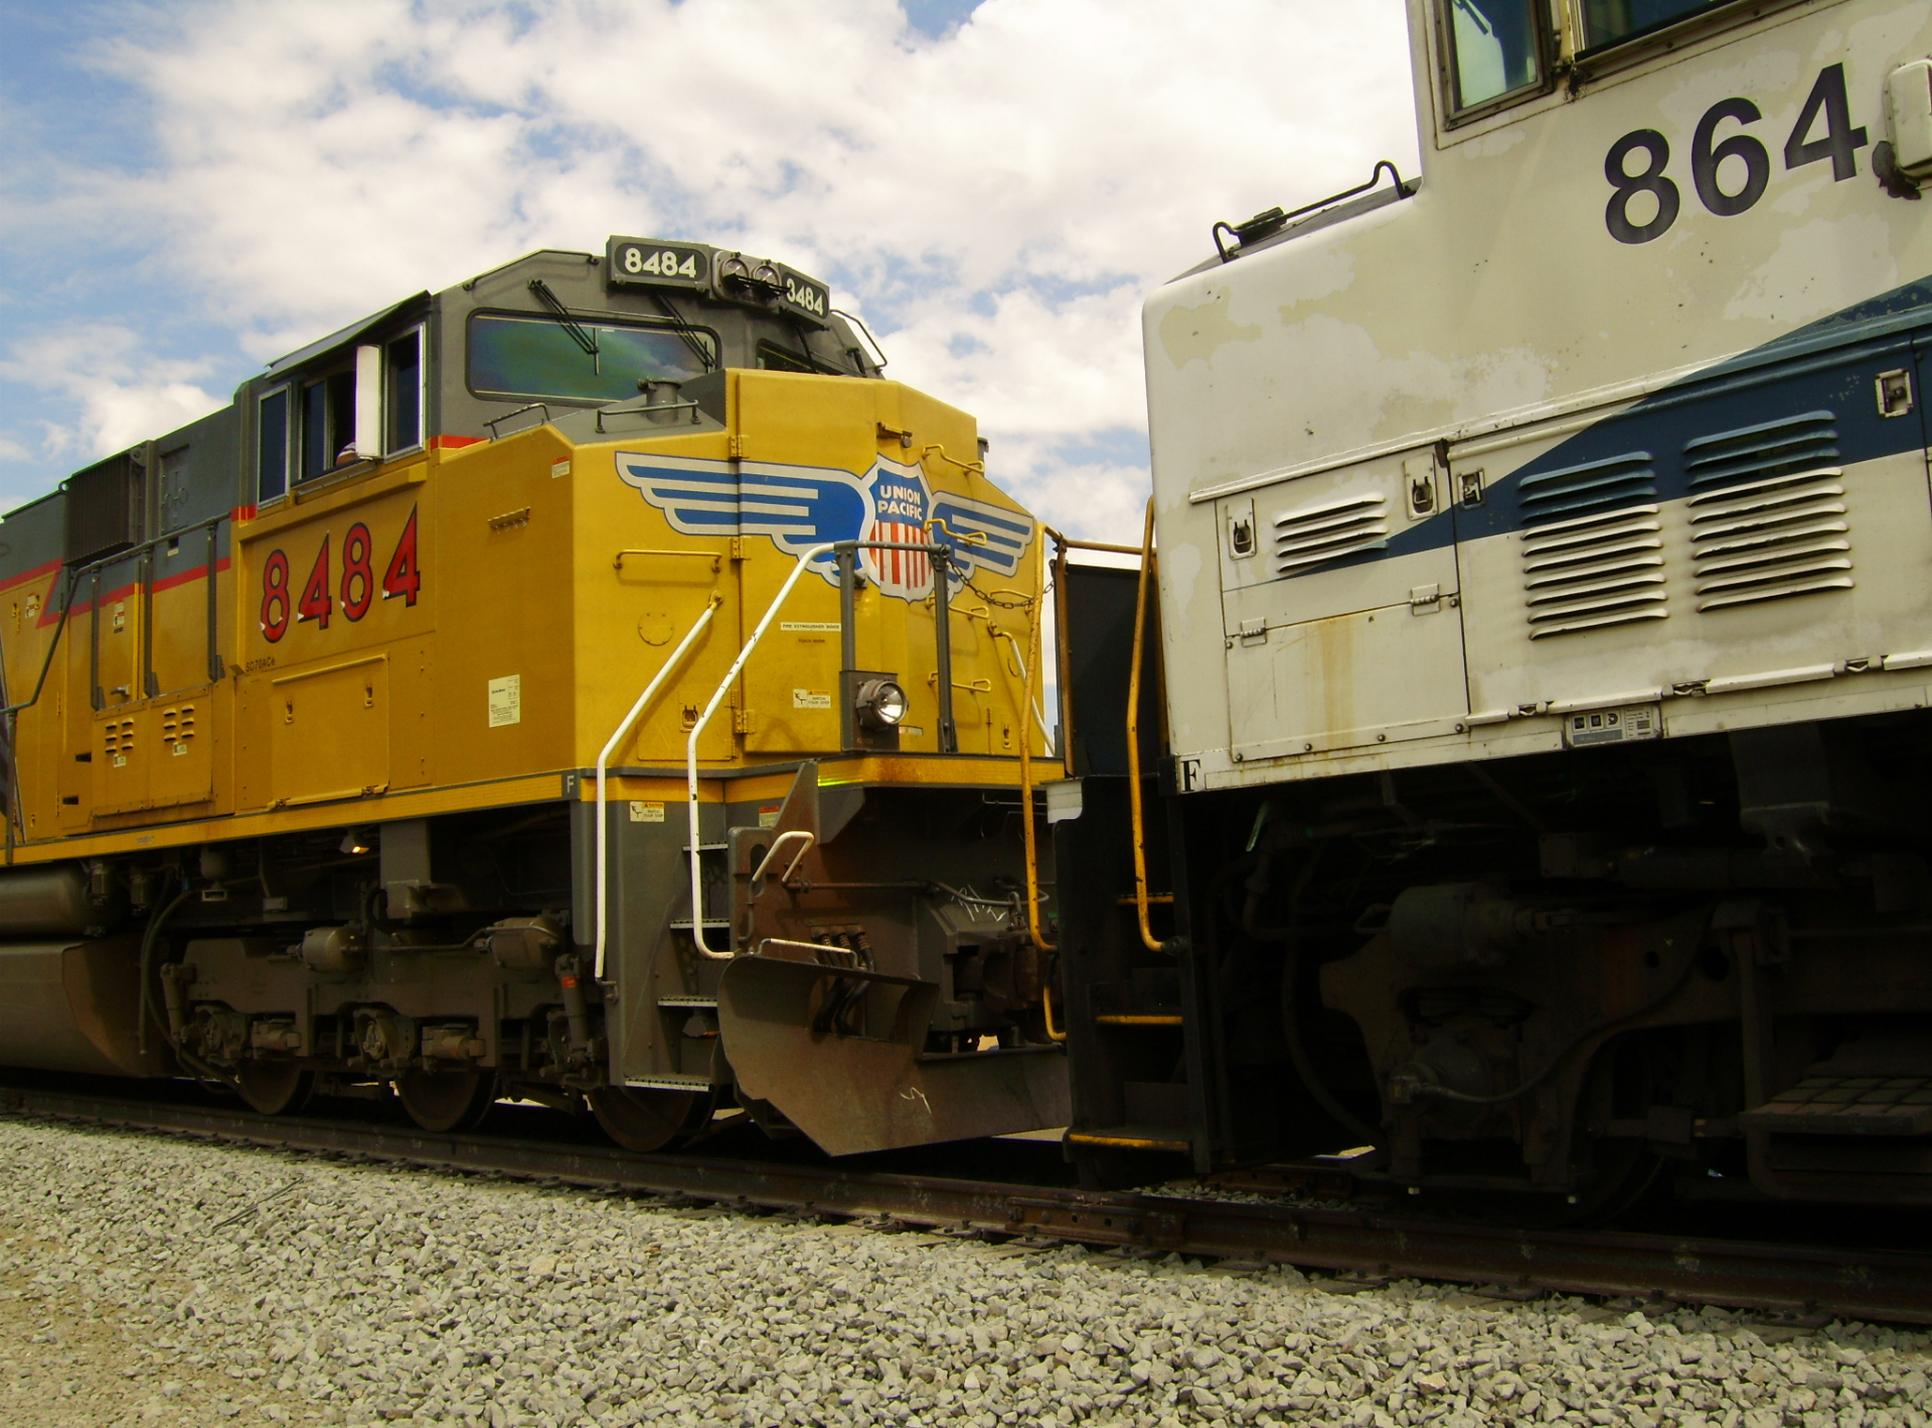
Cab Observations

- When alone in the locomotive, which is normal practice, the engineer cannot be observed.
- When asked how to enforce the prohibition against texting at the Public Hearing held in March 2009, a Connex supervisor said, "...you'd almost have to see a cell phone up to their ear."
- The FRA representative at the Public Hearing said, "...[texting by engineers] is virtually unenforceable."

Because of the privacy afforded by a locomotive cab or train operating compartment, routine efficiency testing and performance monitoring practices are inadequate to determine whether or to what extent engineers or other crew members may not be complying with safety rules such as those regarding use of wireless devices or allowing access by unauthorized persons.

A train crew performance monitoring program that includes the use of in-cab audio and image recordings would serve as a significant deterrent to the types of noncompliant practices engaged in by the Metrolink engineer and the Union Pacific Leesdale Local conductor in this accident and would provide railroads with a more comprehensive means to evaluate the adequacy of their safety programs.
