HWY-05-M-H035
Wilmer, Texas

ATTACHMENT #9

WABCO ABS ECU Printout

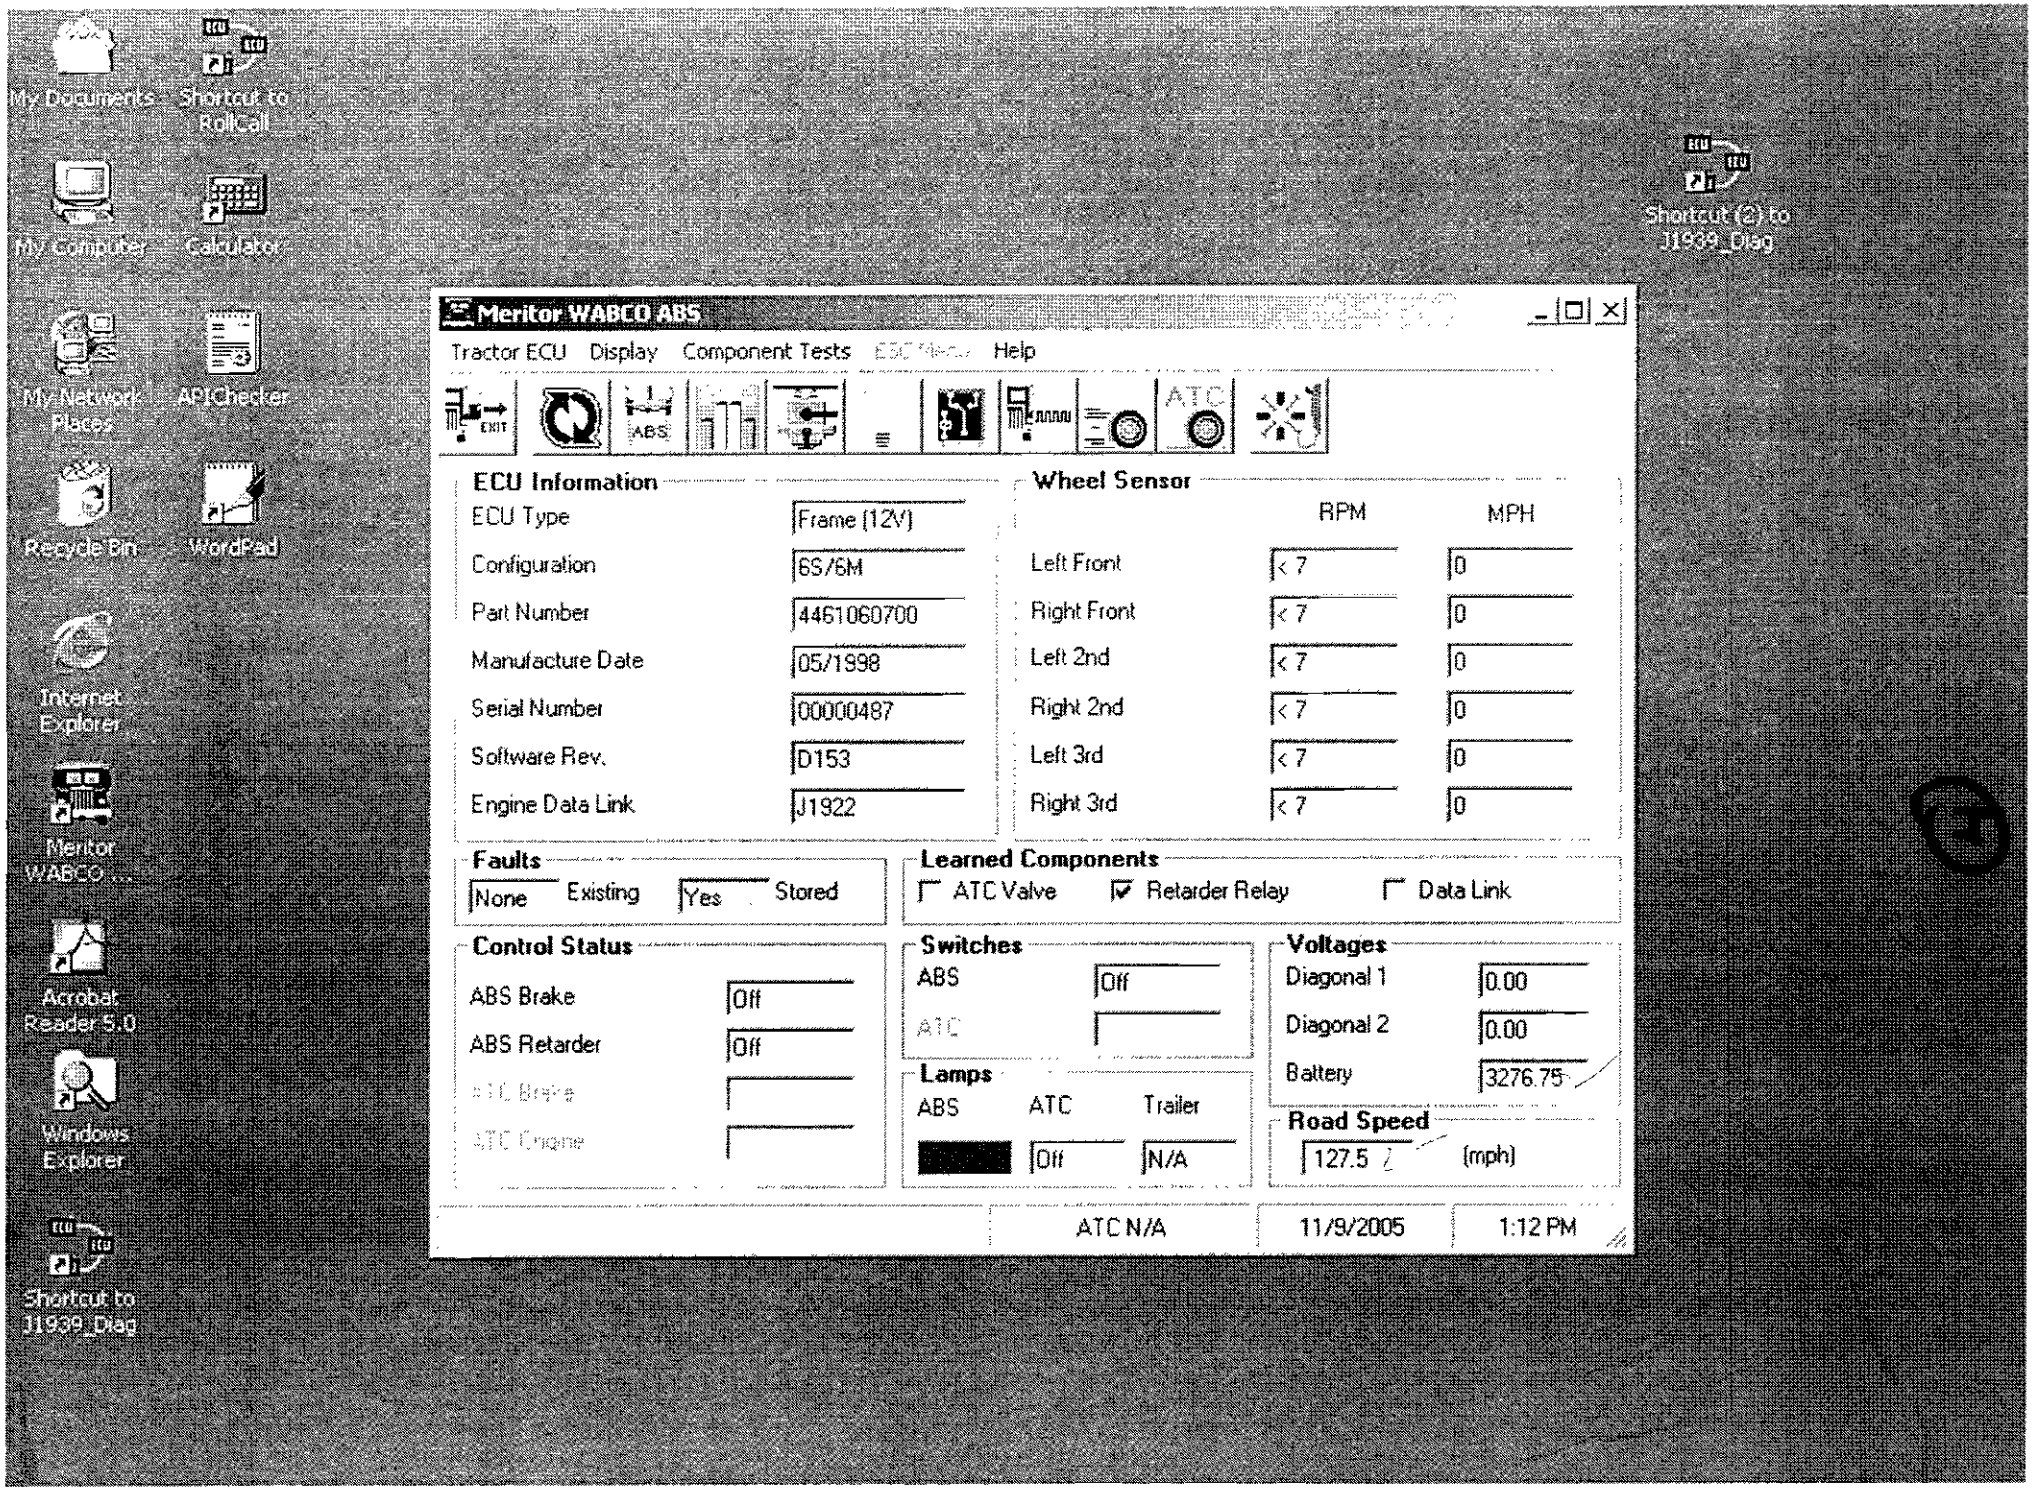
SAE Fault Code: SID 6
FMI 8

Description: Right Third Wheel Sensor Excessive Slip

The ABS ECU has detected a wheel slip condition of more than 16 seconds in duration. Adjust the air gap by pushing the sensor all the way till it touches the tooth wheel.

Fault #	Description	Status	SID	FMI	Count
1	Right 3rd Sensor - Slip	Inactive	6	8	1
