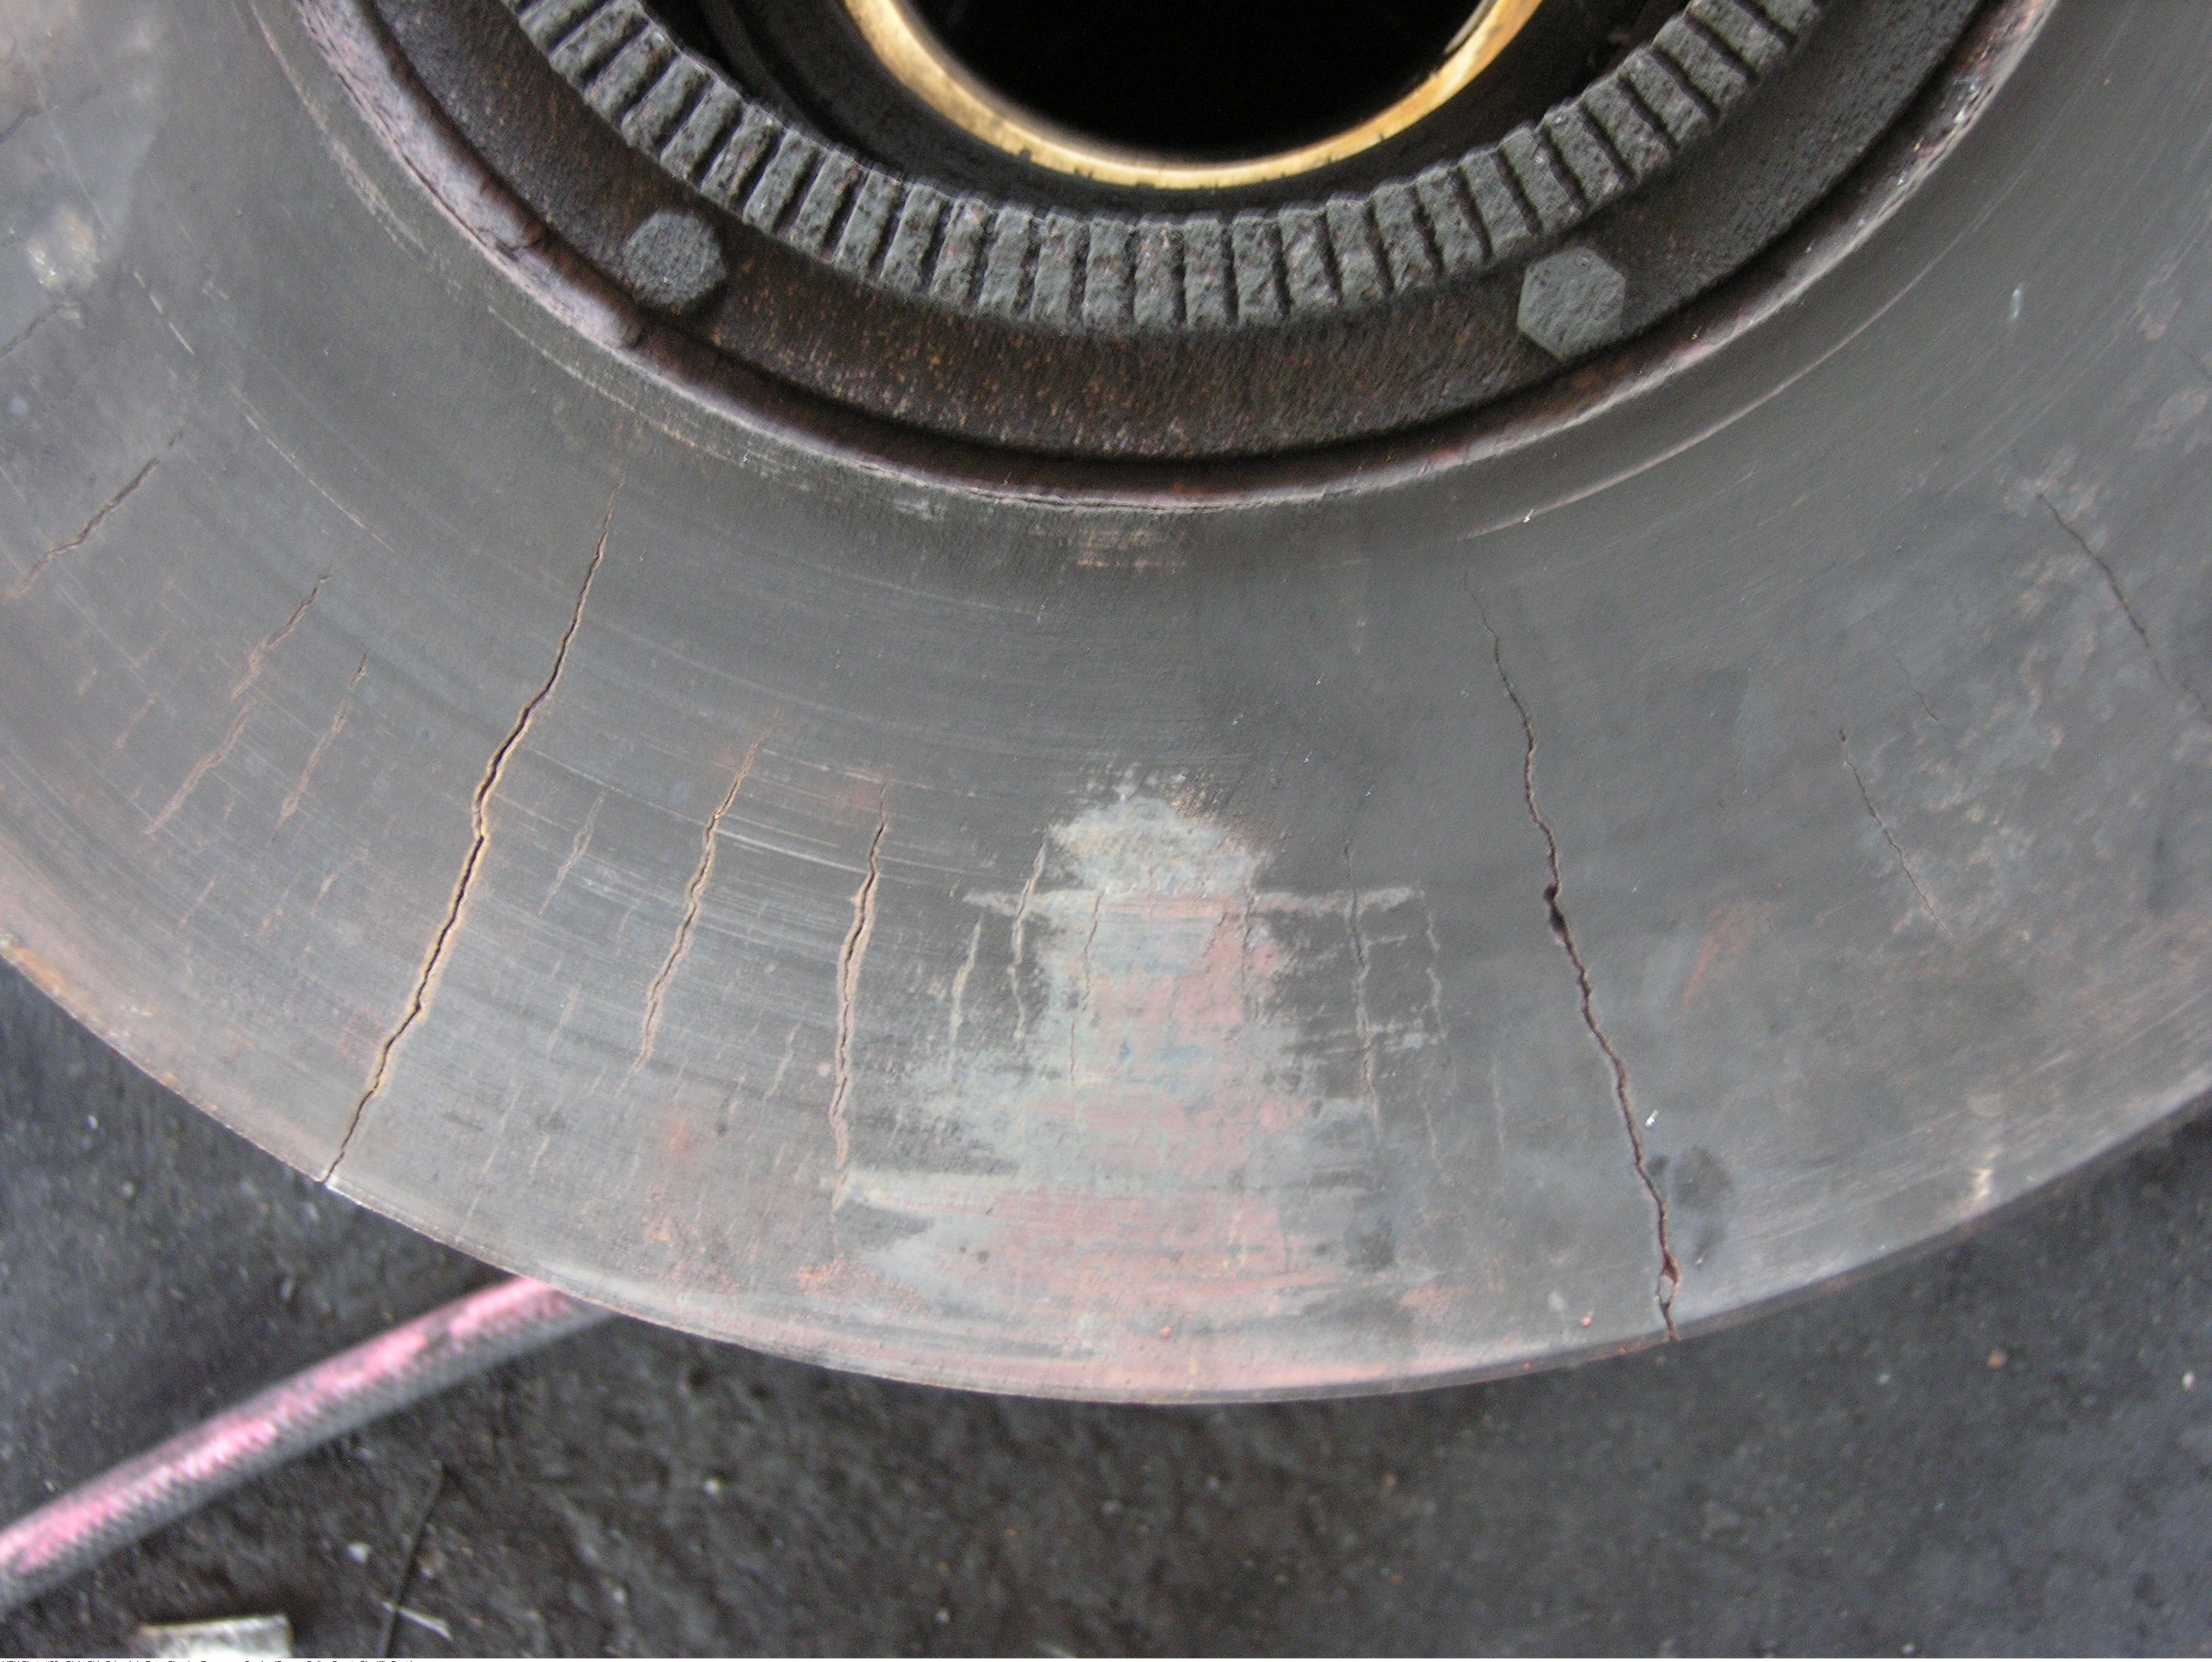
VEH Photo #59 - Right Side Drive-Axle Rotor Showing Transverse Cracks (Source: Dallas County Sheriff's Dept.)
