DOCKET NO. SA-516

METALLURGY/STRUCTURAL GROUP CHAIRMAN
FACTUAL REPORT
SEQUENCING STUDY
(57 pages)

METALLURGY / STRUCTURES SEQUENCING STUDY Report No. 97-38

Place	:	East Moriches, New York
Date	:	July 17, 1996
Airplane	:	Boeing 747-131, N93119
NTSB No.	:	DCA96-M-A070

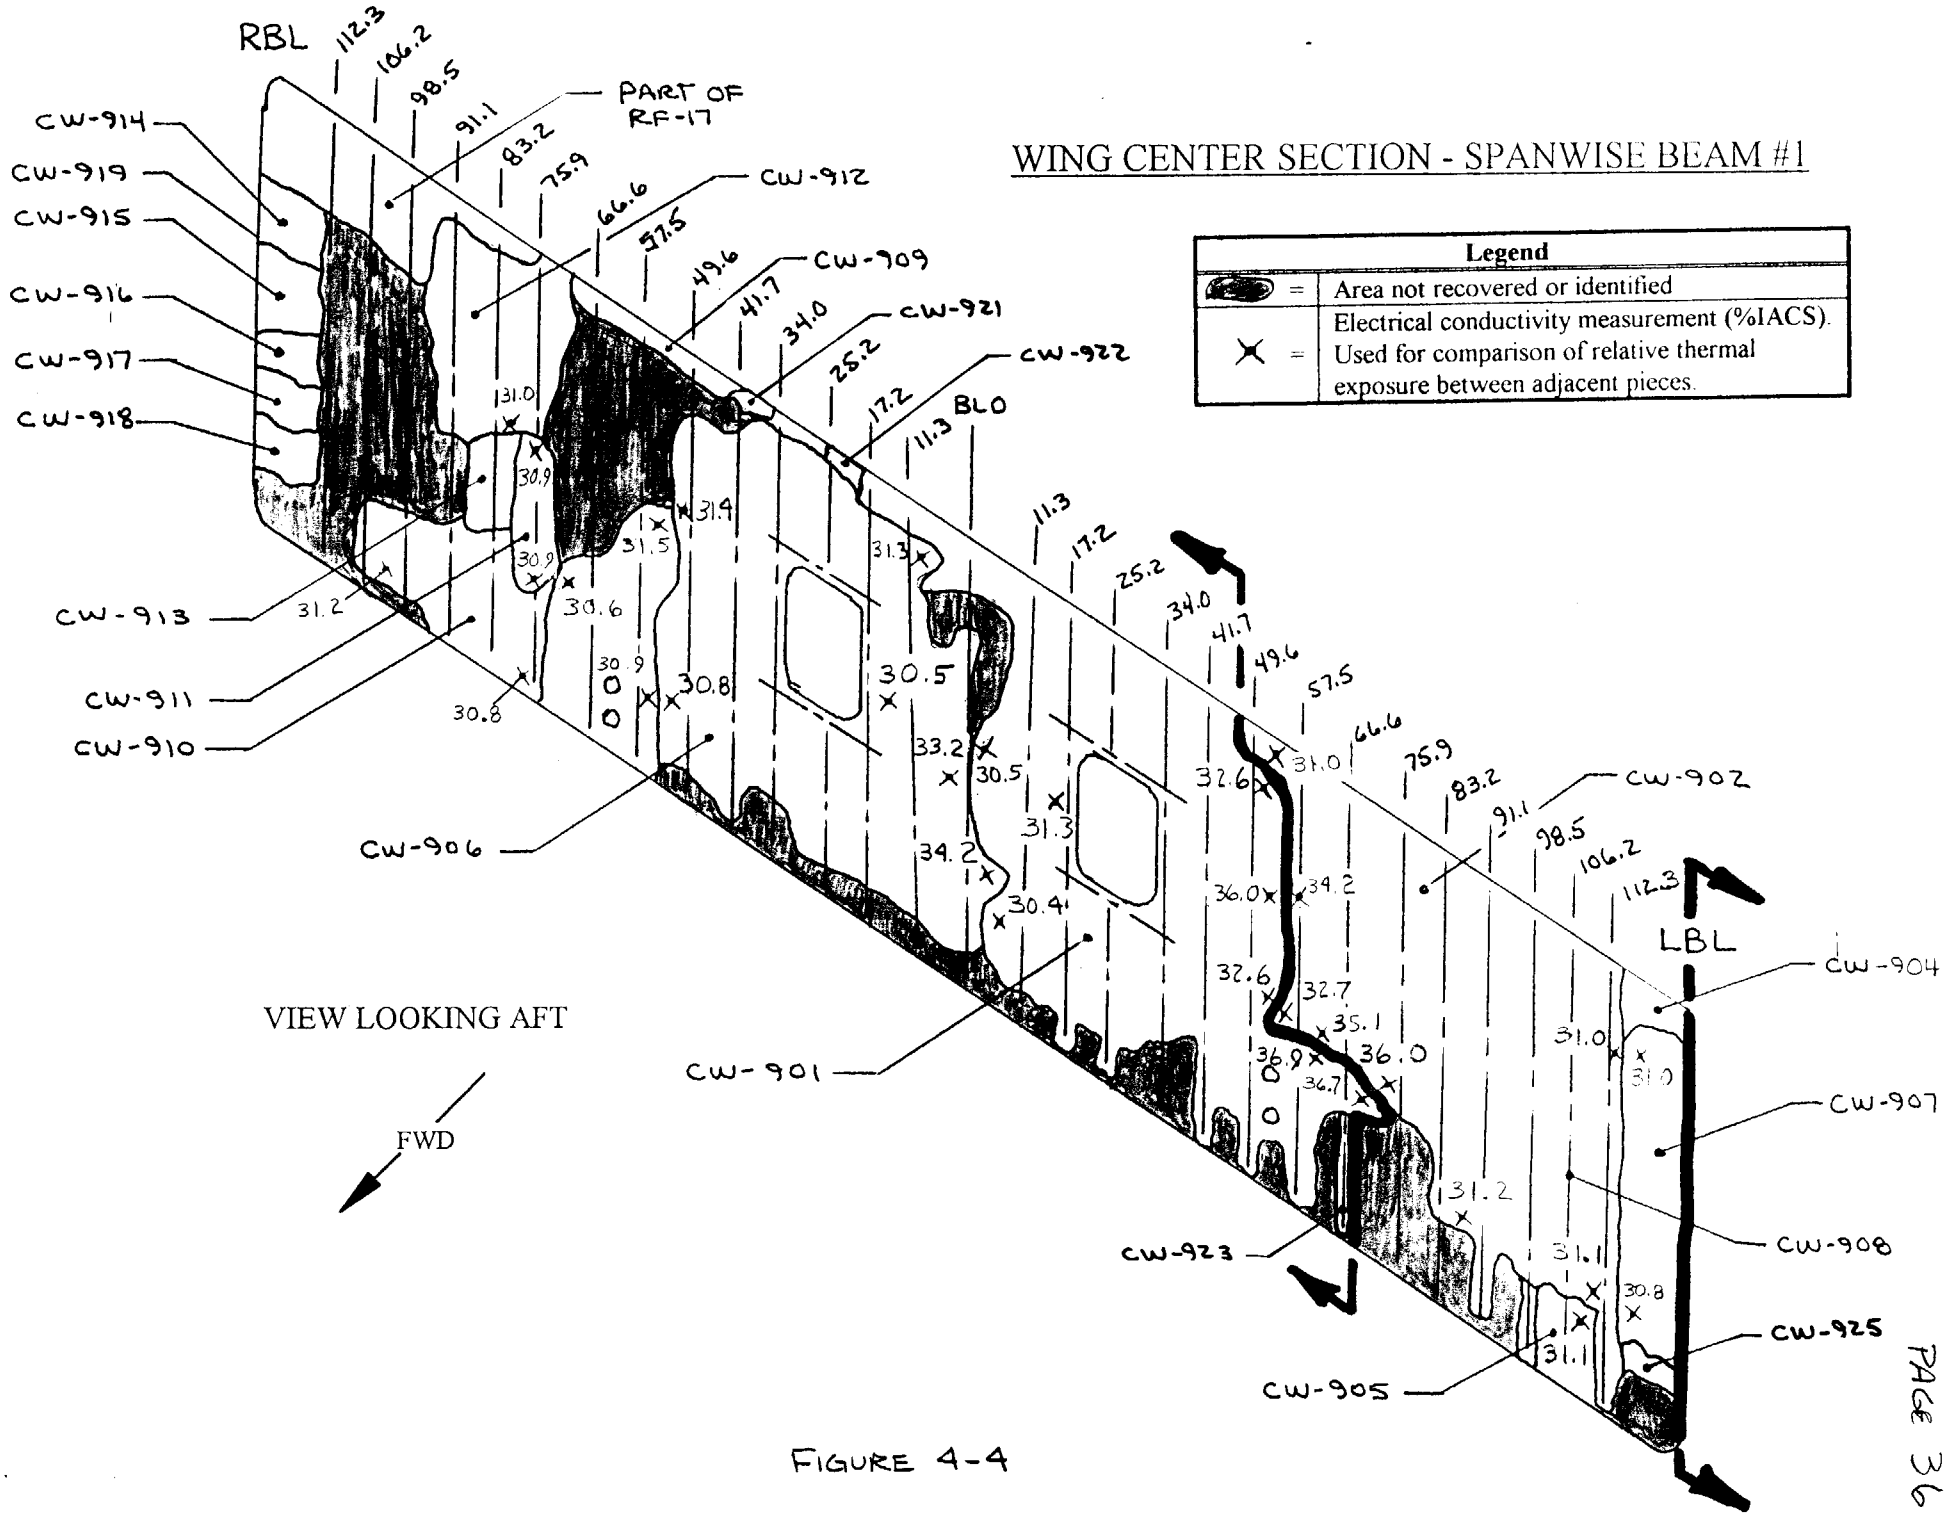
FIGURE 4-4

Spanwise beam #1 (SWB#1) is approximately 90% recovered and identified, with the majority of missing material on the right side and the remainder mostly distributed full span across the lower portion of the beam. Sooting varies from clean to heavy on both the forward and aft surfaces of SWB#1 with a number of mating fracture faces equally sooted. A review of sooting patterns, electrical conductivity readings, and crack morphology indicates there were likely multiple failures at the time of major airplane breakup (RBL 66 to LBL 57). The portion of SWB#1 between the left side of body and approximately LBL 57 either separated independently during wing breakup or remained attached to the right wing for a time after major airplane breakup (see figure 4-4).

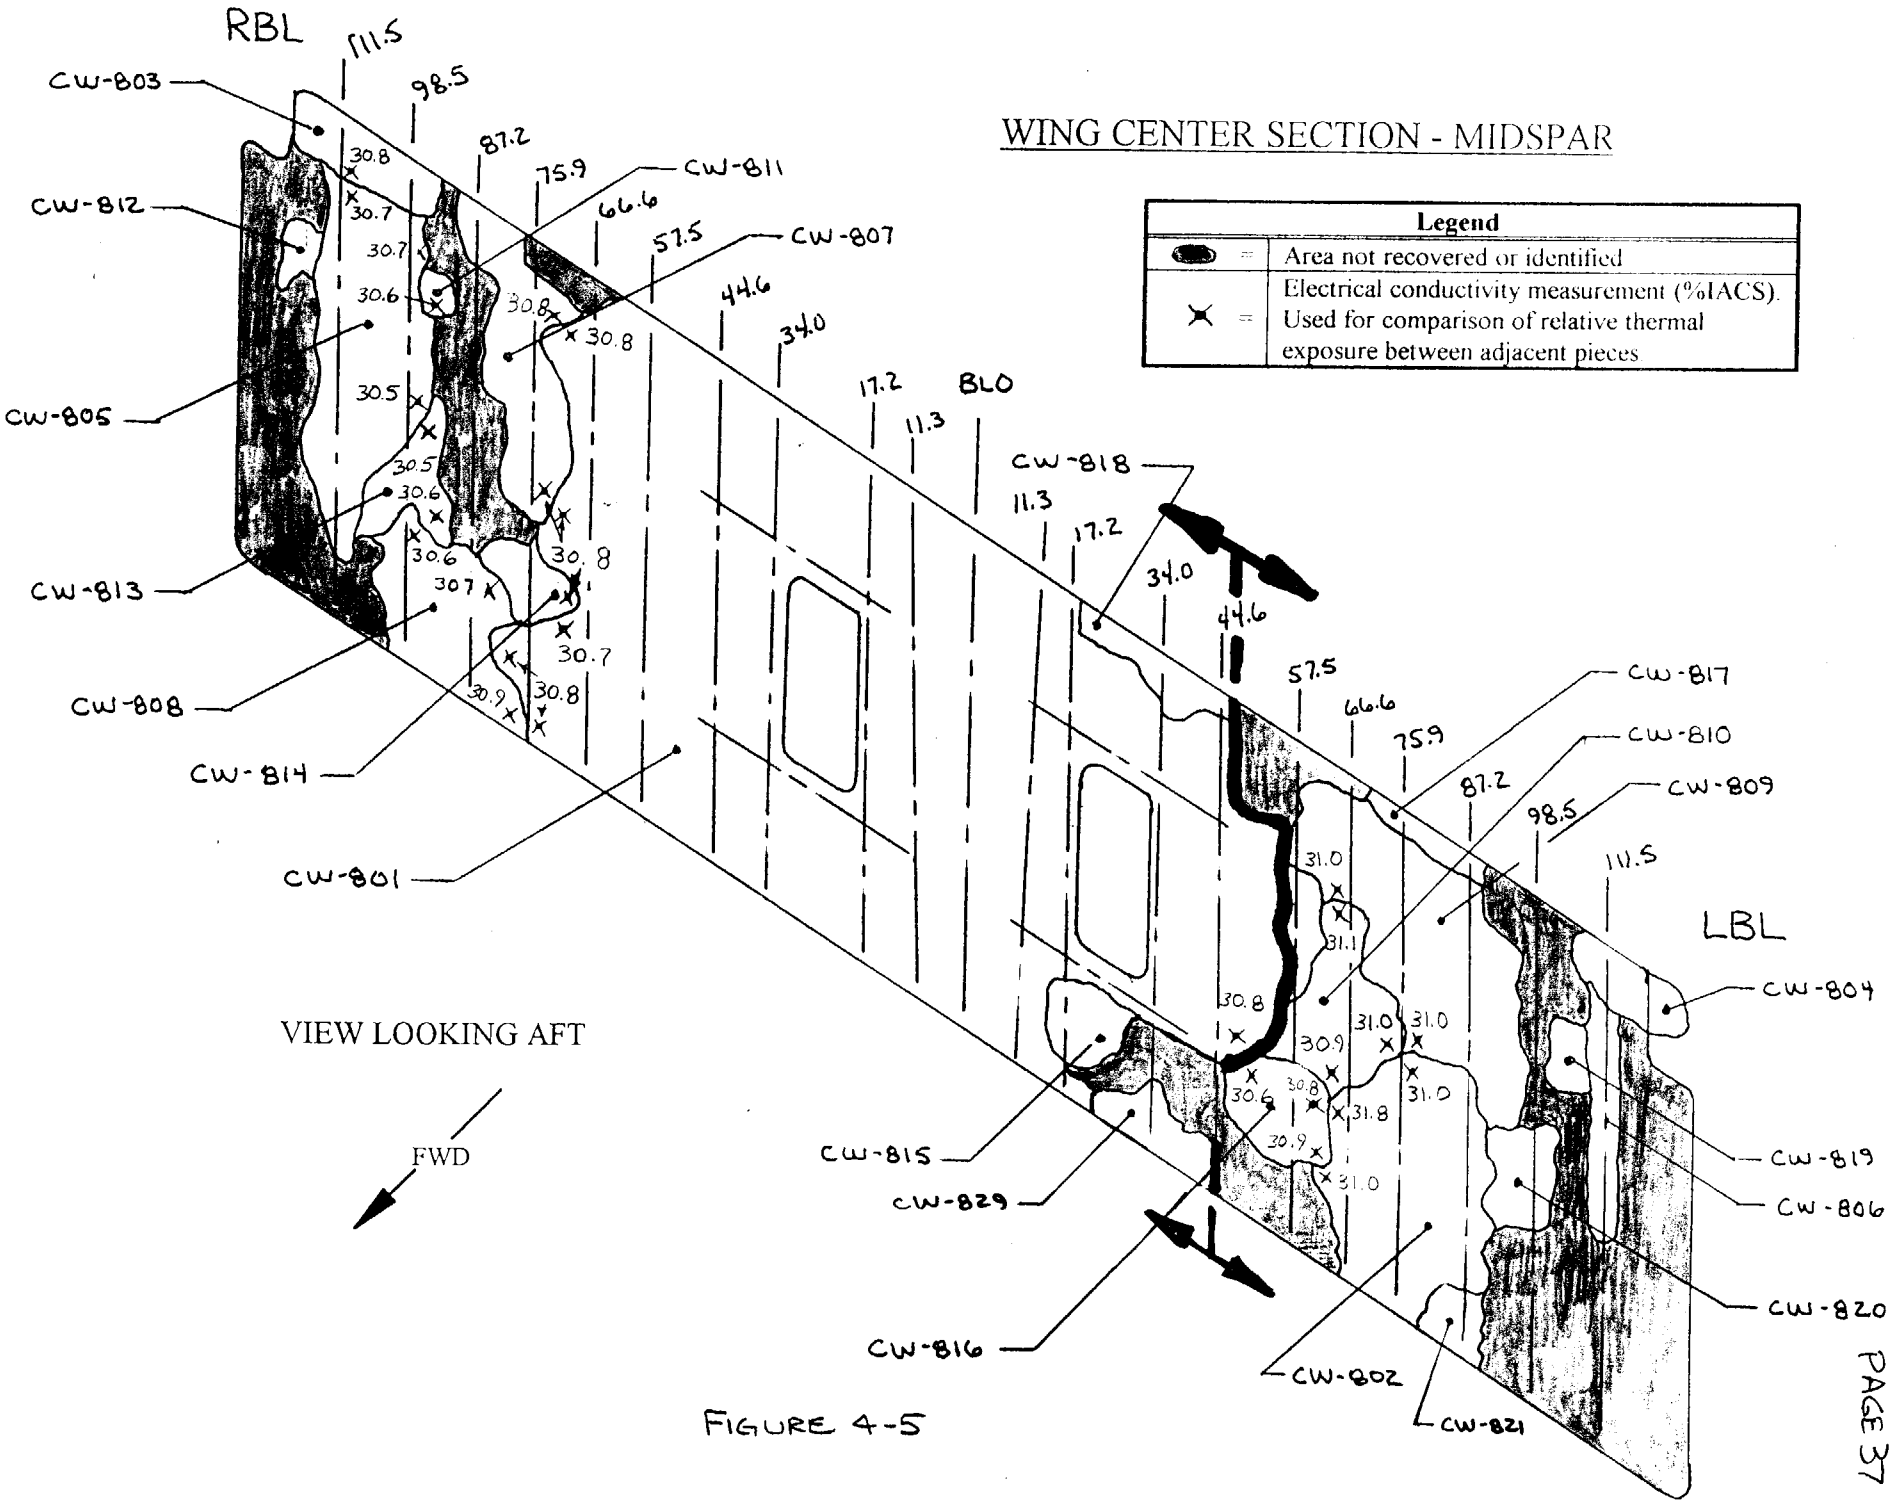
FIGURE 4-5

The midspar is approximately 75% recovered and identified with areas missing on both left and right sides. Sooting (light to heavy) is generally present on the forward surface (RBL 67 to LBL 44) and aft surface (RBL 67 to LBL 98). Sooting of mating fracture faces, crack morphology, and deformation patterns indicate that the midspar failed at LBL 44 consistent with compression buckling during major airplane breakup, with the area to right going with right wing and remainder with the left wing (see figure 4-5). Relatively minor sooting outboard of LBL 44 on the aft surface is another indication of an earlier event involving fire/soot between SWB#1 and midspar (see discussion on SWB#1, section 4.6). The midspar did not contain indications of differential pressure between the forward and aft sides.

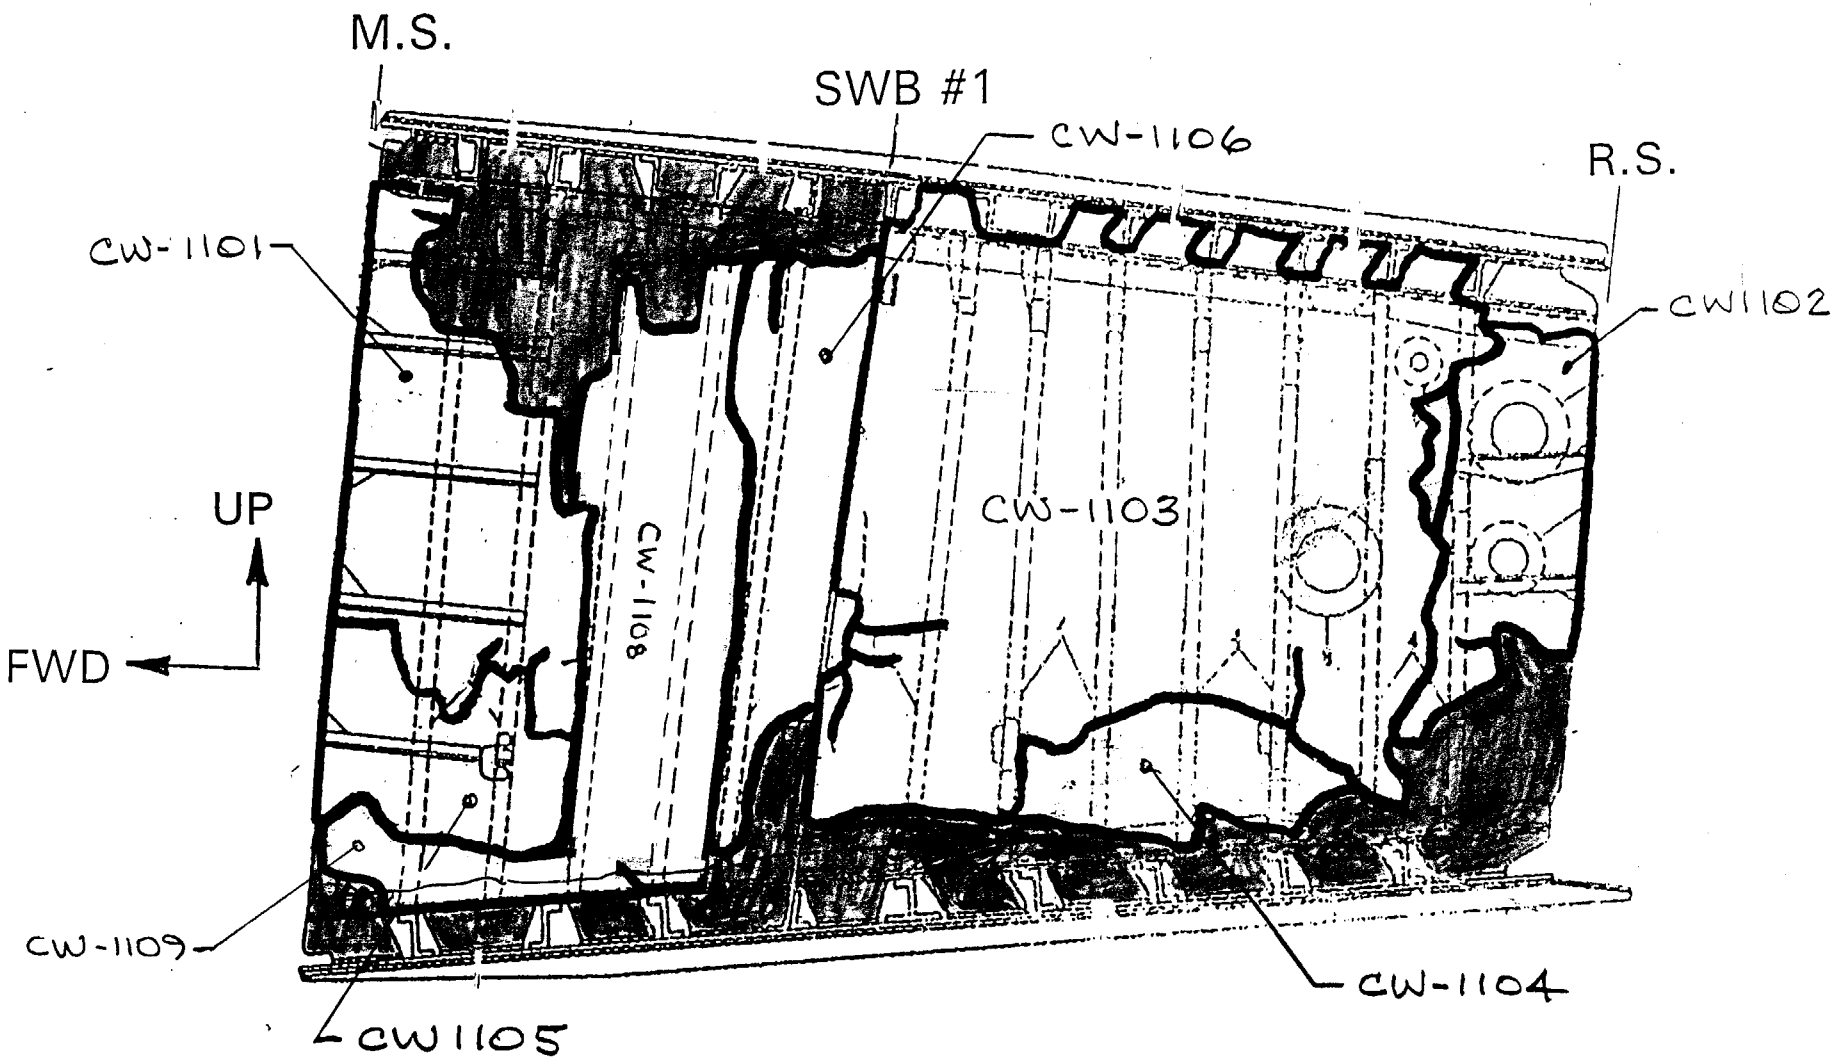
WING CENTER SECTION - BL 0.00 RIB

Approximately 90% of the centerline rib between the rear spar and SWB#1 has been recovered and identified but only 40% of the rib between SWB#1 and midspar (see figure 4-6). The section between rear spar and SWB#1 is heavily sooted on forward, aft, and upper fracture faces. The pieces between SWB#1 and midspar are equally heavily sooted on both the left and right surfaces and most fracture faces. Sooting and the location and features of fractures indicate the centerline rib remained with the right wing at major airplane breakup. Definitive damage or sooting prior to major airplane breakup could not be identified, however see the sections on SWB#1 (section 4.6) and the midspar (section 4.7) for discussion of indications of earlier damage on these components, which may have also related to the centerline rib. There were indications described of an overpressure acting aft on SWB#1 and early presence of fire or soot ahead of SWB#1, either of which might have affected the centerline rib.

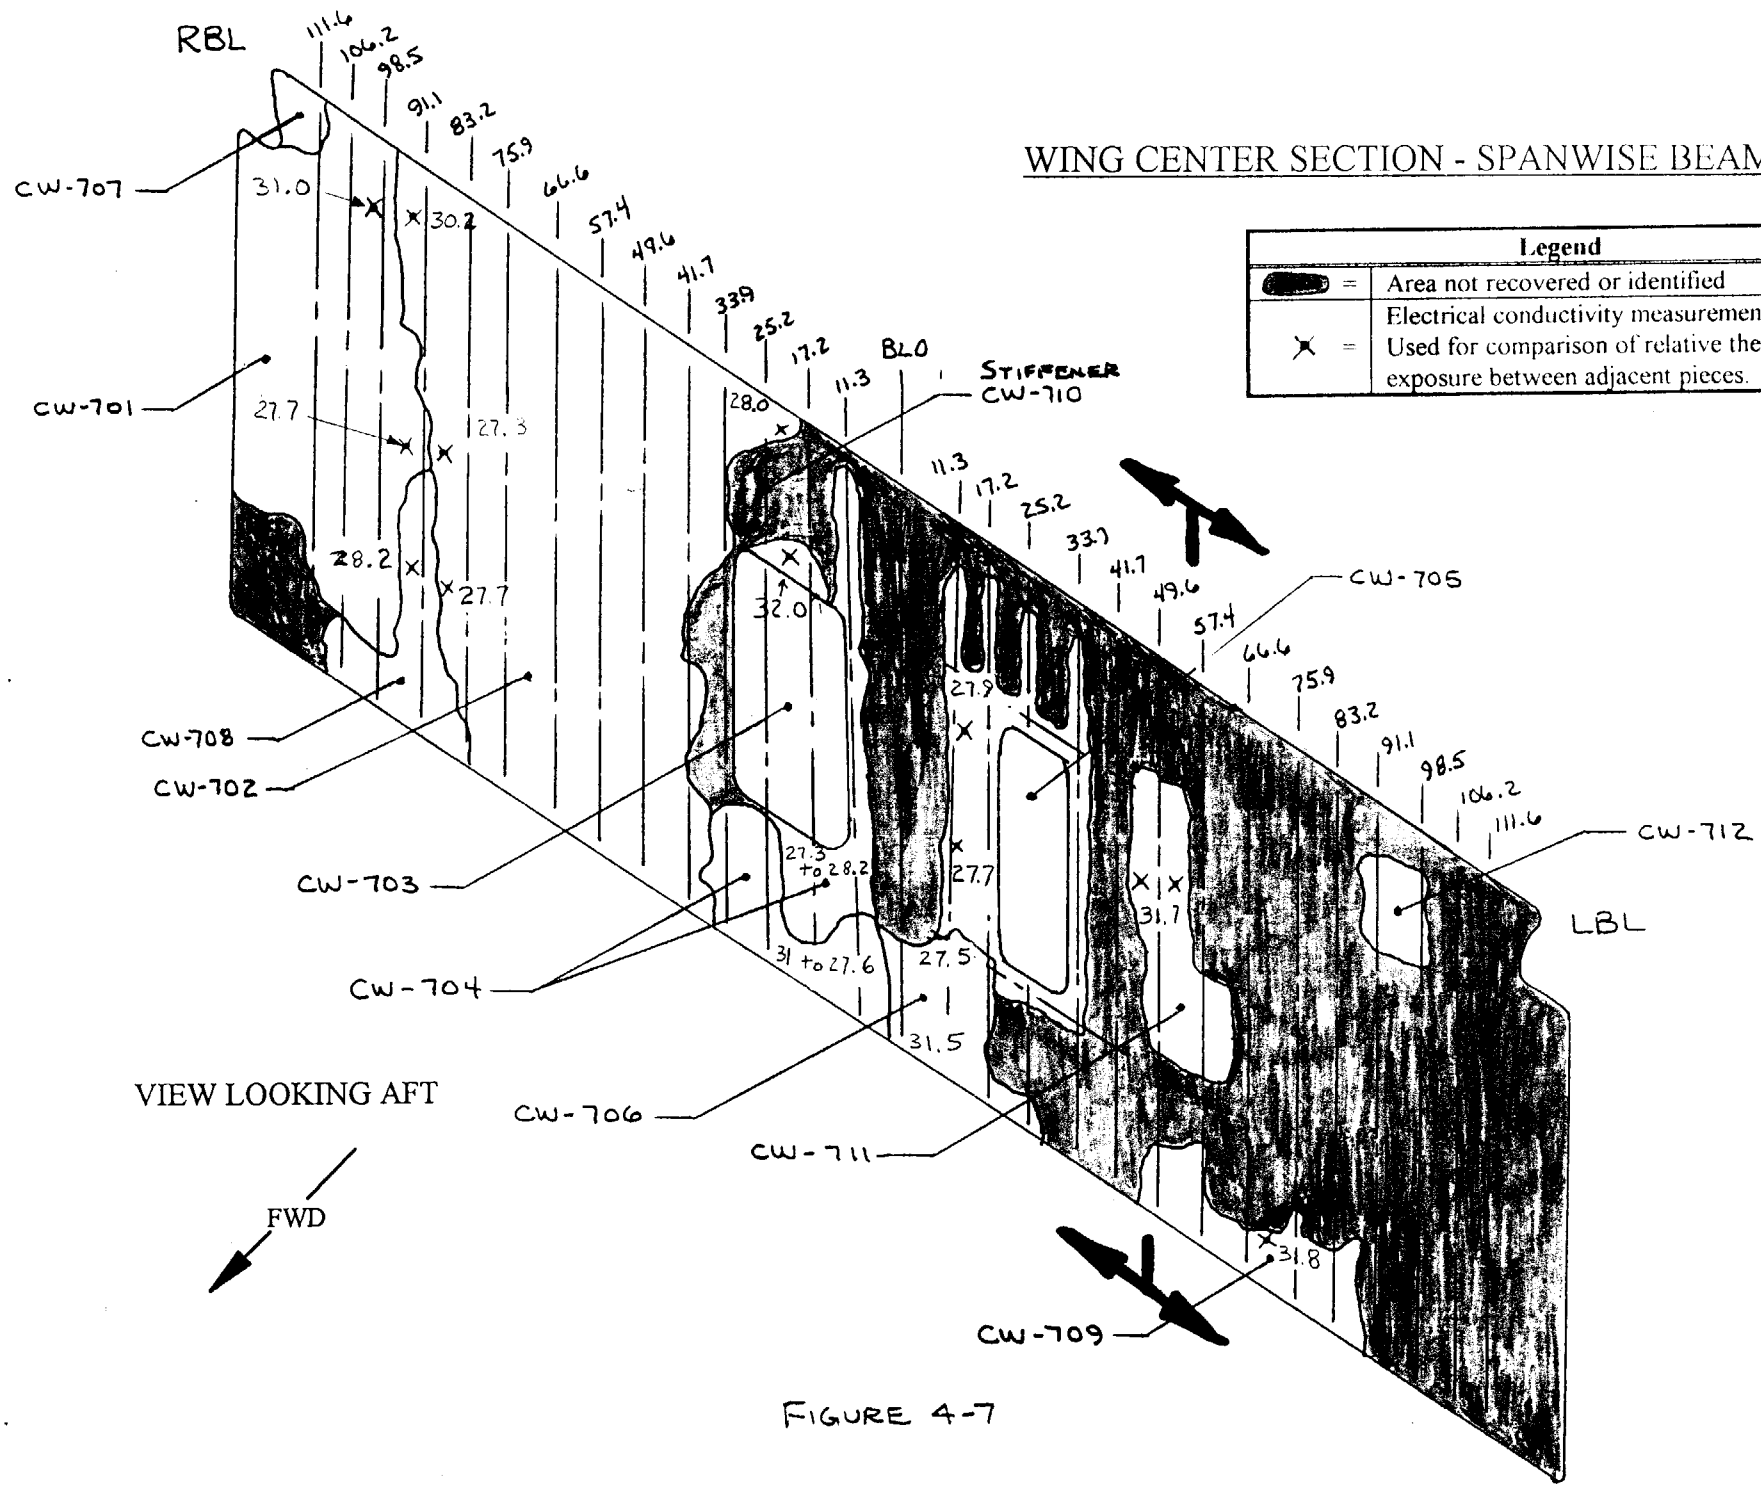
FIGURE 4-7

Spanwise beam #2 (SWB#2) is approximately 65% recovered and identified with most of the left side still missing (see figure 4-7). The manufacturing access door and a small attached portion of web above the door were recovered from the red area indicating early departure from the airplane. The door fasteners on the bottom and left (inboard) sides of the door were separated mostly in vertical shear (door along with upper and outboard surround structure moving up and the remaining surround structure moving down relative to each other). The remainder of the door fasteners were fractured in tension by the door peeling forward and

upward, finally tearing out a small portion of the upper web above the door. Witness marks found on the upper panel corresponded to deformation in the lower inboard corner of the door, indicating that the door separated upward with enough velocity to create this damage. Final separation of the door (peeling upward in the forward direction) indicated that the pressure on the aft surface of the door was significantly greater than the pressure on the forward surface of the door at that time. The access door is only lightly sooted, while sooting is moderate to heavy over most of the other pieces of the beam, consistent with much more substantial fire exposure after separation of the access door. The soot patterns indicated that most of the identified pieces of SWB#2 (with the significant exception of the access door) remained attached to the right wing at major airplane breakup.

A large portion of the right side of SWB#2 remained attached to the upper skin panel. Soot patterns indicate that the lower chord remained attached to the web until water impact but was separated from the lower skin panel before major fire exposure. In general, the features on the right side of the beam indicated that this entire portion of the beam remained largely intact but had separated from the lower panel before fire exposure. Recontact damage and separation of the web from the lower chord occurred after fire exposure.

The right side of SWB#2 also contained “accordion” damage (folding directly inboard) from forces acting in the inboard direction on the outboard end of the beam. No soot accumulation occurred after the deformation was created (see appendix B).

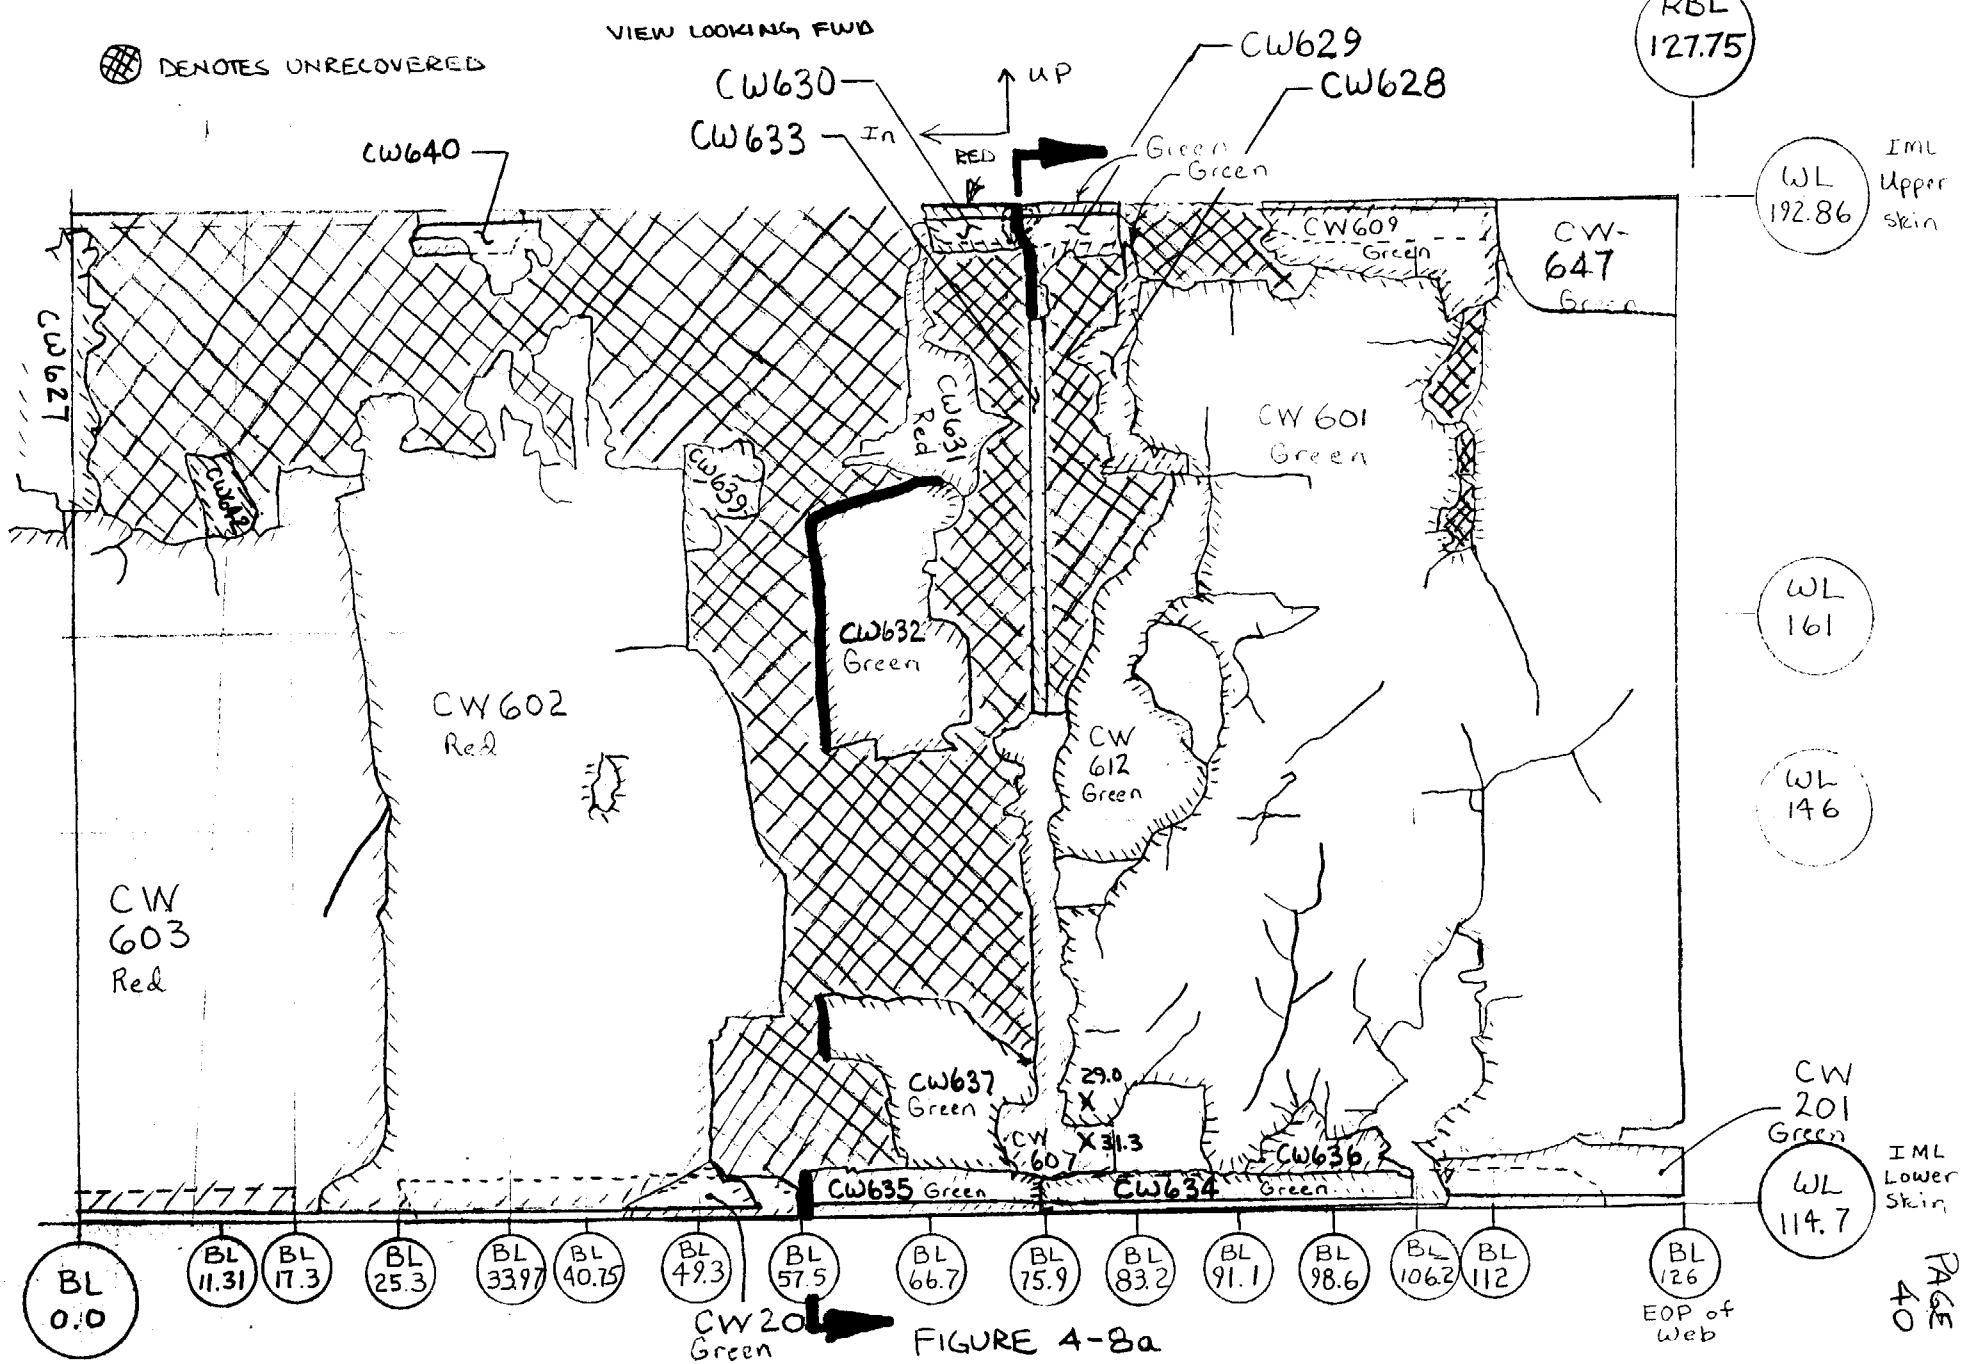
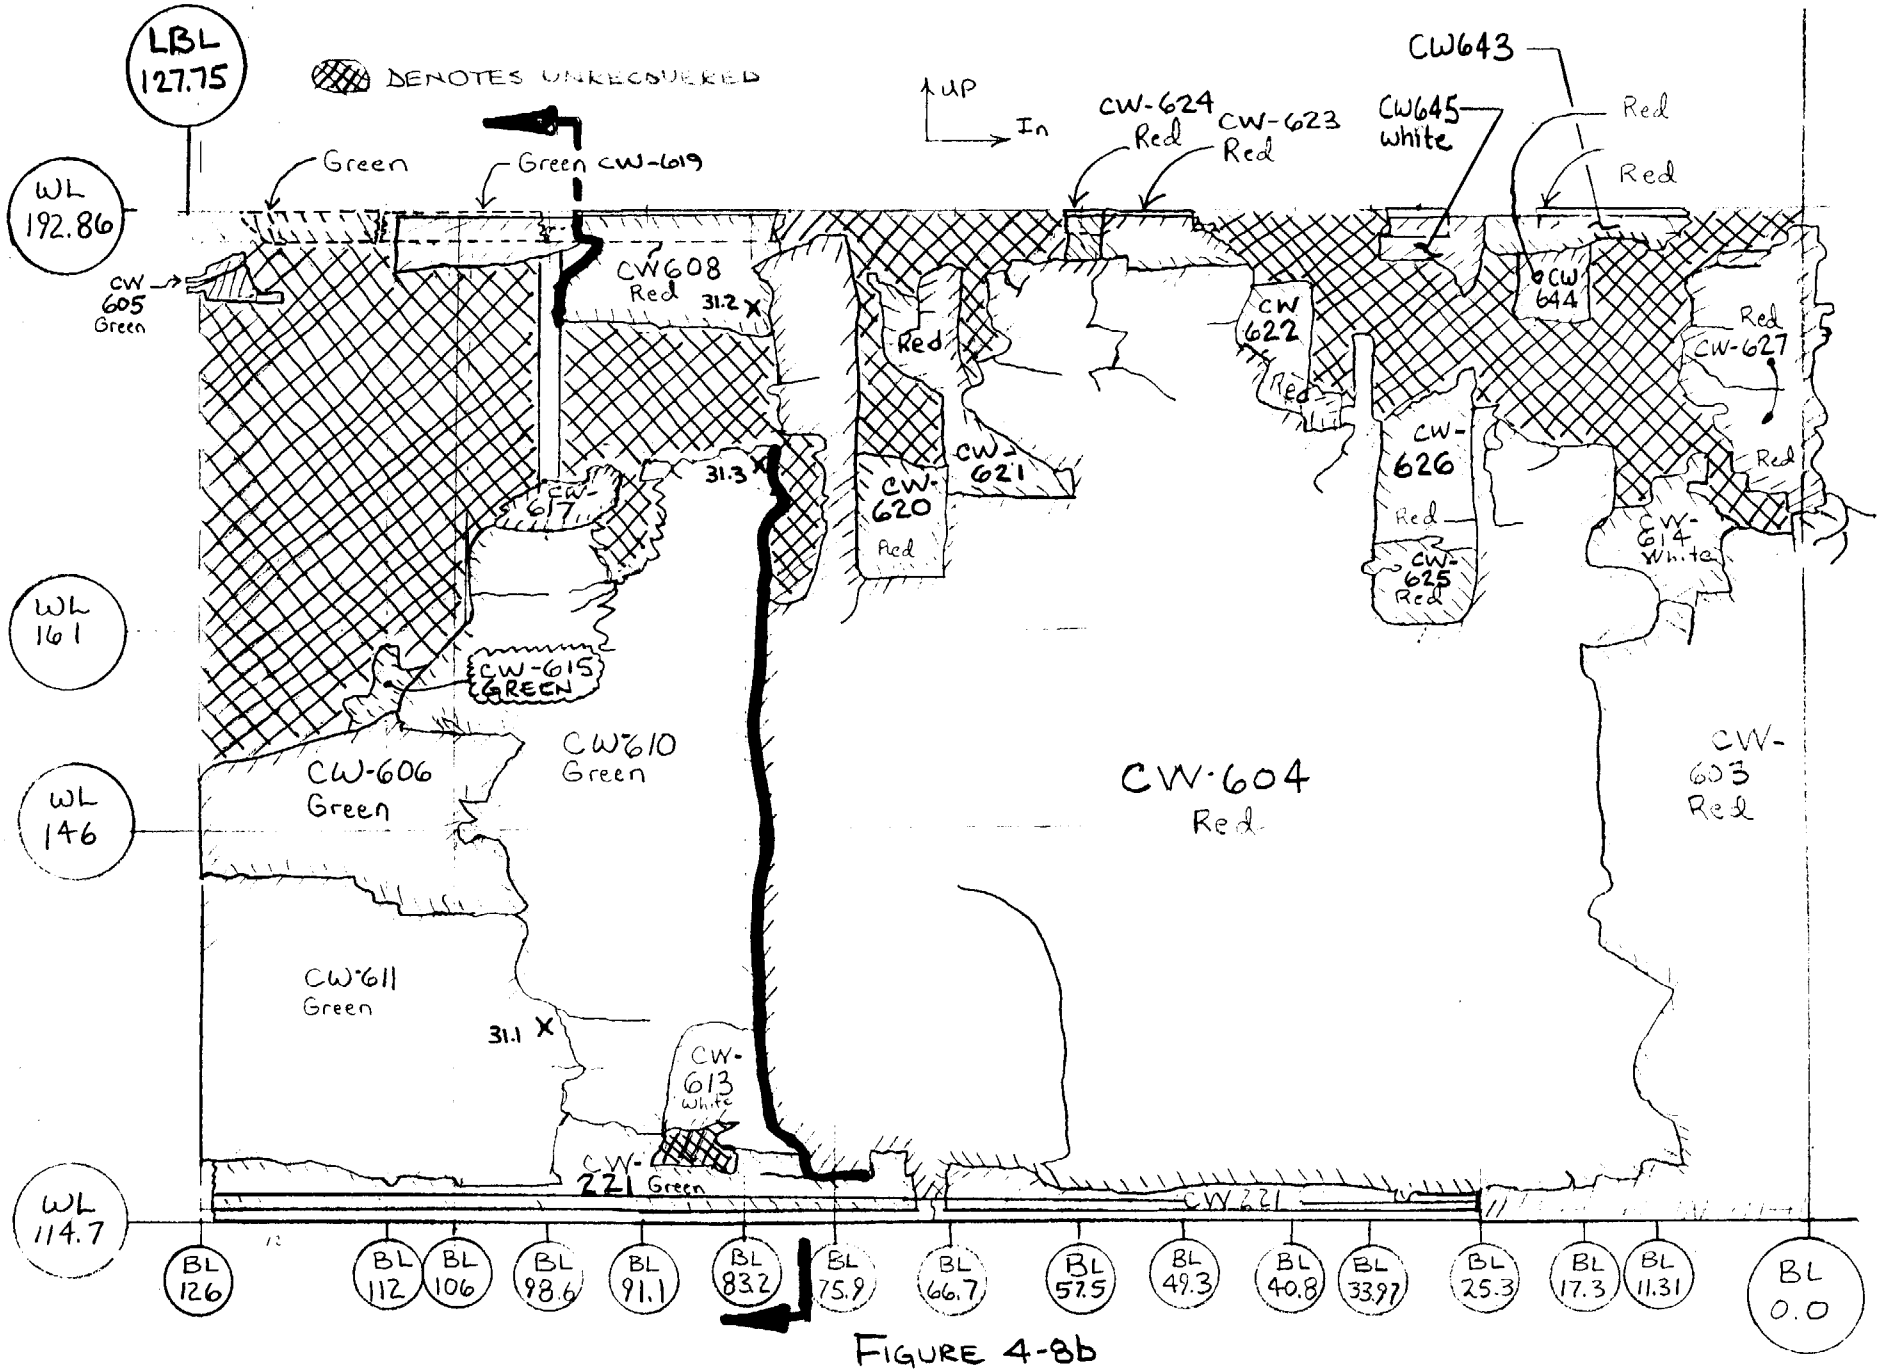
Spanwise beam #3 (SWB#3) is approximately 85% recovered with most of the missing area located between RBL 50 and RBL 90 (see figure 4-8). Pieces of the beam between approximately RBL 50 and LBL 80 were recovered from the red area indicating relatively early departure from the airplane. The part of SWB#3 from RBL 87 to right side-of-body is heavily sooted (burn damage) on both surfaces as well as most fracture faces. The pieces recovered from the red area are generally lightly sooted on both faces with occasionally more sooting on the front face. The pieces between LBL 80 and the left side-of-body (green area) are moderately sooted. Piece CW611 (adjacent to the left side-of-body) exhibits soot tails above the protruding fastener heads on the front surface. During major airplane breakup the pieces outboard of LBL 80 went with left wing and the pieces outboard of RBL 75 with right wing. The sooting on the aft surface on the left side and on red area pieces is indicative of an earlier event. Larger amounts of soot accumulation and fire damage on the right wing pieces indicate that this portion of the structure

was involved in a later major fire. The soot and fire damage associated with the later major fire masked any possible features that may have been associated with a possible earlier fire affecting the pieces of SWB#3 to the right of RBL 57.5.

The upper chord for SWB#3 was fractured through the fillet radius between the vertical leg and the upper horizontal leg of the chord. The upper chord fracture initiated at multiple locations and progressed essentially the full width of the beam.

Initial forward rotation of the upper portion of SWB#3 caused the upper chord of this beam to impact the aft face of the vertical portion of stringer 29, located 6 inches in front of SWB#3. This stringer also has a "Z" shape, with the upper horizontal leg pointing aft and the lower horizontal leg pointing forward. The upper horizontal leg of stringer 29 remained attached to the upper skin over most of the width of the WCS. The vertical leg had separated from the upper horizontal leg at the fillet radius. Only three pieces of the vertical leg of stringer 29 have been identified to date. These pieces extended from LBL 50 to RBL 36 and from RBL 55 to RBL 104. Except for small pieces attached to the vertical portion, no pieces of the lower horizontal leg were identified.

Vertical fractures through SWB#3 were found at various locations including near the respective sides-of-body. These fractures are also consistent with a forward acting overpressure on the aft surface of SWB#3. Separation of the top of the SWB#3 allowed the segments to rotate forward about the lower intercostals (or, in the case of the center segment, about the beam's lower chord) until the top of the beam impacted the stiffeners on the aft surface of the front spar approximately 12" below the upper skin panel. The impact broke off parts of the upper web and stiffeners of SWB#3. The remaining lower portion of SWB#3 continued rotating forward and down with upper stiffener ends tearing vertical holes in the front spar web at various locations down to about 1 to 2 feet from the lower panel.
