DOCKET NO. SA-516

METALLURGY/STRUCTURAL GROUP CHAIRMAN
FACTUAL REPORT
SEQUENCING STUDY
(57 pages)

METALLURGY / STRUCTURES SEQUENCING STUDY Report No. 97-38

Place	:	East Moriches, New York
Date	:	July 17, 1996
Airplane	:	Boeing 747-131, N93119
NTSB No.	:	DCA96-M-A070

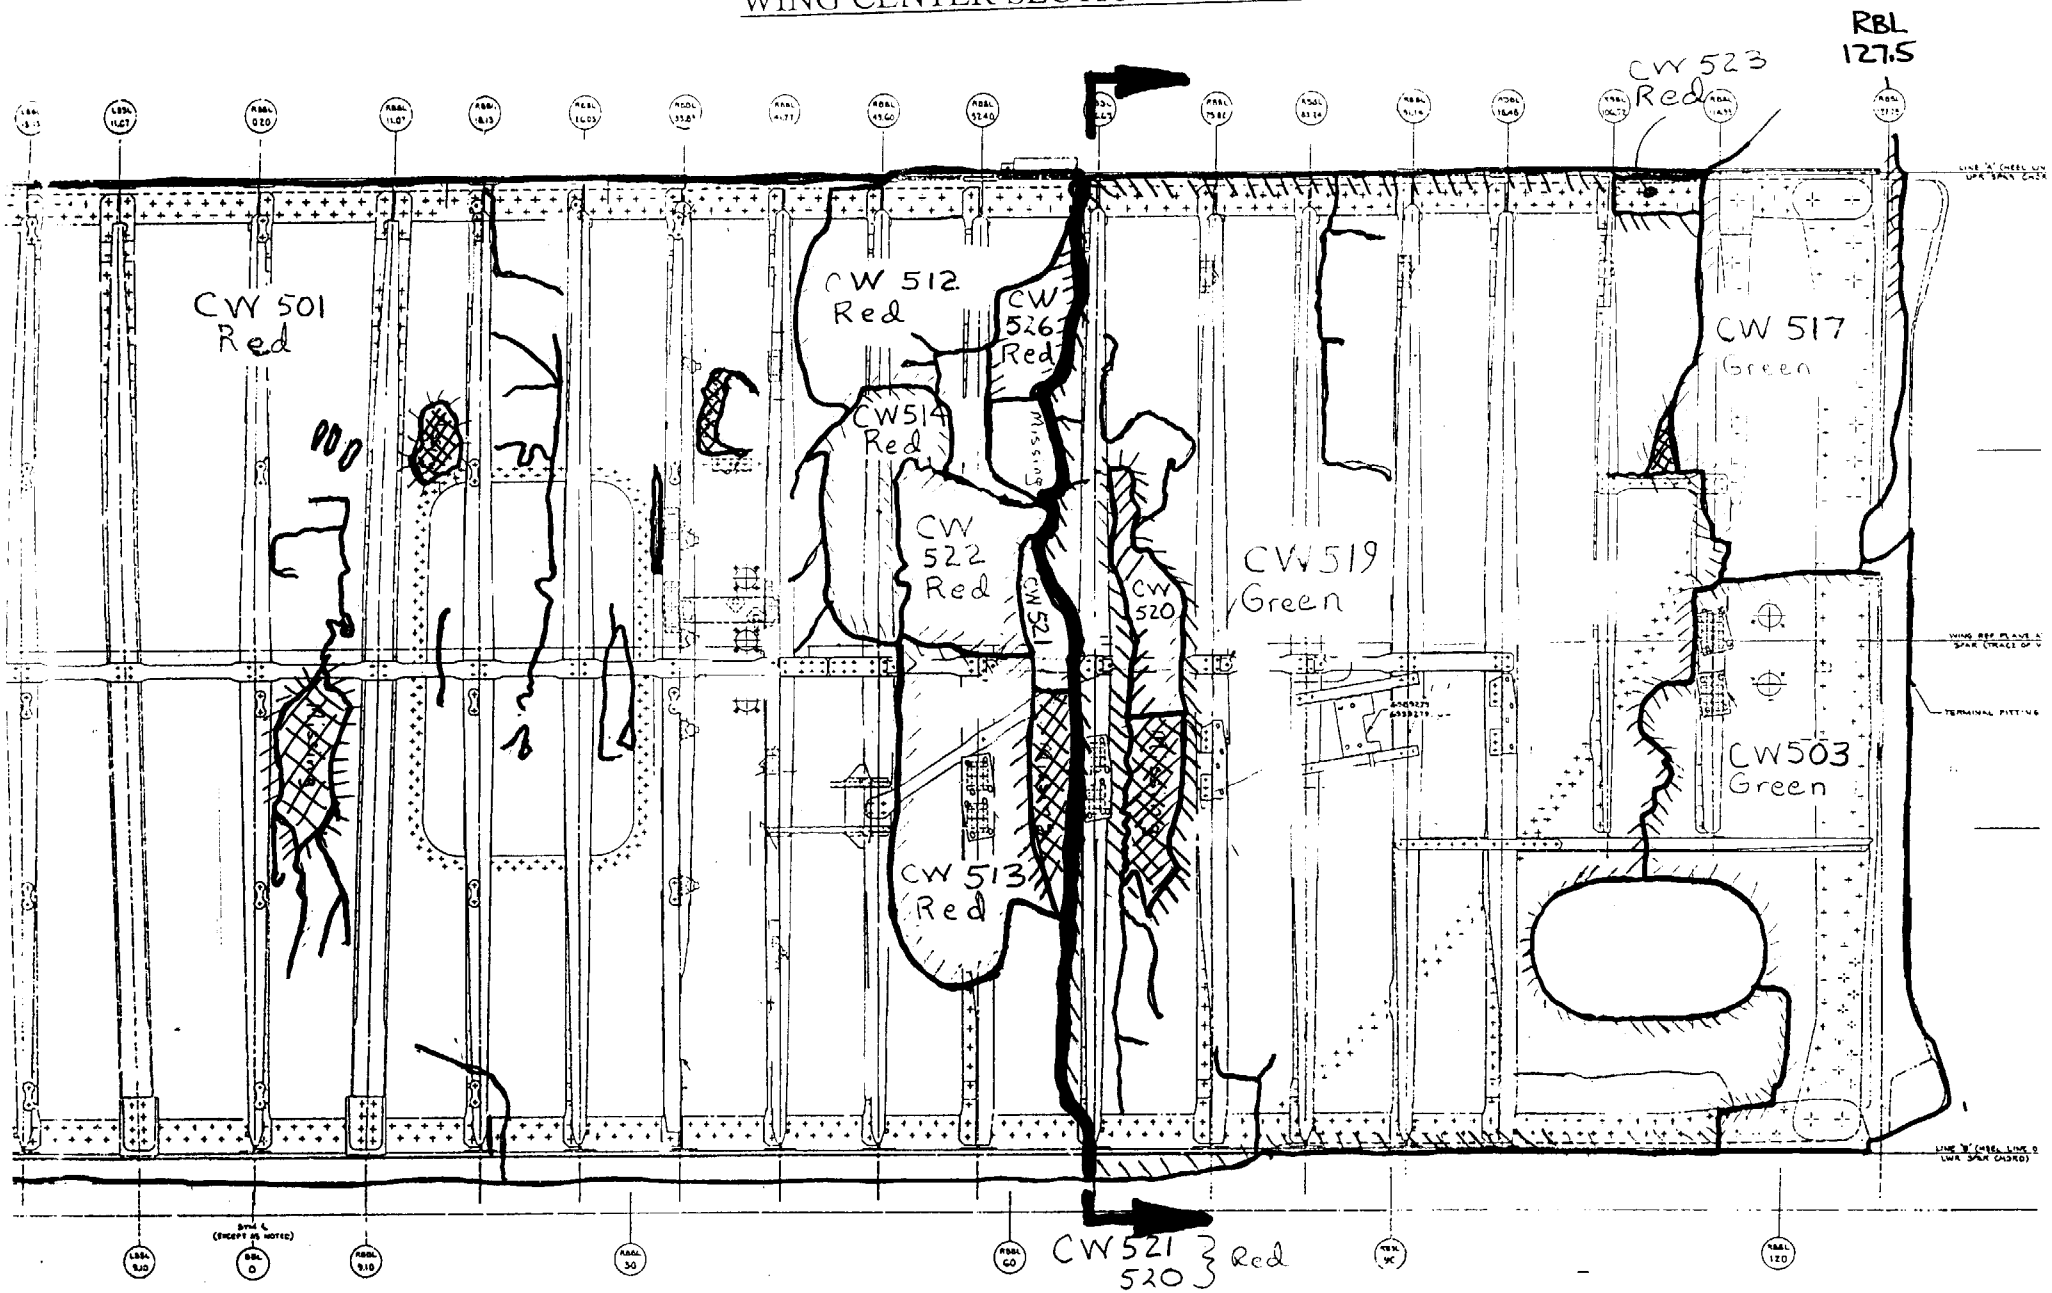
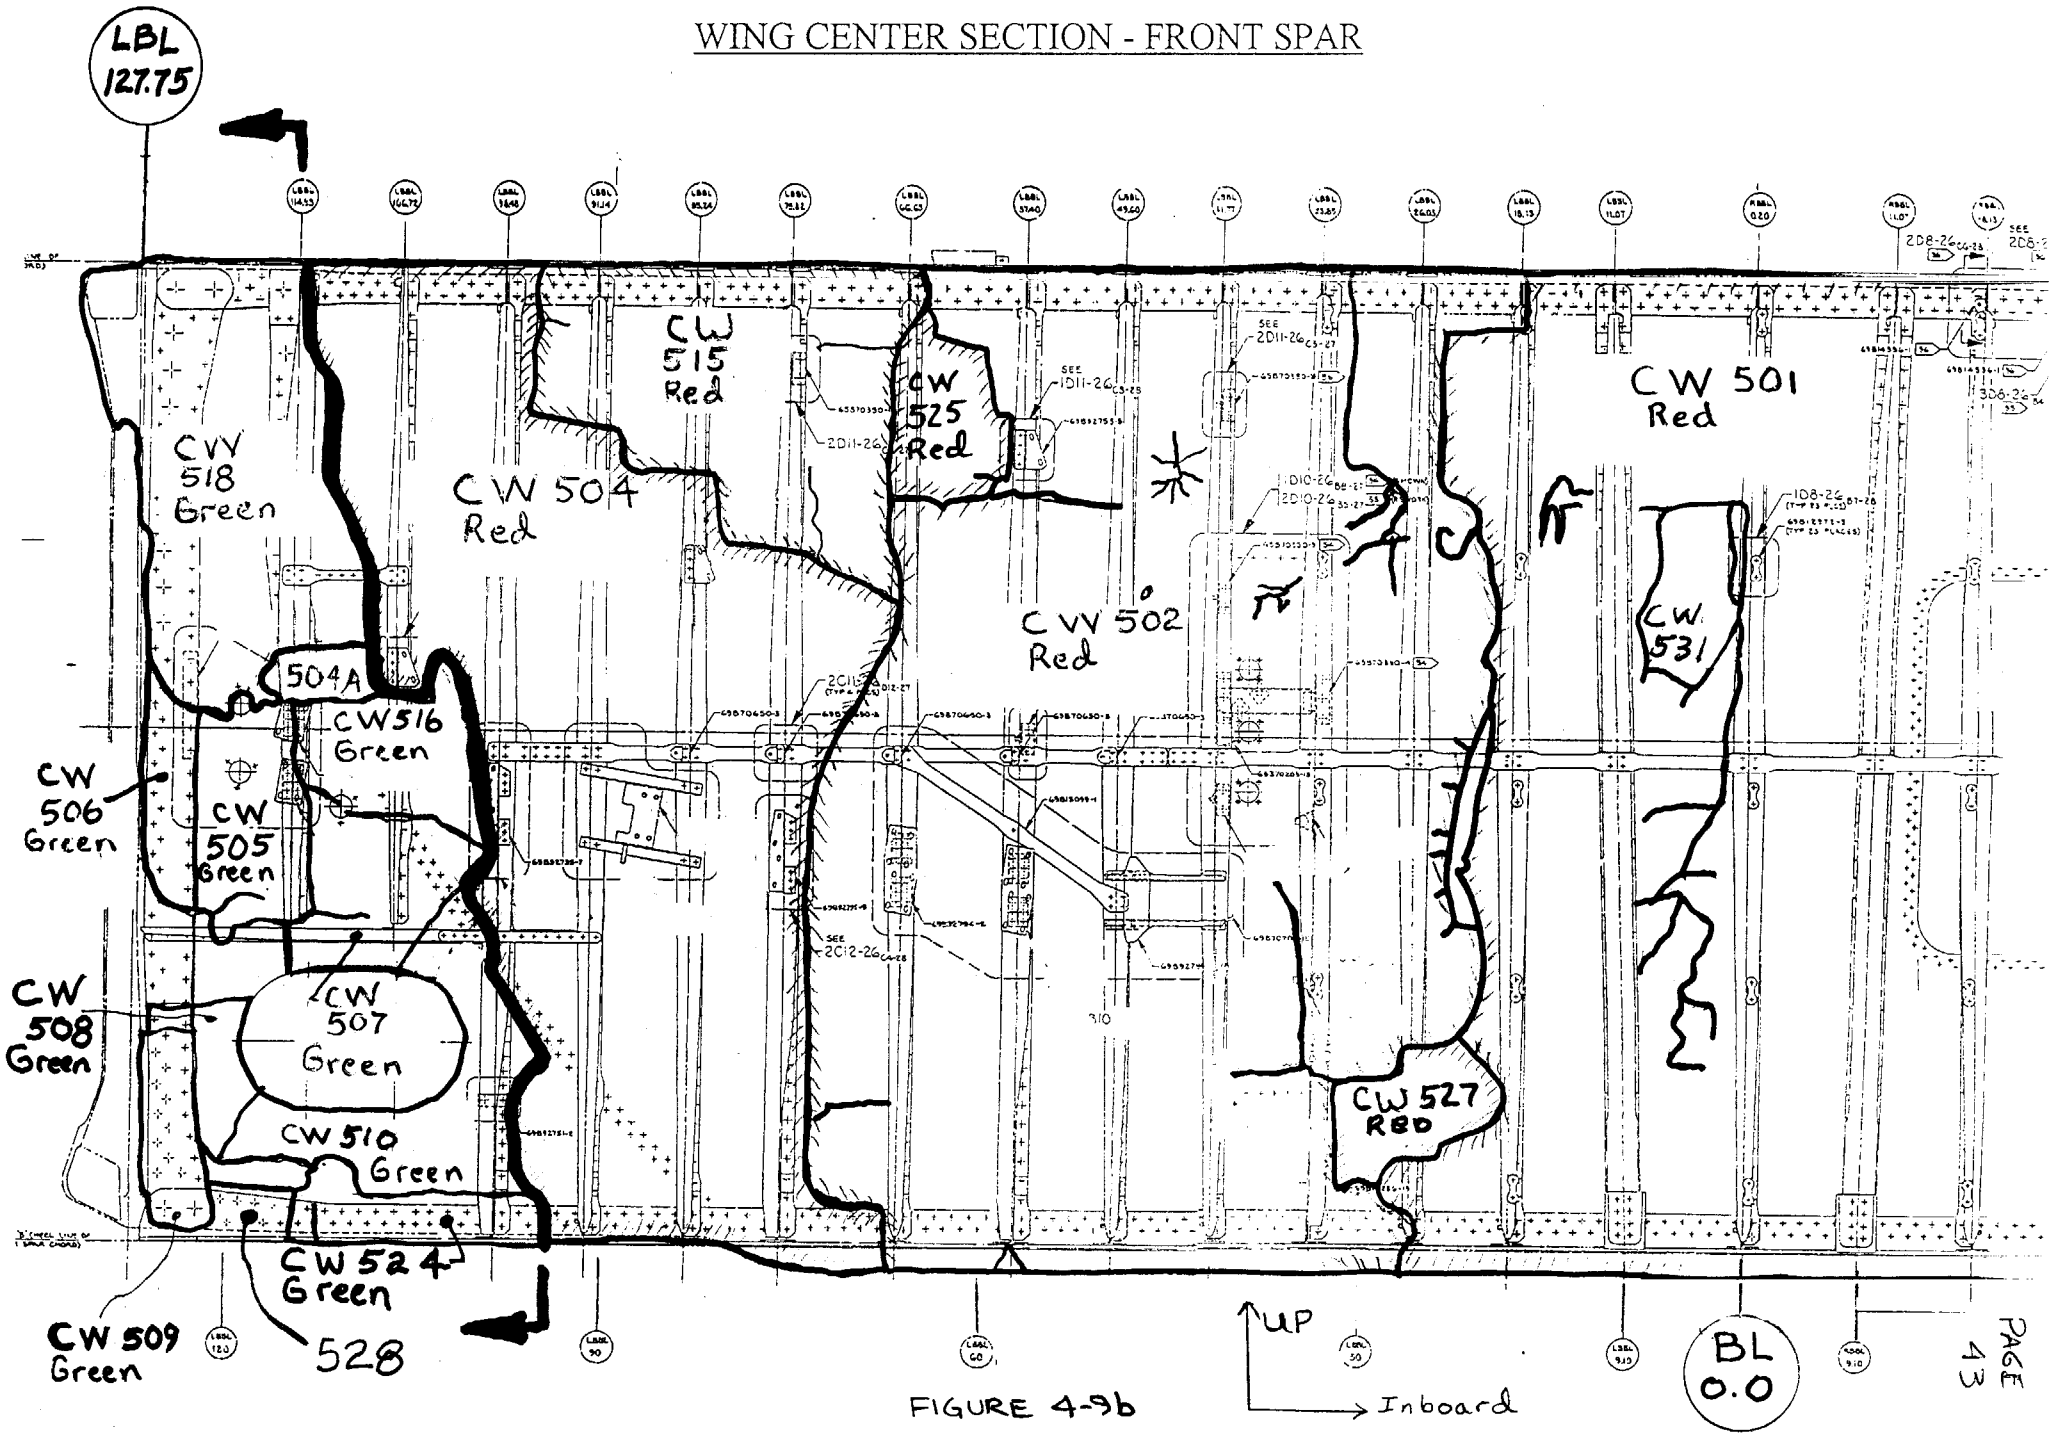
Forward rotation of the front spar about its lower end is consistent with overpressure loads released by SWB#3 as it rotated forward. Deformations in the upper chord of the front spar were in a symmetric "sine wave" shape, with a lobe bulged forward on each side of center. Forward deflection amplitude was maximum at approximately LBL 66 and RBL 66 and minimum at the approximate center of the span of the spar (corresponding to the potable water bottle locations). Tension separations of the vertical leg of the front spar upper chord were found in multiple locations (LBL 66 and RBL 48, see figure B-12 in appendix B) corresponding to the forward bulges on each side of center. These separations are consistent with tension generated by the stretching of the vertical leg of the upper chord as the upper portion of the front spar rotated forward. Vertical fractures through the front spar web progressed downward to the front spar lower chord. Compression buckling of the vertical stiffeners attaching the front spar to the lower pressure bulkhead (located below the front spar and above the ring chord, see figure 4-11) indicates that separation of the front spar pieces from the lower skin panel and the lower pressure bulkhead was as a result of forward rotation of the front spar pieces about the lower chord caused by impact loads and/or pressure loads on the aft surface of the spar.

Close examination revealed small pre-existing fatigue cracking areas in the upper and lower shear ties for the stiffeners on the aft surface of the front spar, in the front spar lower chord near the underwing longerons, and in a longitudinal floor beam detail. The shear tie fatigue cracks and front spar lower chord fatigue cracks are in areas subject to Service Bulletin directed inspections and/or modification.

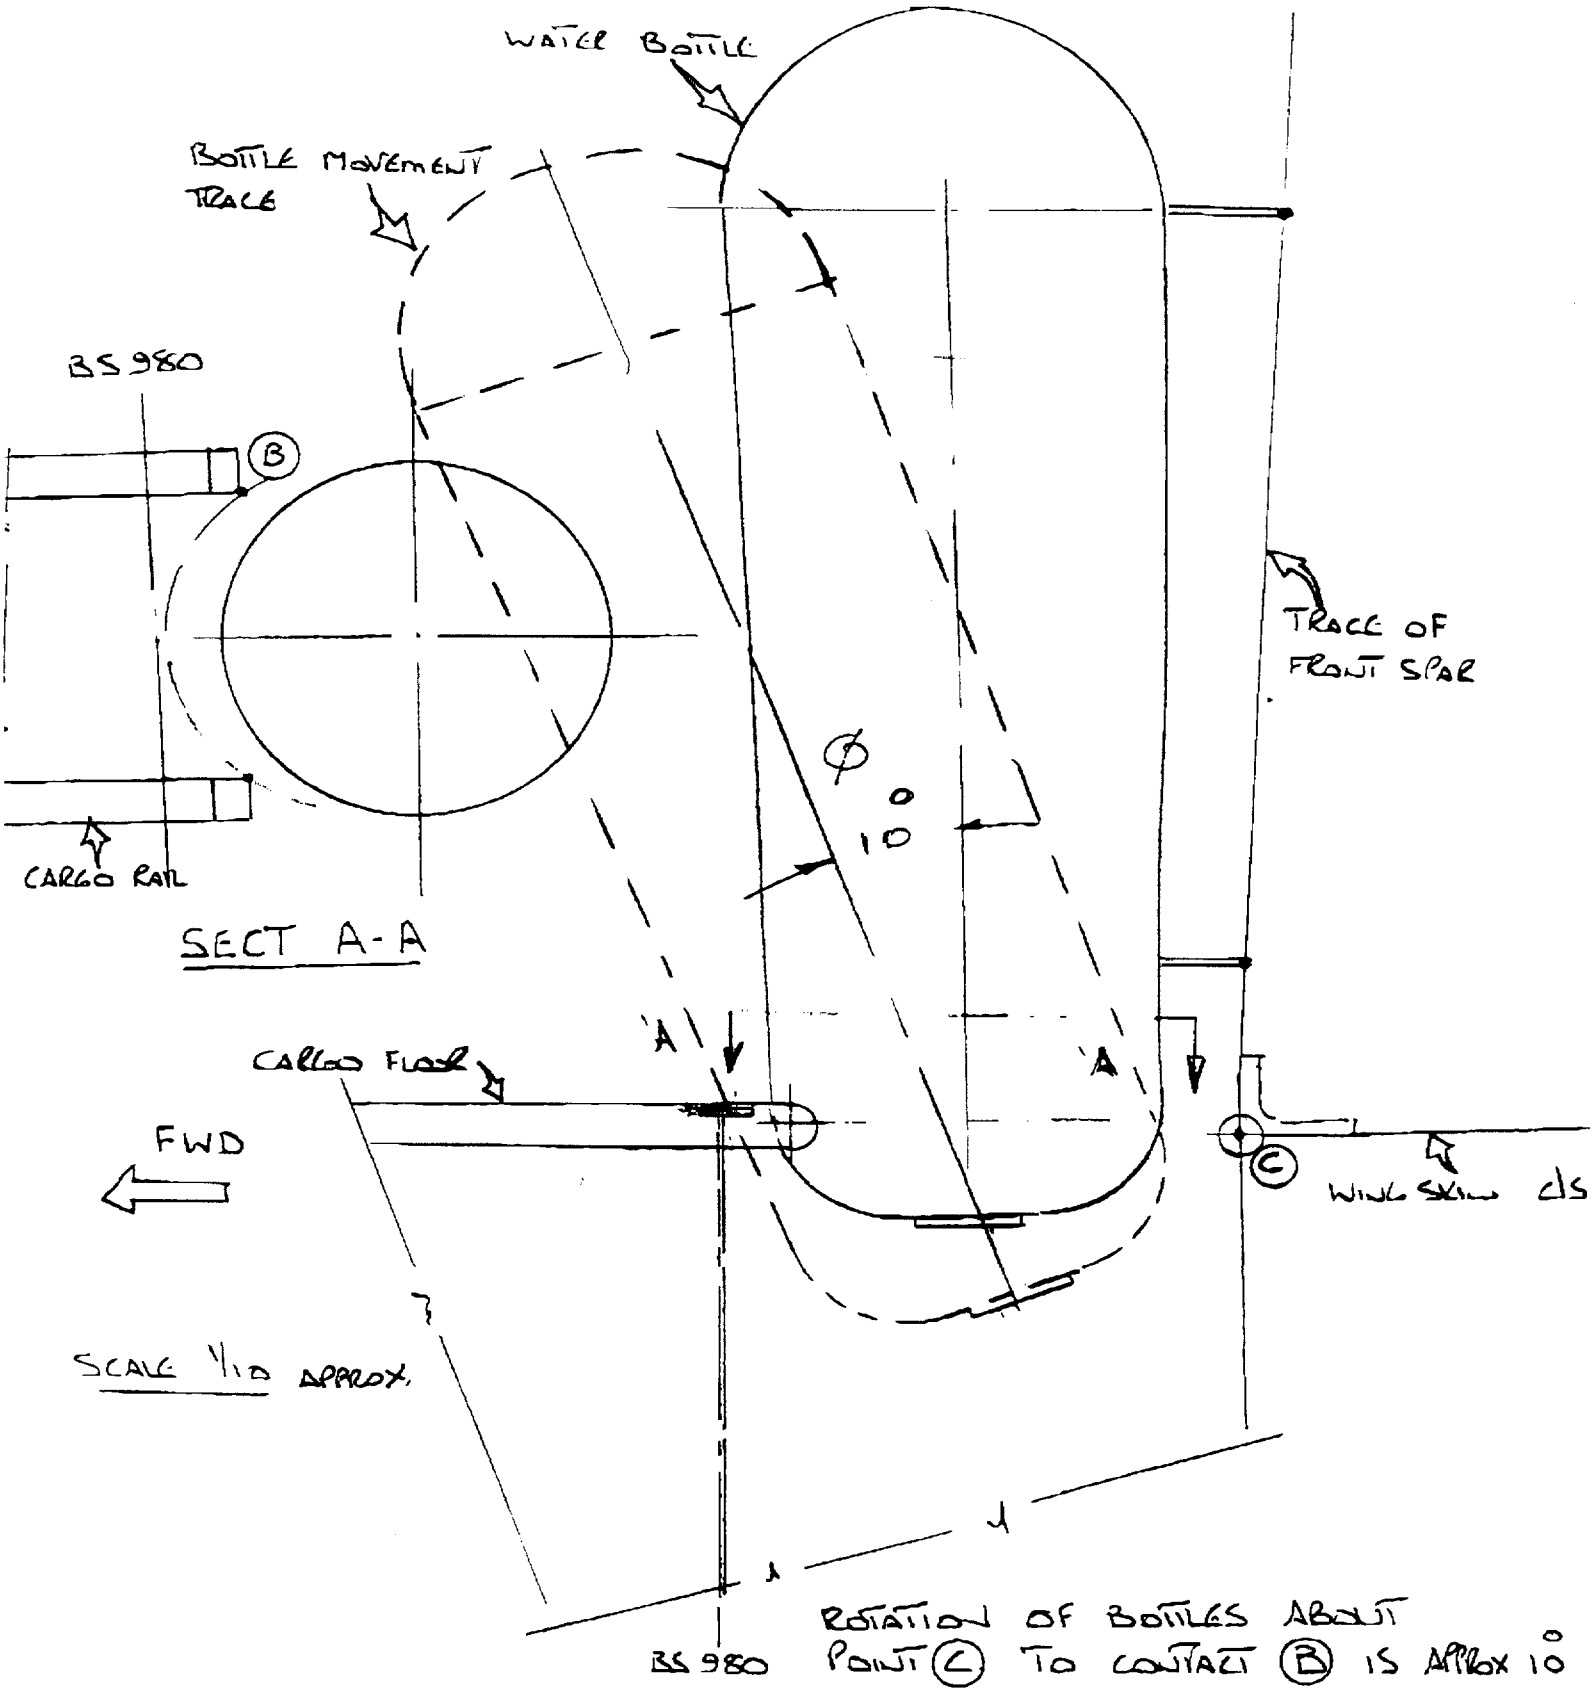
FIGURE 4-10

As discussed in section 4.10, SWB#3 rotated forward impacting the vertical stiffeners on the aft surface of the front spar. The impact, along with possible overpressure from behind SWB#3 fractured the front spar upper chord in the radius between the horizontal and vertical legs of the chord. The horizontal leg of the chord remained attached to the upper skin panel, and the vertical leg remained attached to the web of the front spar. Continued forward and downward rotation of SWB#3 tore holes in the front spar web, at various locations down to about 1 to 2 feet from the lower panel. Geometric layouts (see Appendix B) indicate that SWB#3 probably rotated almost fully forward and down prior to full rotation of the front spar about its connection to the WCS lower panel. The potable water bottles (centered on the front surface of the front spar) sustained relatively minor damage on their aft sides from impact with pieces of SWB#3. The forward side of the right bottle contained impact marks and fractures roughly corresponding to cargo floor structure. A geometric layout indicates that only about 10 degrees of rotation of the front spar would be needed to force contact between the bottles and the cargo floor structure (see figure 4-10).

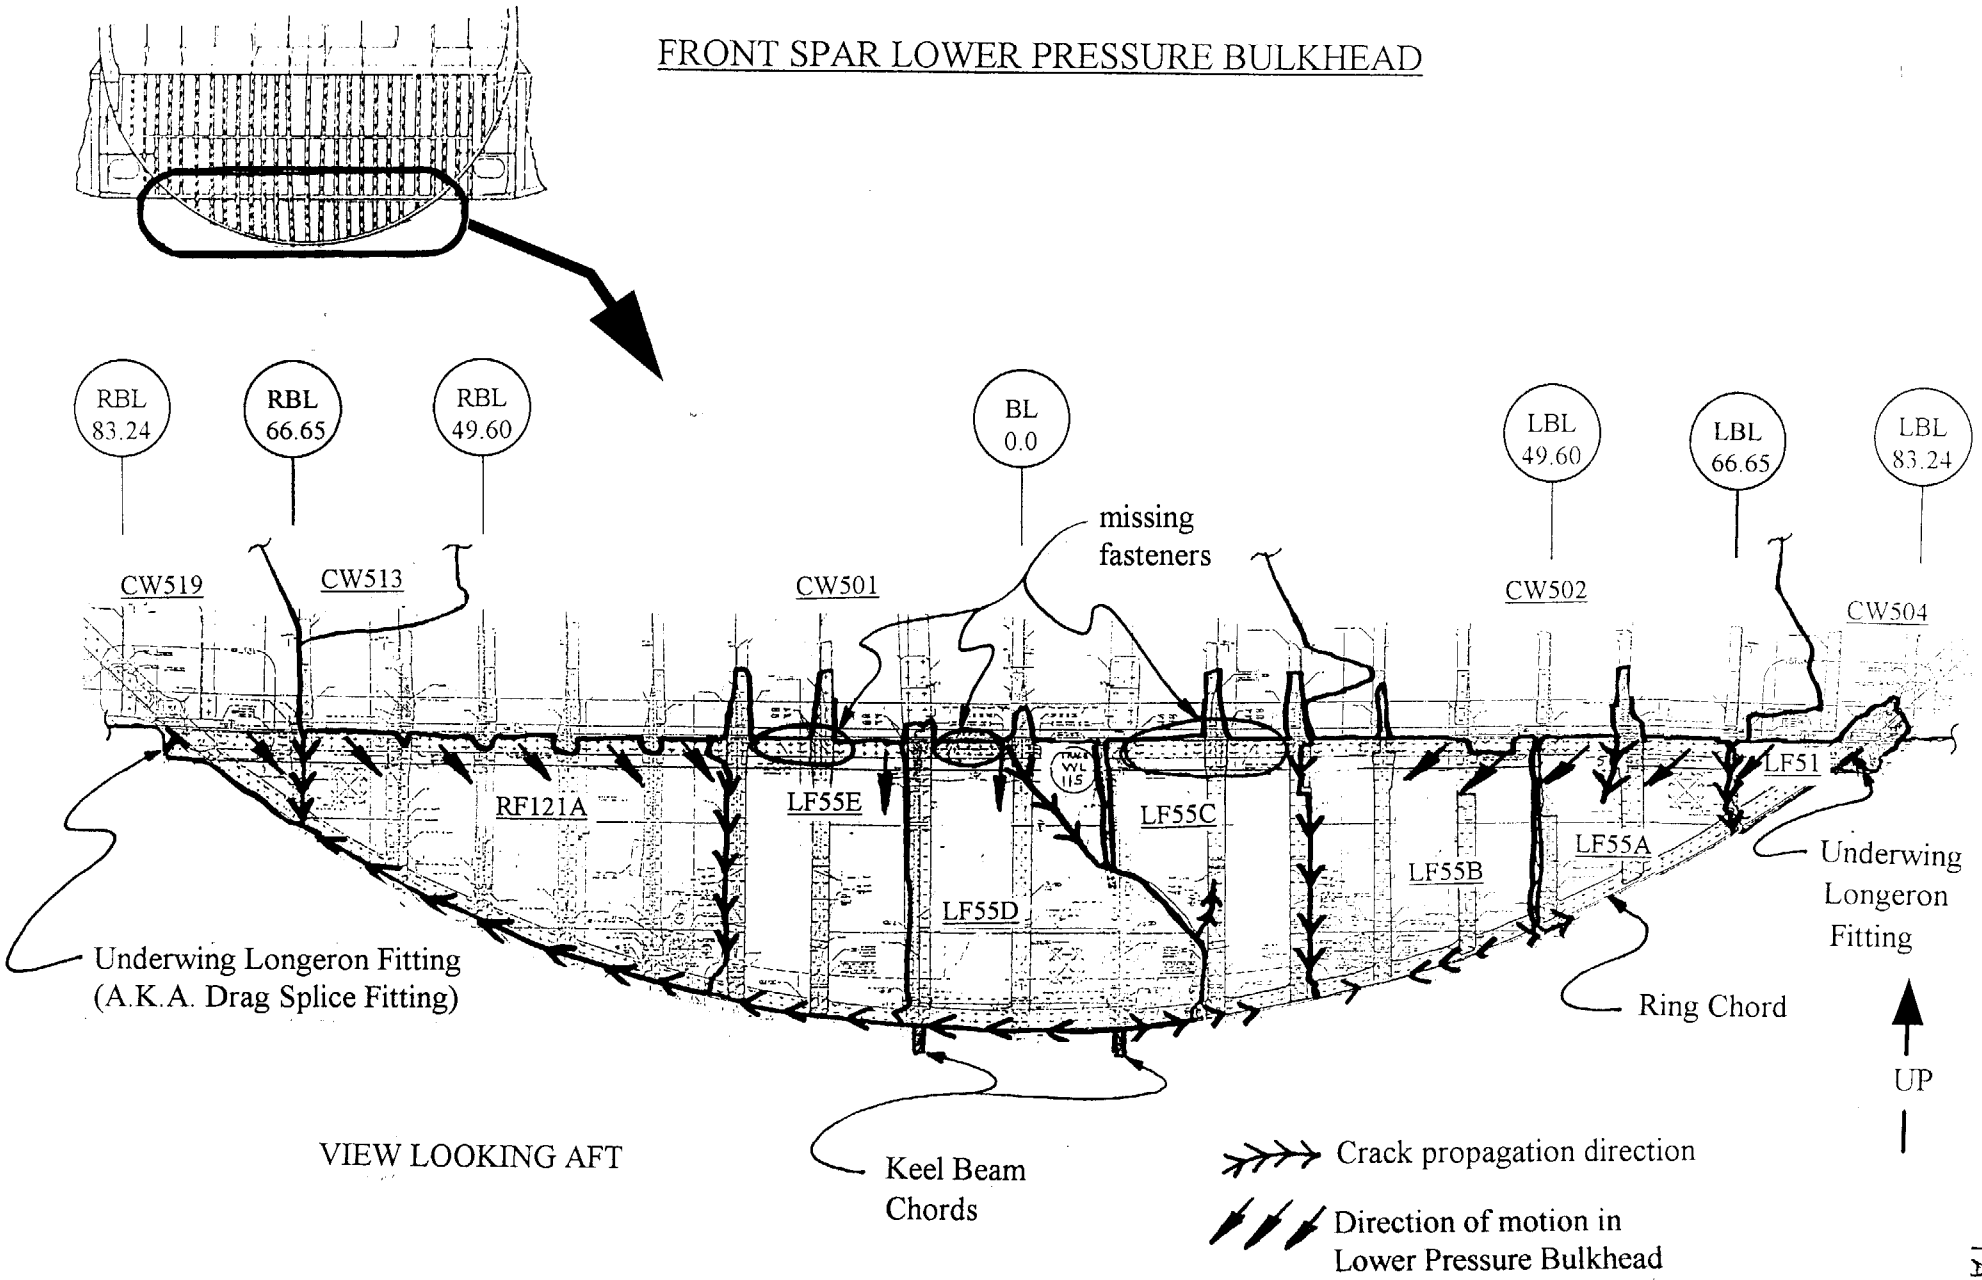
FIGURE 4-11

adjacent fittings stayed with the airplane and were recovered from the green area. The aft surface of the lower pressure bulkhead pieces to the left of the keel beam had soot deposits, especially on the upper edges of protruding head fasteners and on other protruding objects. Some soot was also noted on the aft surface of the bulkhead to the right of the keel beam. Crack propagation directions have been identified and documented on Figure 4-11.

At RBL 66, LBL 26, and LBL 66 web cracks propagated down from the front spar web and reinitiated downward in the lower pressure bulkhead with eventual associated axial fracture of the ring chord. There are additional lower bulkhead fractures at RBL 9 and LBL 9 which are close to the keel beam interface. There is an additional vertical web crack at LBL 49 which is associated with the separation of piece LF55A. The stiffeners "splicing" webs of the front spar and lower bulkhead are uniformly buckled in the free flange consistent with the motion of the front spar rotating forward. The stiffener at LBL18 is not bent forward as far as the others indicating limited forward rotation of the front spar in this area prior to ring chord separation at the bottom of the stiffener. The fasteners common to the splice between the webs of the front spar and lower pressure bulkhead are consistently (left and right sides, BL26 to BL75) separated in shear with the lower web being pulled downward and somewhat inboard.

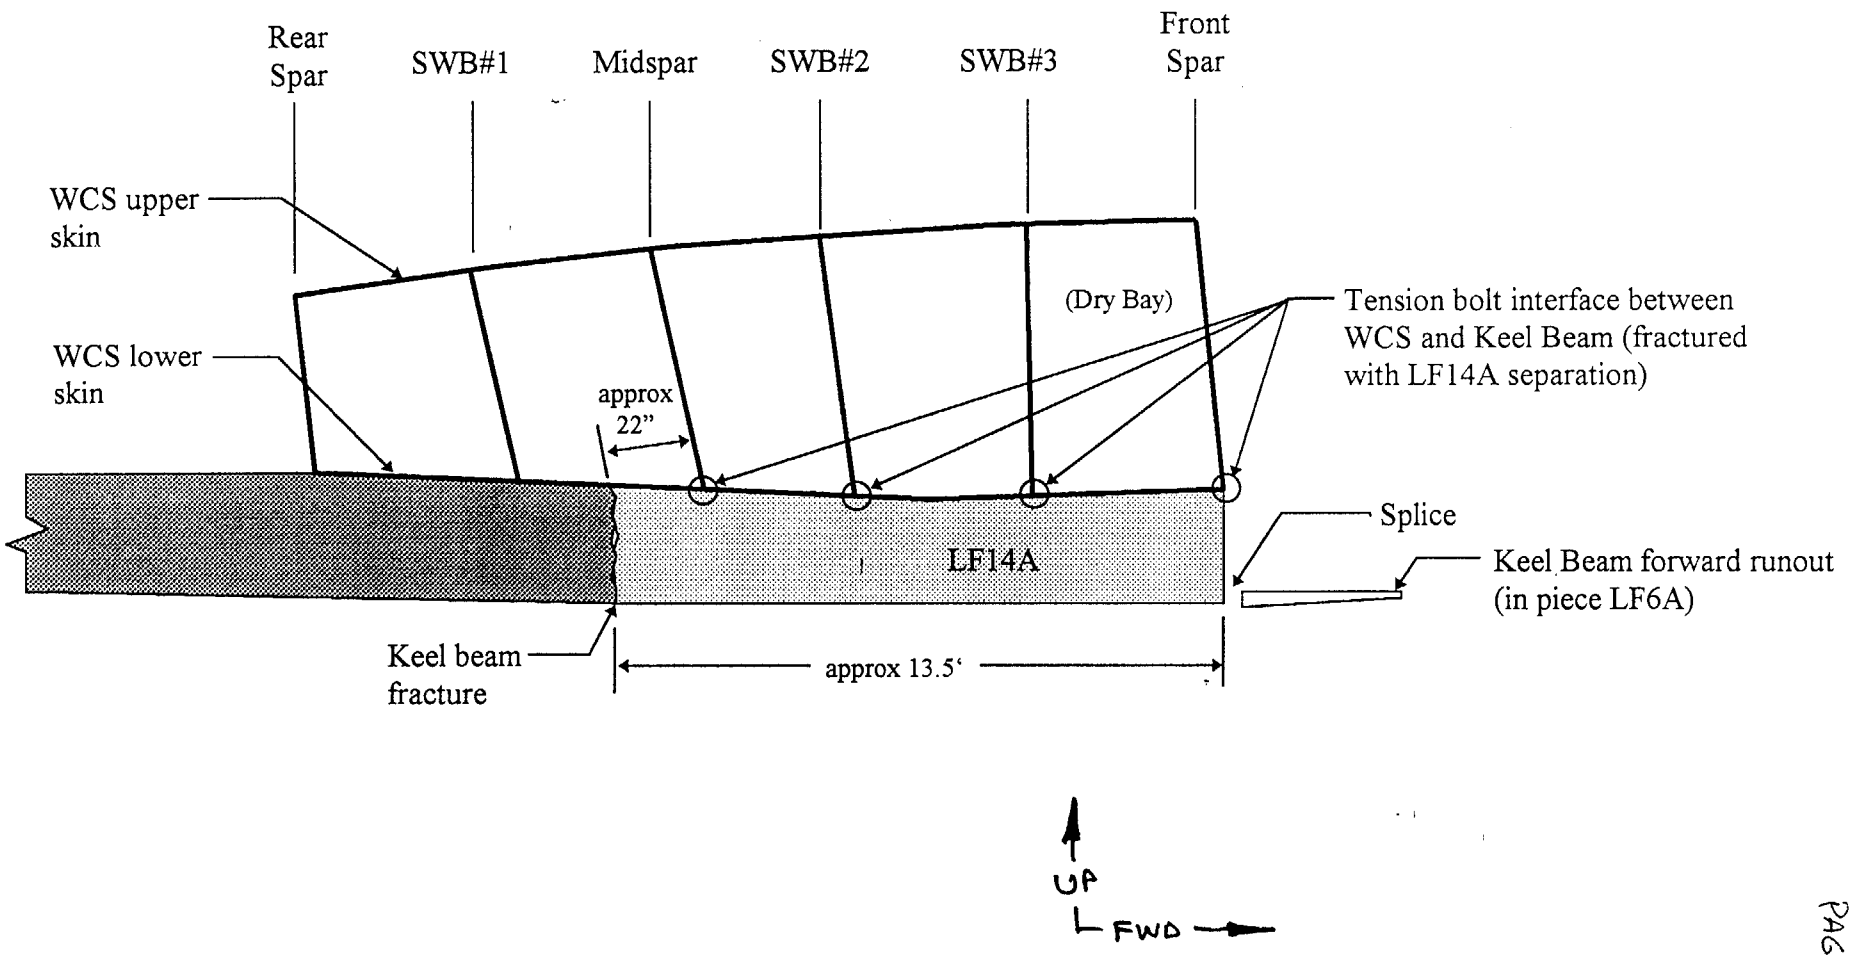
Figure 5-1

The keel beam (see figure 5-1) is located along the centerline of the airplane under the WCS from below the front spar aft through the wheel wells to the STA 1480 bulkhead. The beam is a box structure with two vertical webs (at LBL 9 and RBL 9). Each web has a heavy chord along its lower edge and a smaller chord along its upper edge. The upper chord is attached to the lower surface of the lower skin panel of the WCS through a series of aluminum rivets forward of the midspar and titanium bolts aft of the midspar as well as stronger steel tension bolts at each transverse beam inside the WCS (front spar, SWB #3, SWB #2, midspar, SWB #1, and rear spar).

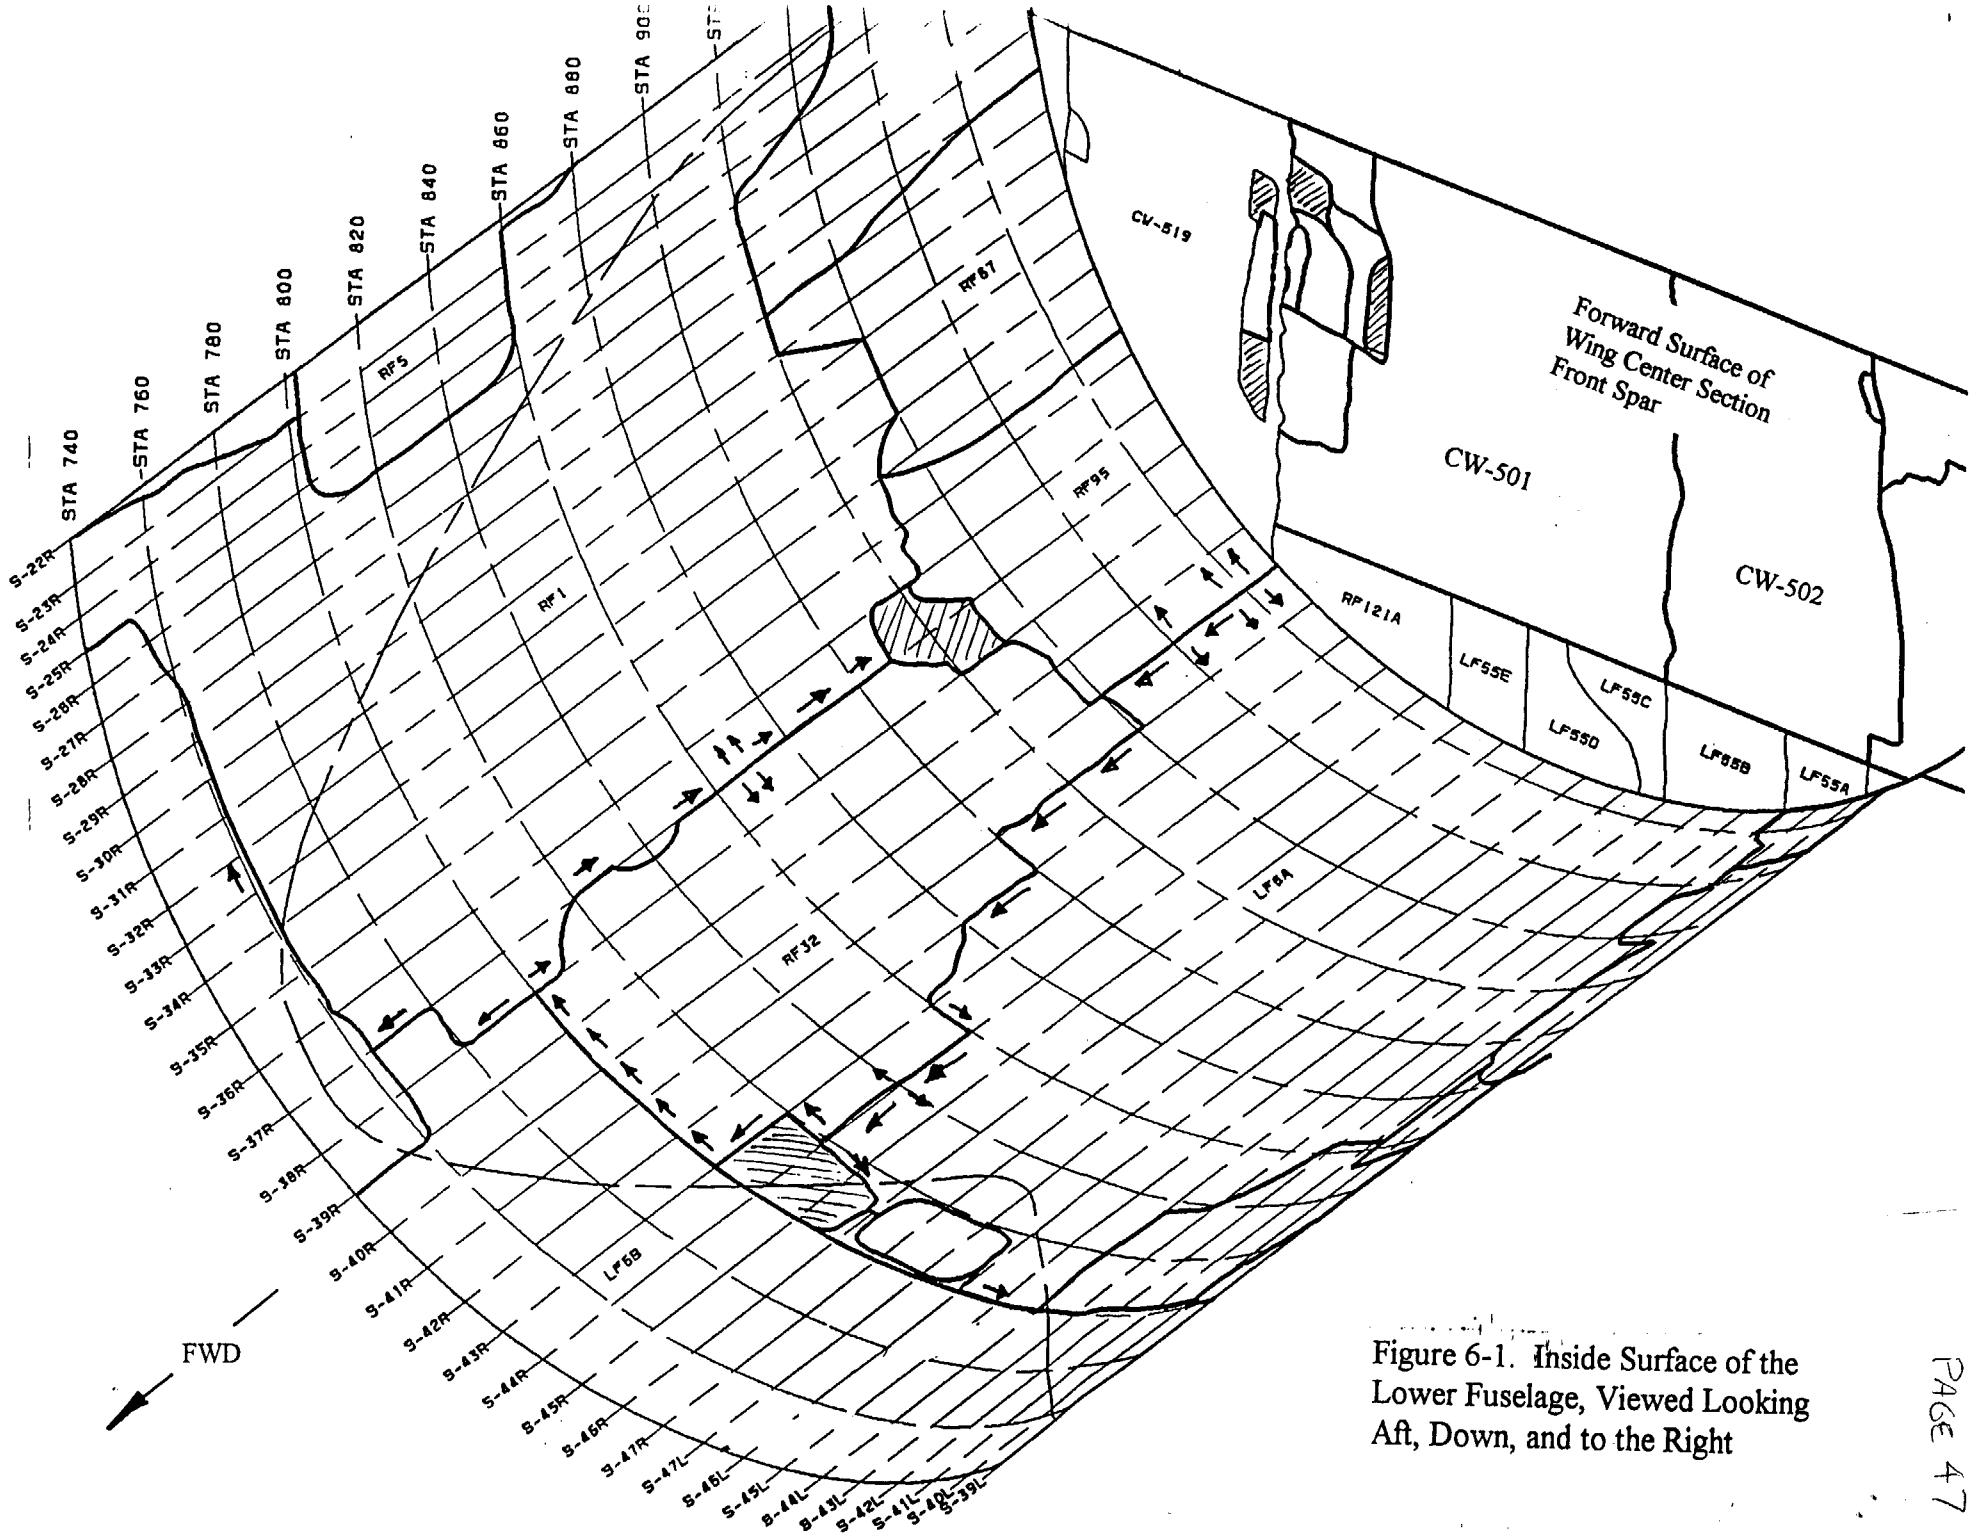
All of the fuselage skin fractures on the pieces from the areas shown in figures 6-1 and 6-2 were examined in detail. No evidence of fractures originating from pre-existing fatigue or corrosion damage was found. Some of the skin fractures progressed along a row of rivets, either longitudinally along a stringer or lap joint, or circumferentially along a frame attachment location. Others were in the skin away from a row of rivets. None of the fuselage pieces from below the window belt in this area contained signs of longitudinal compression buckling. Fractures that were along a row of rivet holes and were consistent with in-plane[4] loading (hoop or longitudinal tension with the possible presence of in-plane shear were sequenced as occurring before fractures bending or out-of-plane shear deformation. Three types of earlier fractures were identified:

Unlabeled arrowheads oriented parallel to skin fracture locations in figures 6-1 and 6-2 indicate the location and direction of propagation of the earlier fuselage skin fractures. In places where the earlier longitudinal fractures did not have features indicating a crack propagation direction, arrowheads perpendicular to the separation indicate the tension loading that is consistent with the fracture features. The earlier fuselage skin fractures discussed above separated the right edge, the forward edge, and a portion of the left edge of a combined piece from the bottom of the fuselage (pieces LF6A and LF24A). The earlier fractures also progressed nearly completely around the circumference of piece RF32 and circumferentially across the bottom of the fuselage from S33L to S32R.

Additional fuselage skin fractures with features indicative of separation under a combined tension and either bending or out-of-plane shear loads were found on the red area pieces from the left side of the fuselage and are indicated by the arrows labeled with a “1” or “2” in a circle in figure 6-2. These fracture areas stemmed from the earlier cracks or were along the bottom row of rivets at a lap joint. Fracture areas labeled with “1” contained bending deformation and fracture areas labeled with “2” contained out-of-plane shear deformation. These additional fractures nearly completed the separation of a large combined piece from the bottom of the fuselage (combined pieces LF6A, LF24A, LF95, and LF55A).

Fuselage skin fracture areas not indicated by arrowheads in figures 6-1 and 6-2 were classified as later fractures.

Figure 6-1. Inside Surface of the Lower Fuselage, Viewed Looking Aft, Down, and to the Right

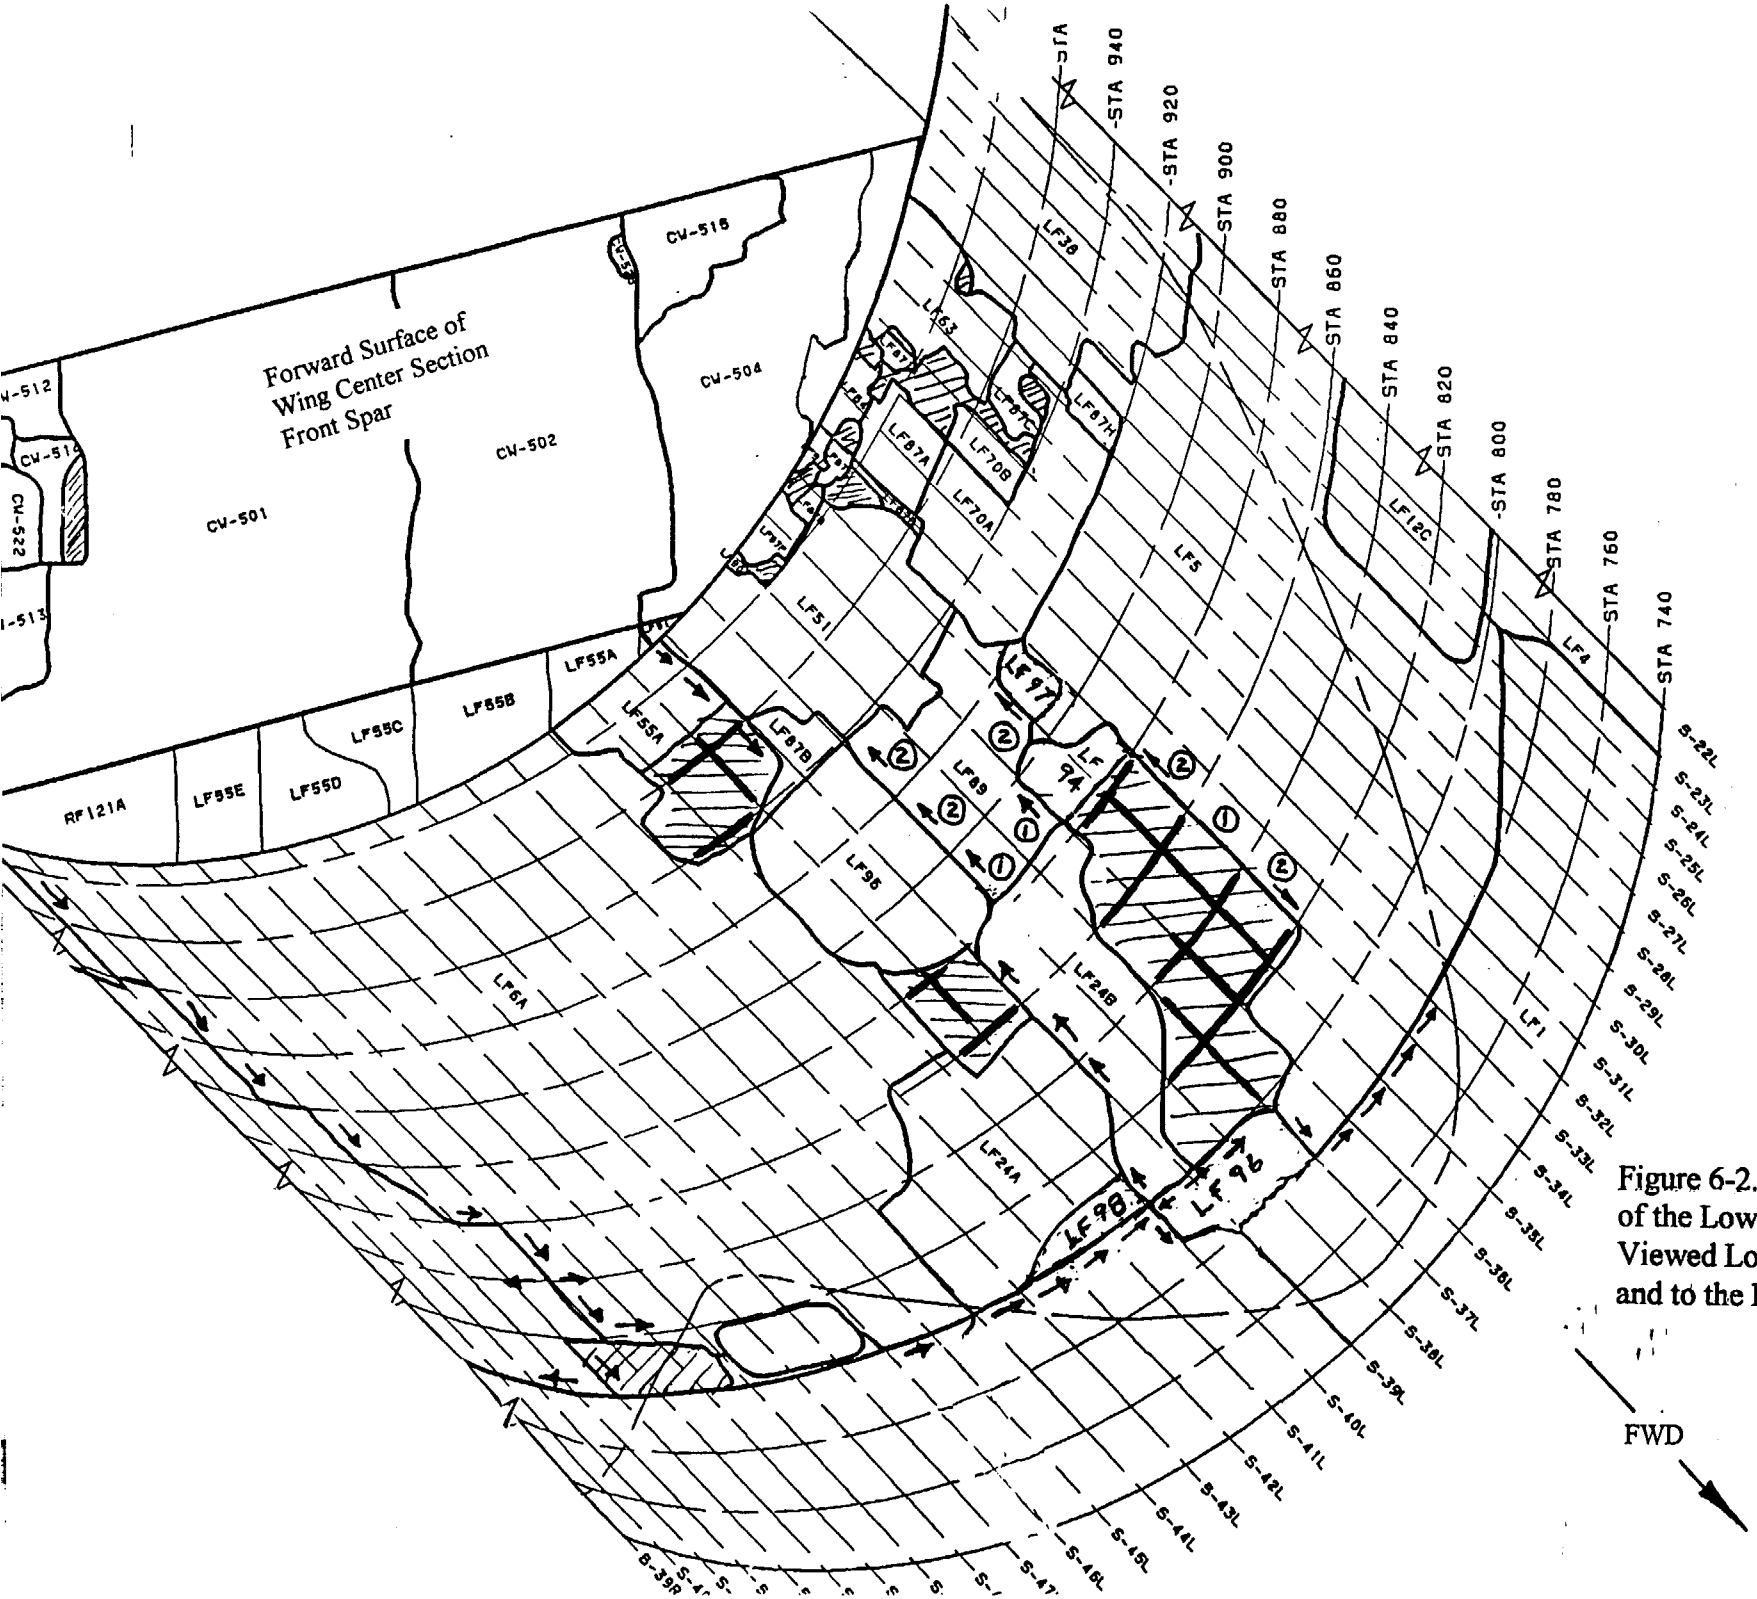
Figure 6-2. Inside Surface of the Lower Fuselage, Viewed Looking Aft, Down, and to the Left
