DOCKET NO. SA-516

METALLURGY/STRUCTURAL GROUP CHAIRMAN
FACTUAL REPORT
SEQUENCING STUDY
(57 pages)

METALLURGY / STRUCTURES SEQUENCING STUDY Report No. 97-38

Place	:	East Moriches, New York
Date	:	July 17, 1996
Airplane	:	Boeing 747-131, N93119
NTSB No.	:	DCA96-M-A070

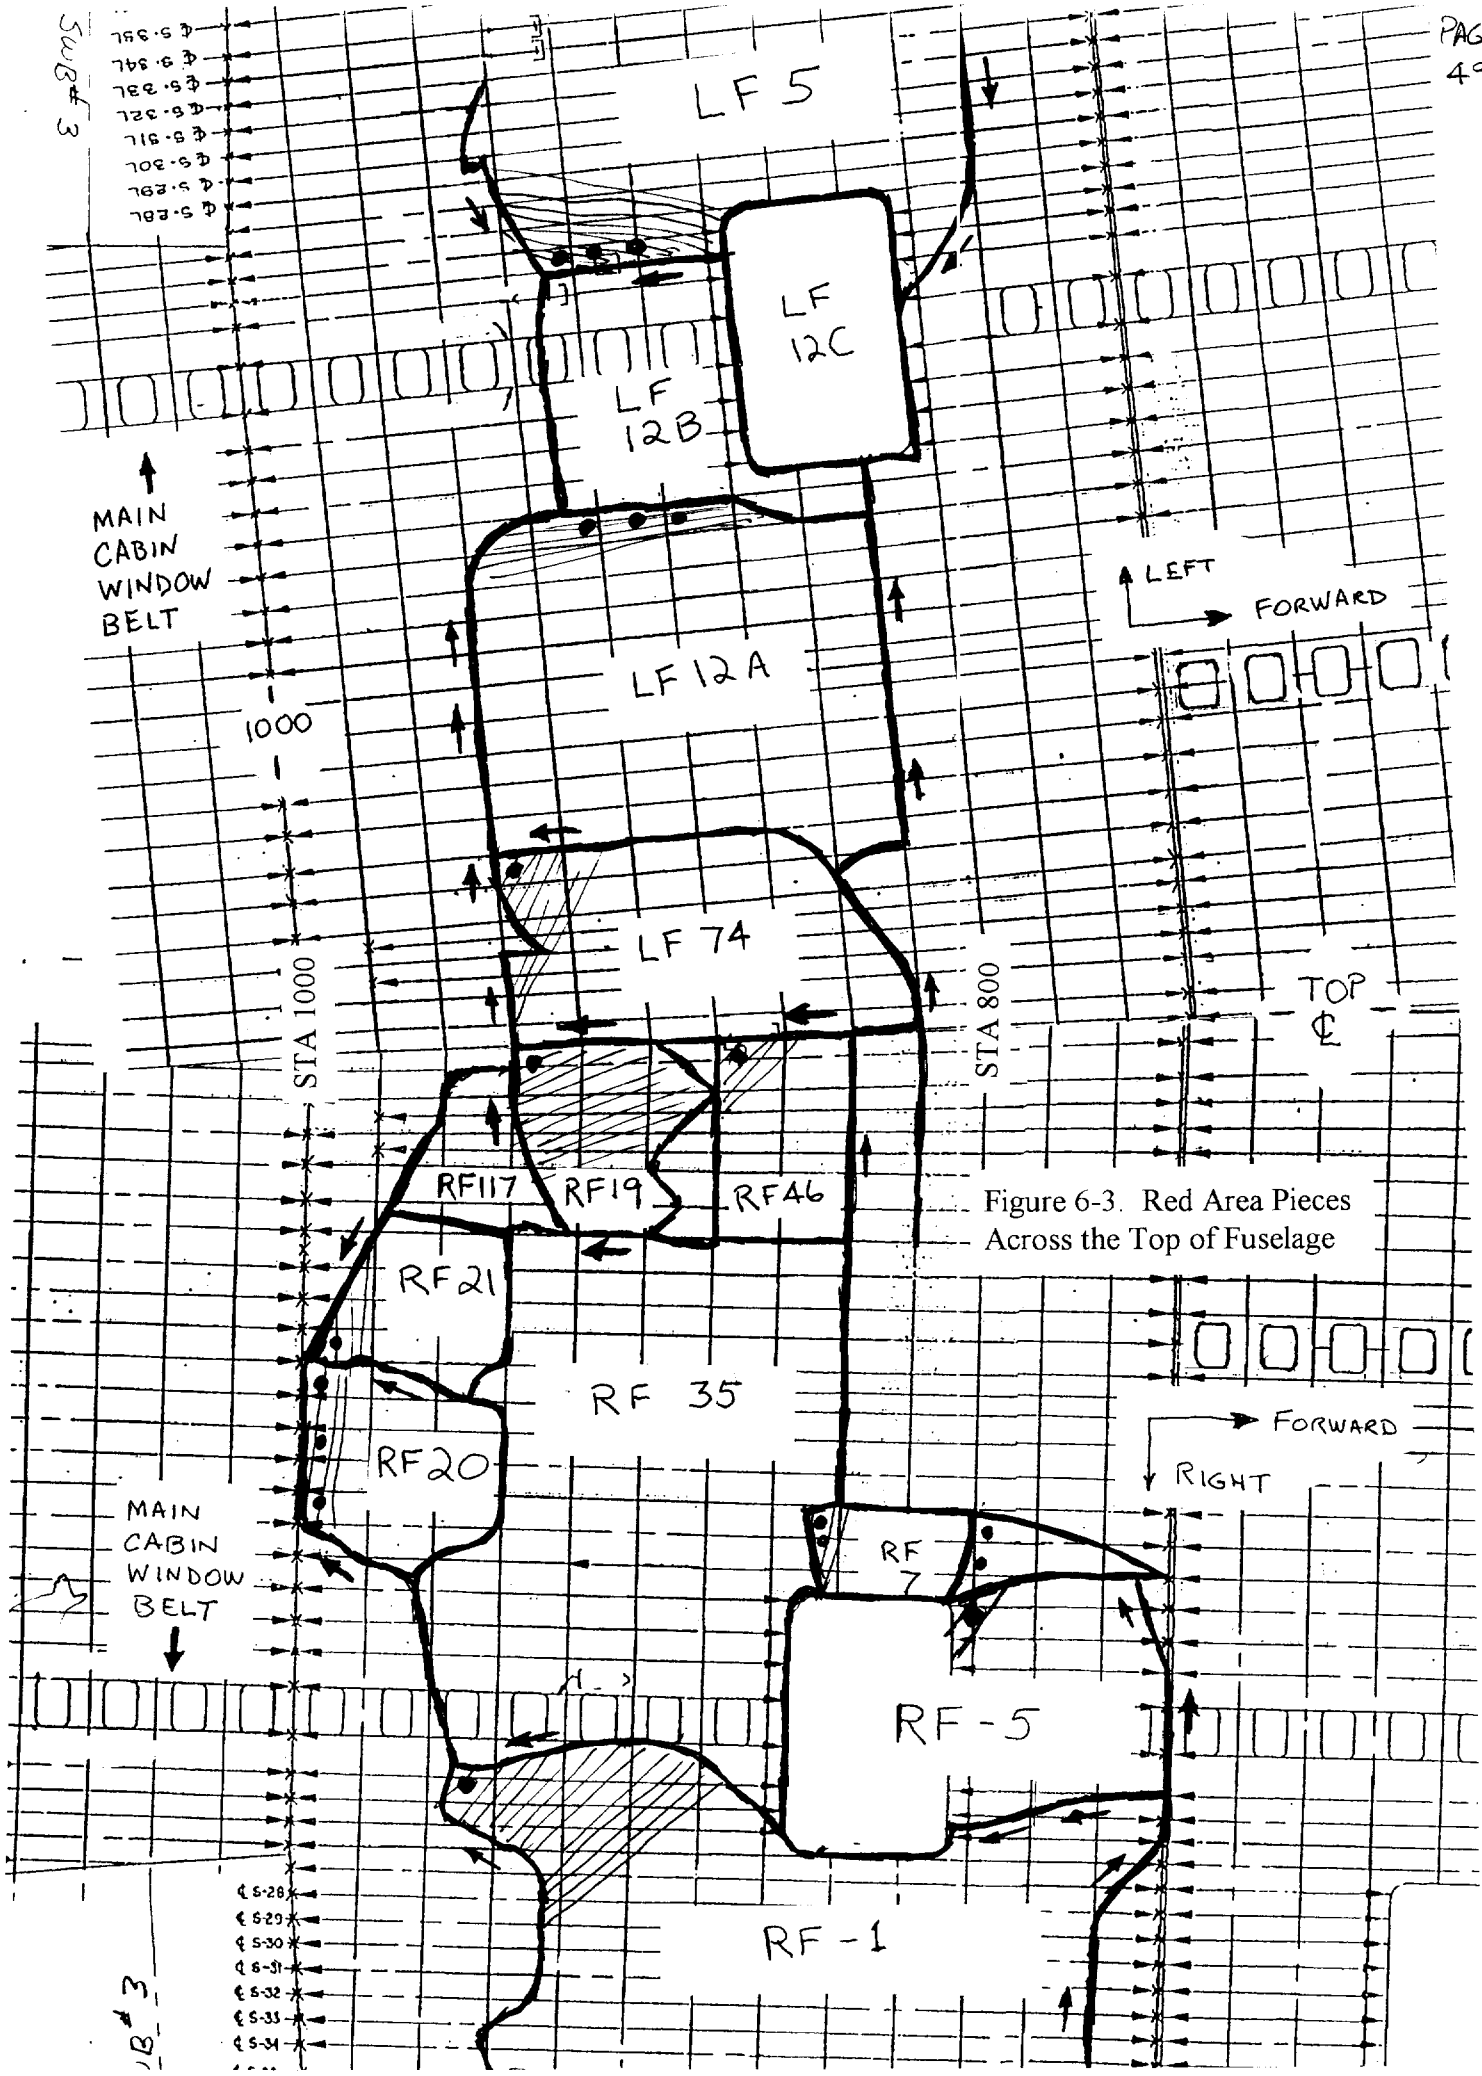
Figure 6-3. Red Area Pieces Across the Top of Fuselage

Figure 6-3 shows a stringer diagram of the fuselage in the area above the main deck window belts. The fracture locations in this diagram are denoted by the dark lines. All fractures in these fuselage skin pieces were "later" fractures, as defined in the section addressing the structure below the main deck window belts. Fracture directions of the fuselage skin structure above the main deck window belts are indicated by the arrowheads adjacent to the fractures in figure 6-3.

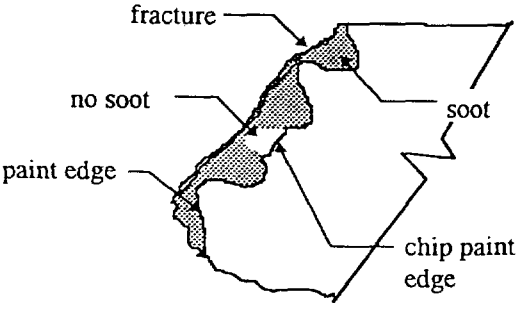
FIGURE 10-1

It can be seen from both the external and internal sooting patterns (figures 10-1 through 10-6) that there is a clear distinction between structure that departed with the left wing and the remainder of the right wing and aft fuselage. Lack of soot accumulation on the large fuselage piece (LF38) above the wing and fuselage pieces along the crown (RF34, RF41, and LF69) indicate that these pieces separated with the left wing. Soot accumulation on the remaining right

Sooting deposits evident on edges with arrows.

Determination primarily made by examining external paint failures near the fracture edge. Soot deposits remain on underlying paint when the top layer peels near fracture.

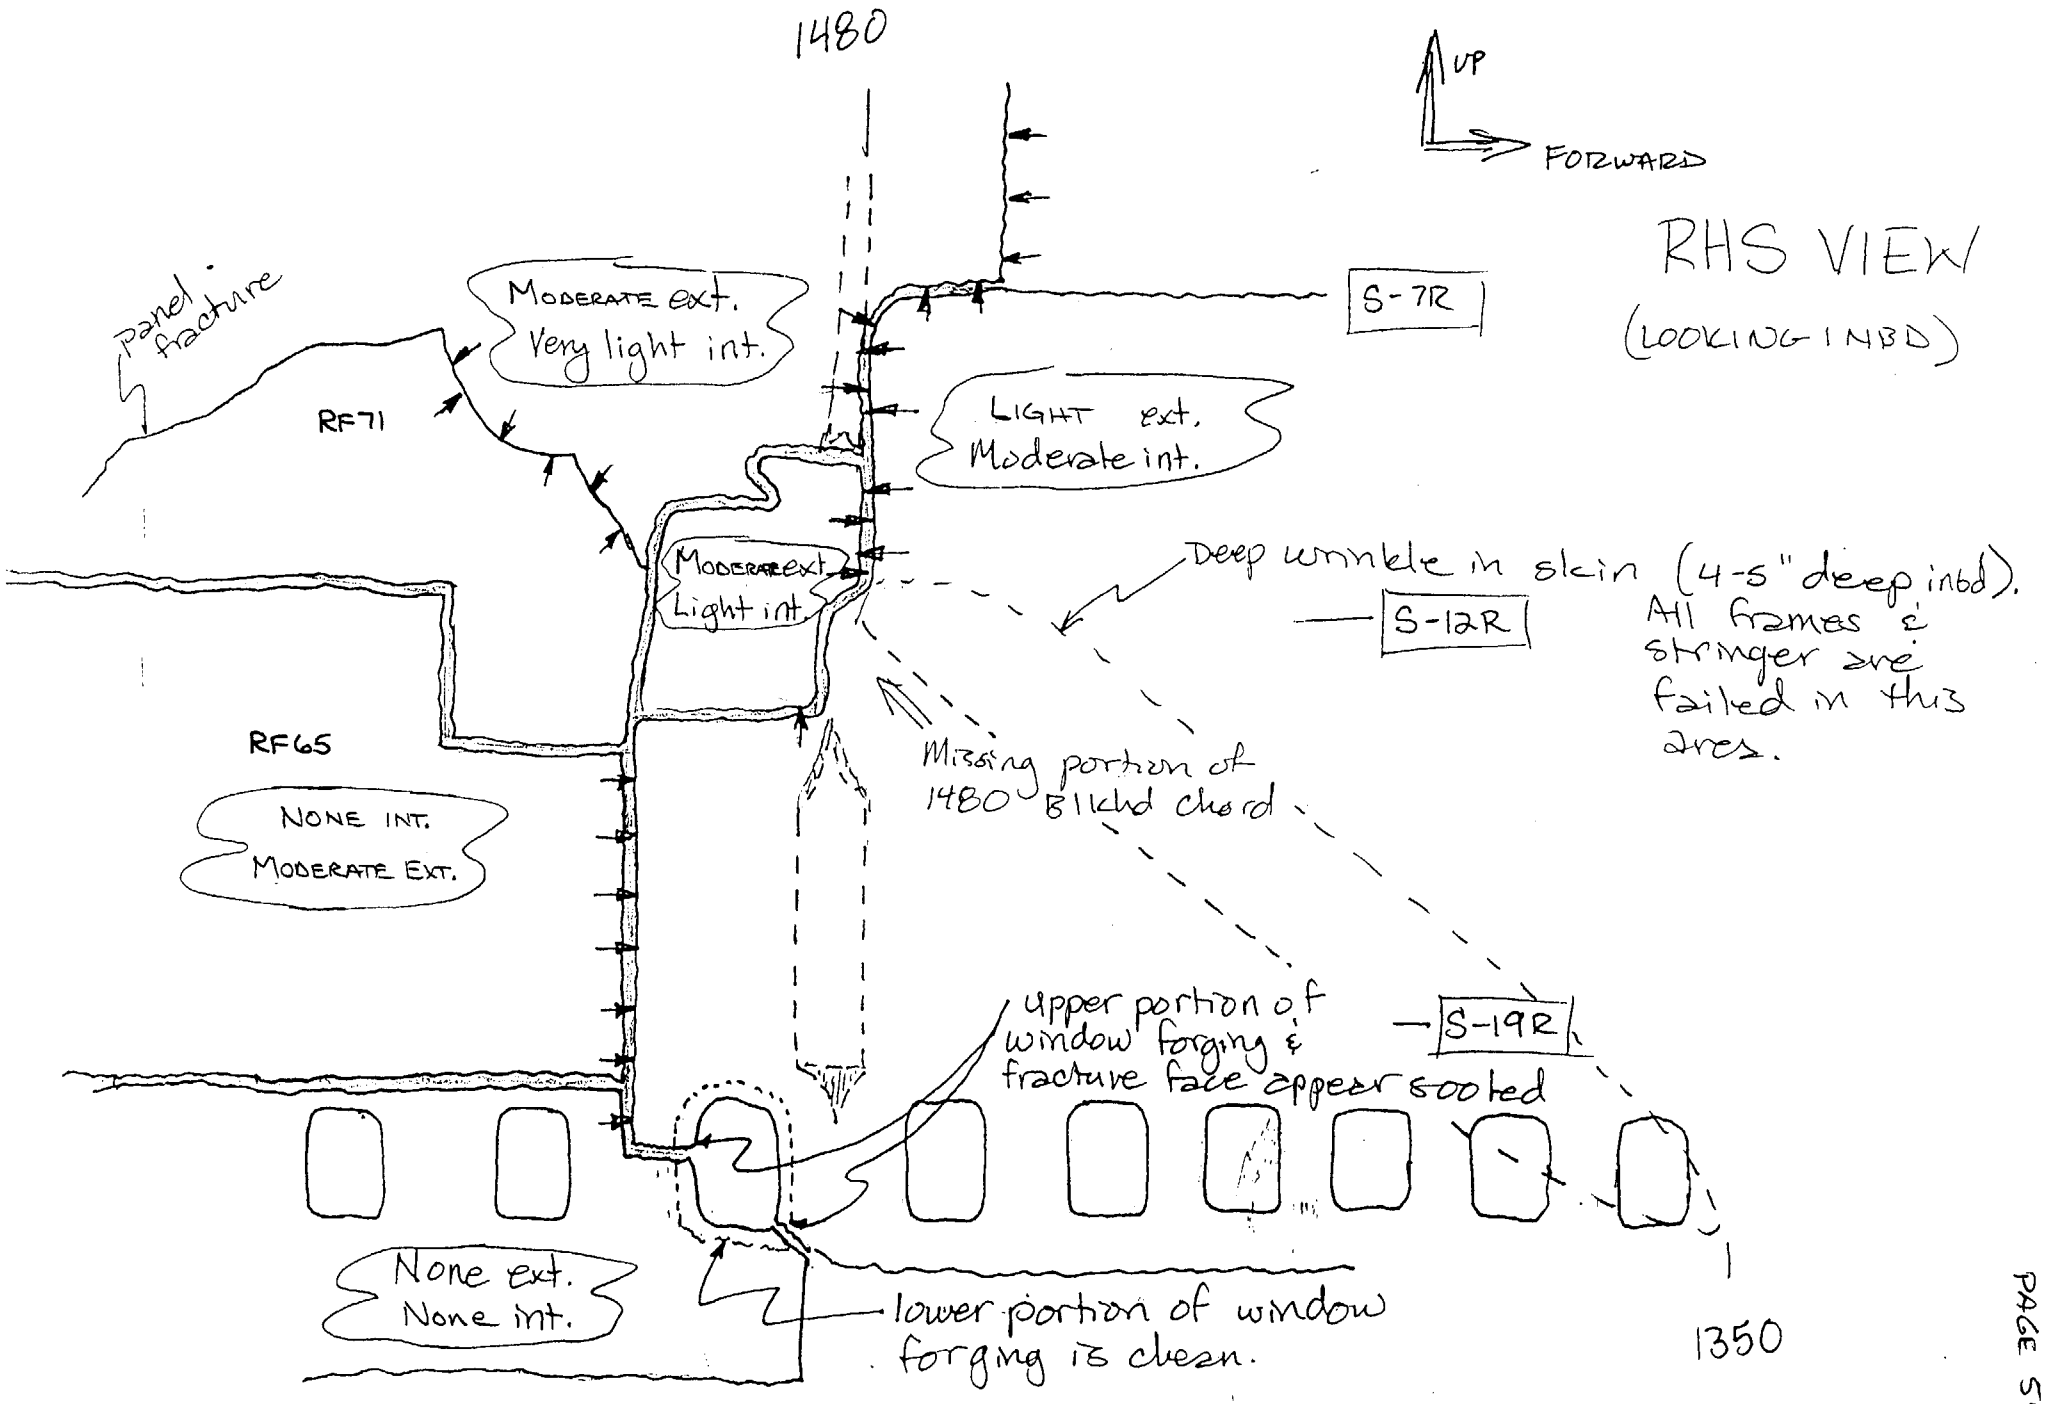
FIGURE 10-6

1480
UP
FORWARD
RHS VIEW
(LOOKING INBD)
S-7R
panel fracture
Moderate ext.
Very light int.
RF71
Light ext.
Moderate int.
Moderate ext.
Light int.
Deep wrinkle in skin (4-5" deep inbd).
All frames & stringer are failed in this area.
S-12R
RF65
Missing portion of 1480 Blkhd chord
None int.
Moderate Ext.
upper portion of window forging & fracture face appear sooted
S-19R
None ext.
None int.
lower portion of window forging is clean.
1350

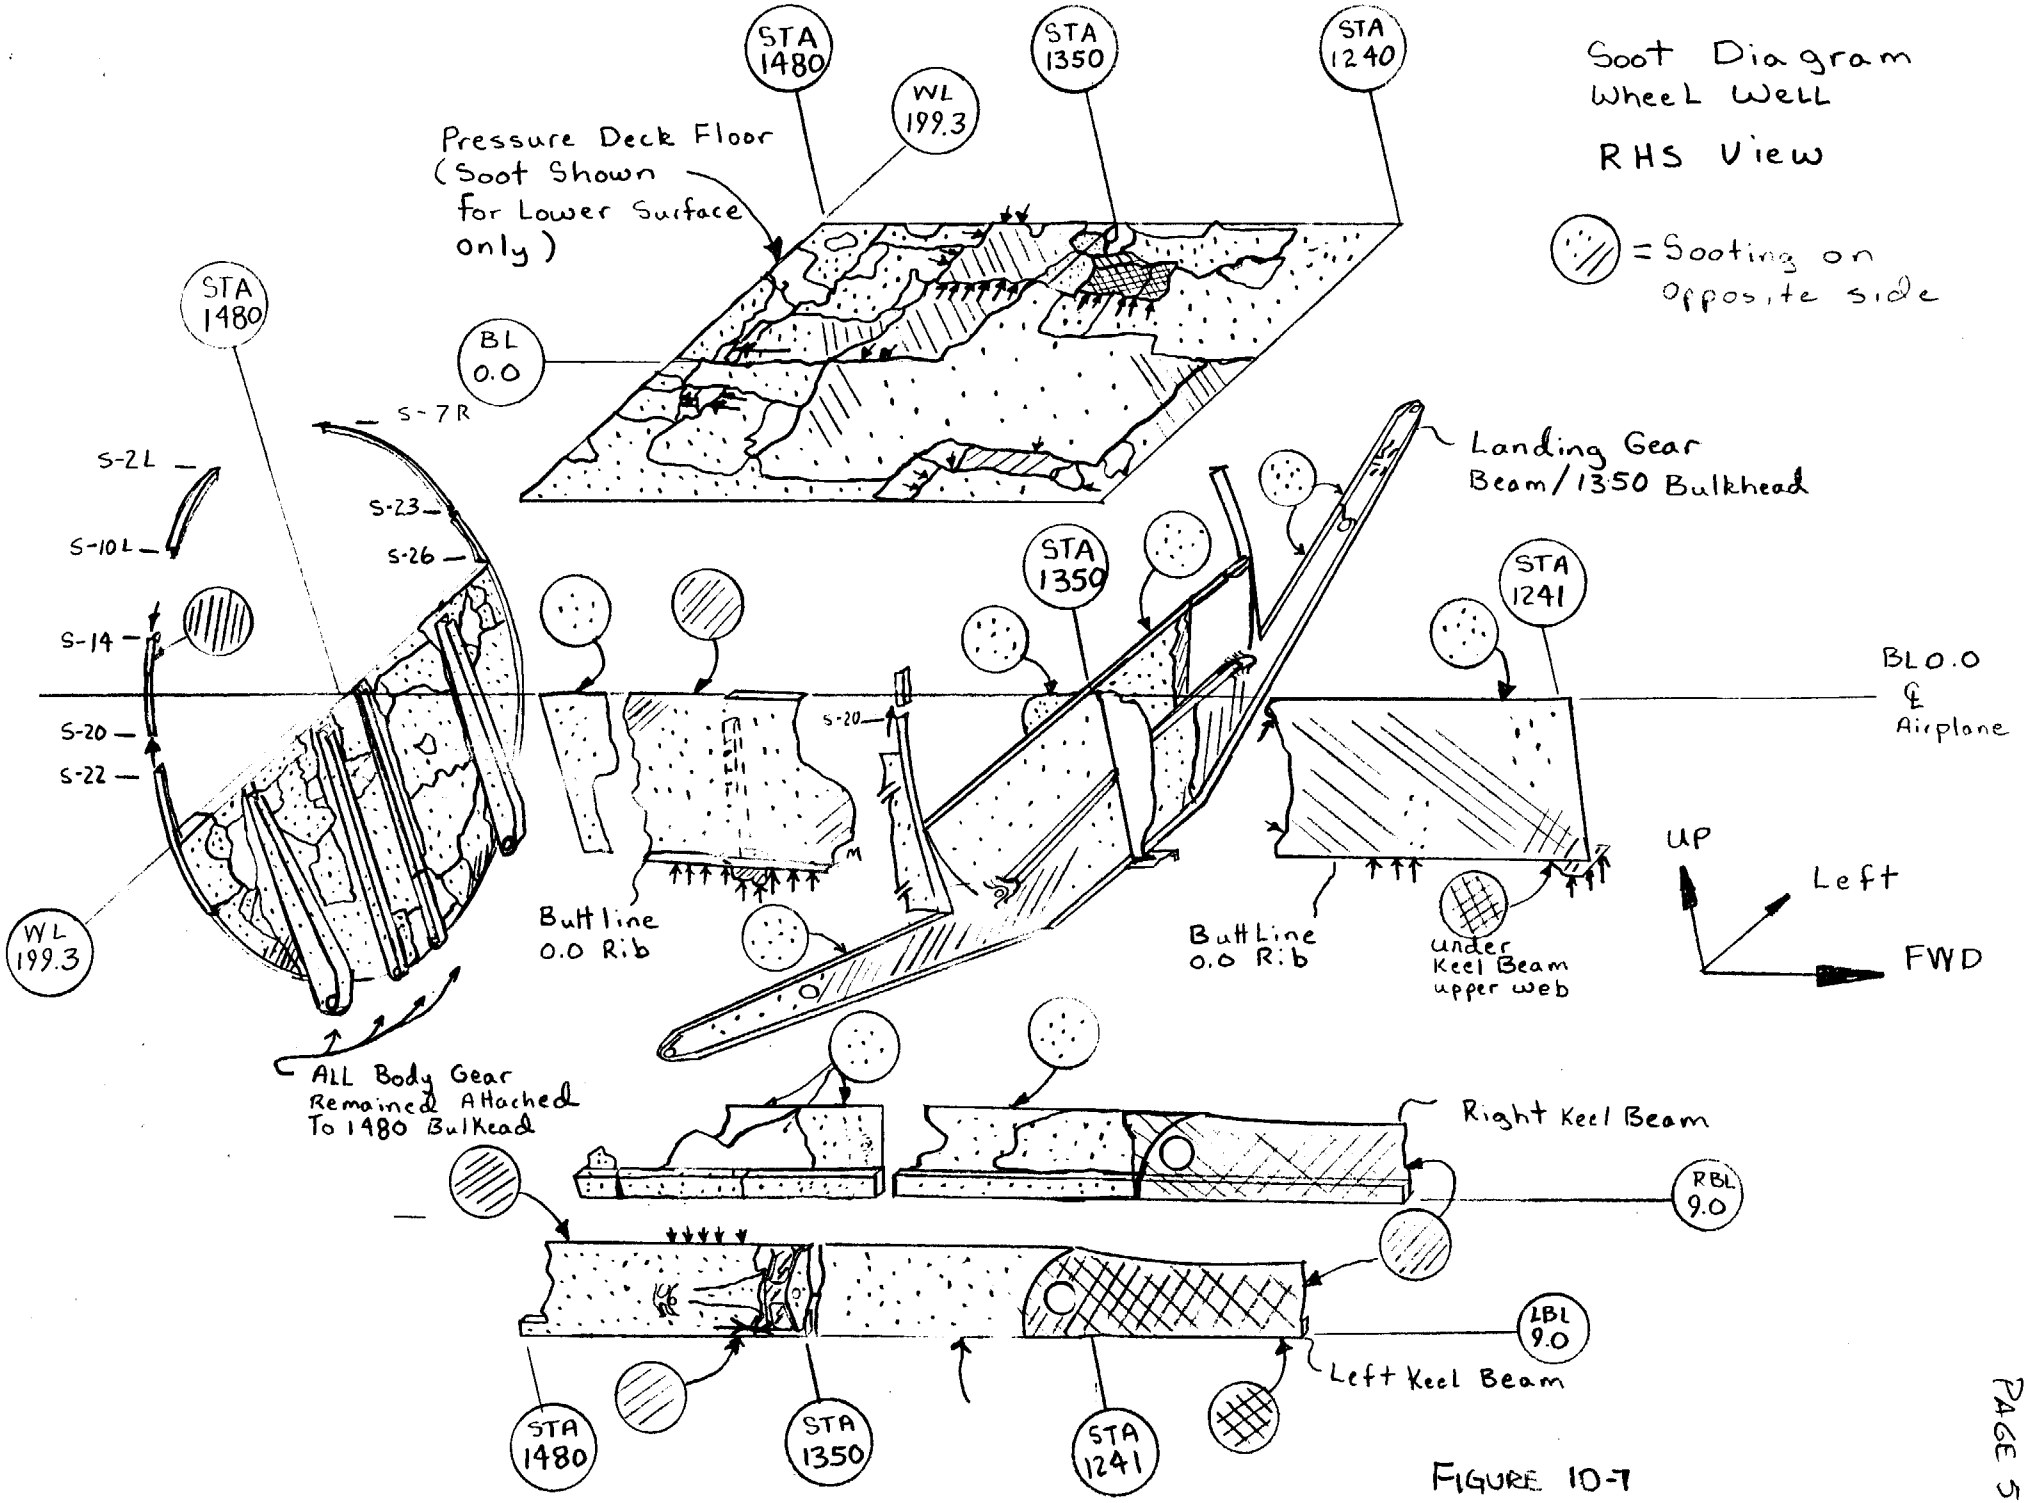
FIGURE 10-7

Following loss of the aft fuselage, some fuselage pieces (including major pieces LF39A, RF42, RF23) and some wheel well structure (including a portion of the keel beam and the STA 1350 bulkhead right of LBL 75 along with the right landing gear beam) remained with the right wing for a period of time and accumulated additional soot from a fire source on the right wing. See figure 10-7 for a diagram of the sooting patterns on the lower body structure between STA 1241 and STA 1480. These pieces subsequently separated before exposure to the major fire associated with the right wing. The right landing gear beam separated from the right wing at the outboard attach point liberating the right wing gear. Heavy soot accumulation and fire damage on pieces RF14 and RF37 indicated that they remained attached to the right wing for some period of time during the major fire. Fuselage piece RF17 was recovered attached to the right wing structure and was severely burned.
