SAFER SEAS DIGEST

LESSONS LEARNED FROM MARINE ACCIDENT INVESTIGATIONS
LESSONS LEARNED FROM MARINE ACCIDENT INVESTIGATIONS

2016

NATIONAL
TRANSPORTATION
SAFETY BOARD

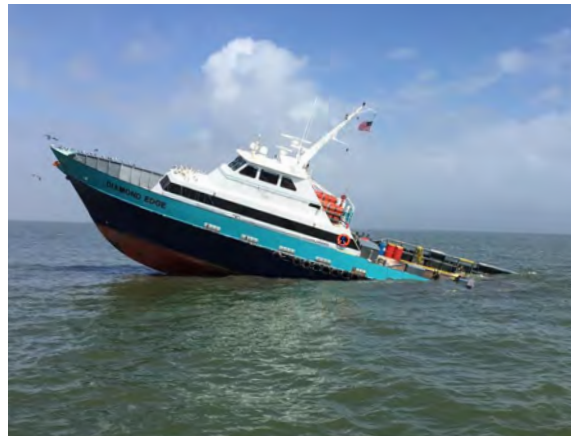
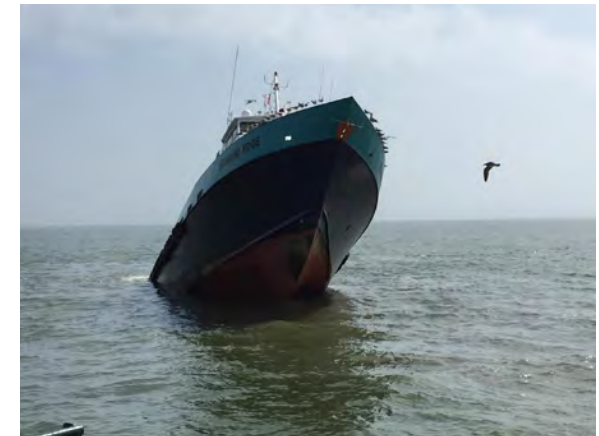
Figures 19–20: Partially submerged passenger vessel *Diamond Edge* following the collision. PHOTOS BY COAST GUARD

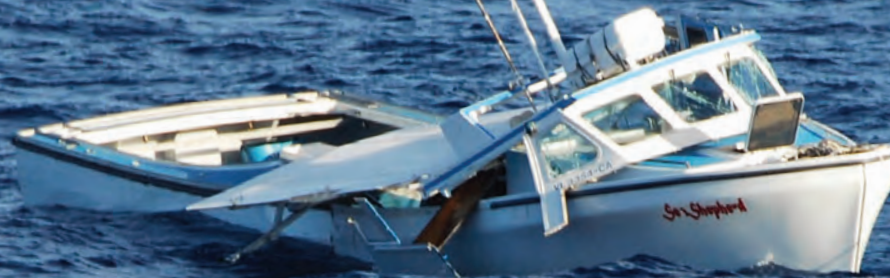
Figure 21: Fishing vessel
Sea Shepherd just after
the collision.

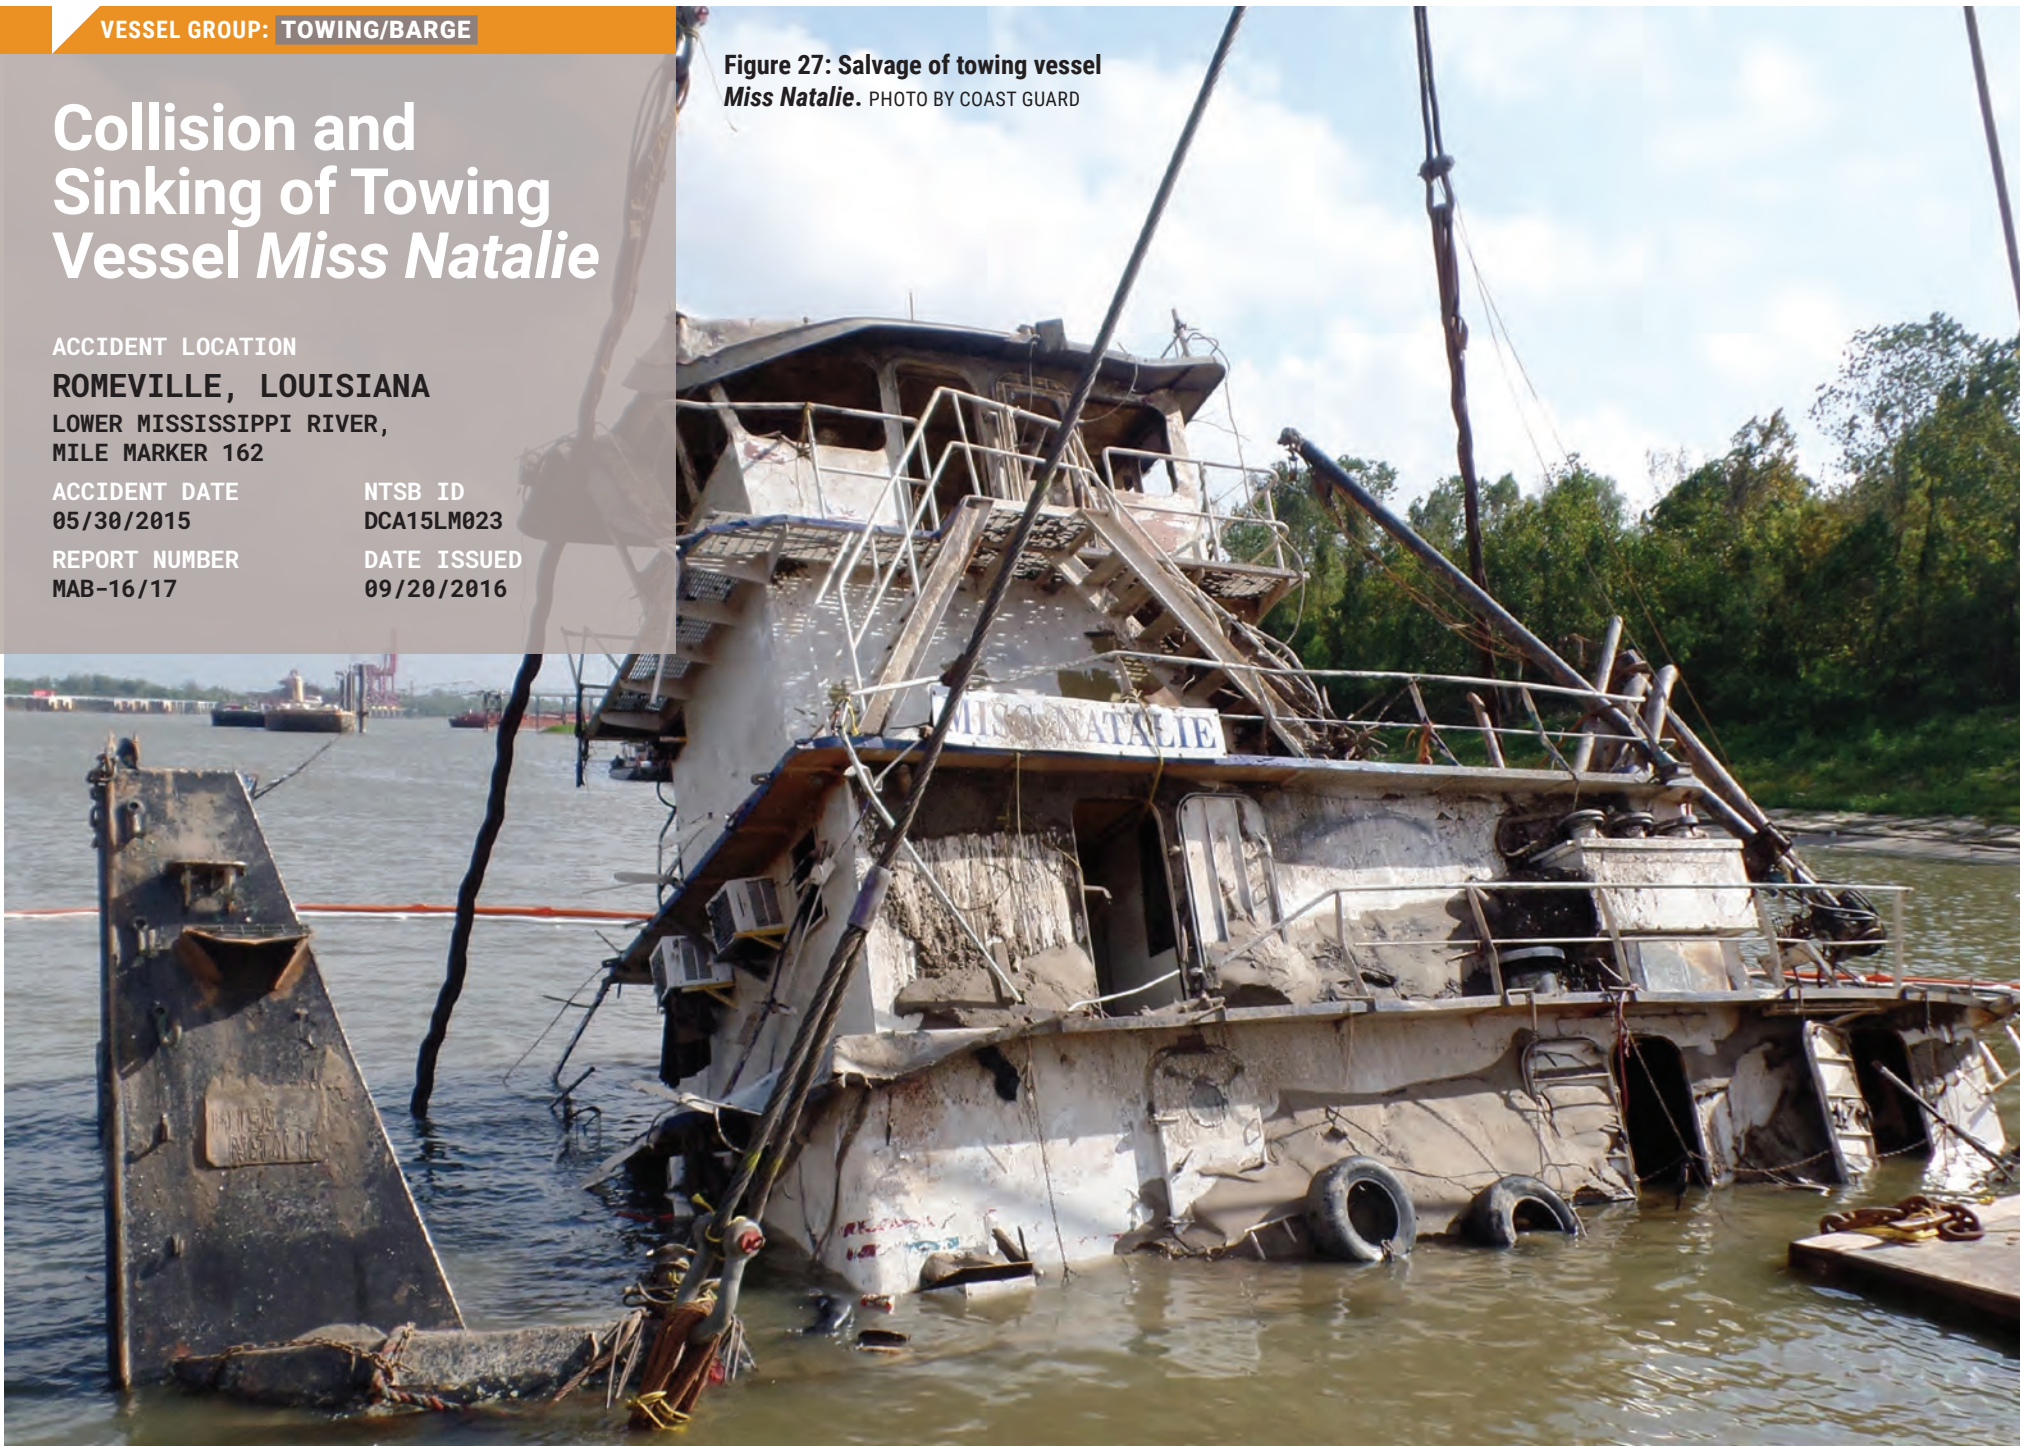
Figure 27: Salvage of towing vessel *Miss Natalie*. PHOTO BY COAST GUARD

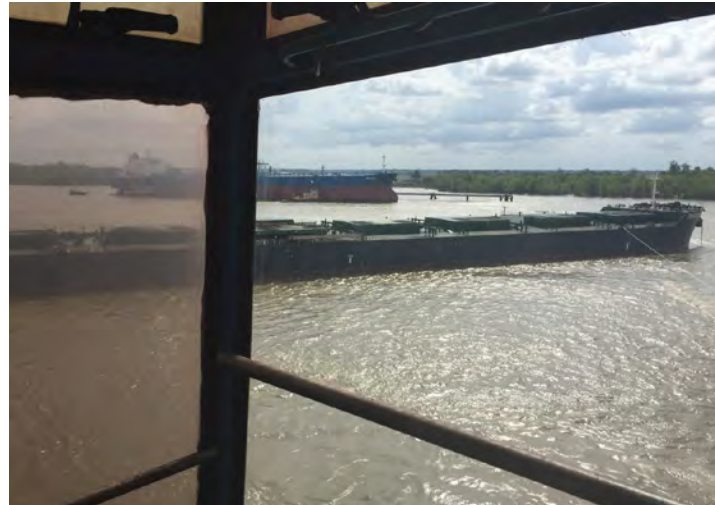
Figure 30: Bulk carrier *Privocean* drifting across the river, with tanker *Bravo* in the background.

As the *Privocean* loaded cargo, its draft increased, subjecting more of the vessel’s hull to the strong currents. After 2 days of loading, the power of the two hold-in tugs became insufficient to hold the bulk carrier in place. Therefore, about 1548 on April 6, the master called the charterer’s agent to request a third hold-in tug. Three minutes later, before a third tug was dispatched, the first forward mooring hawser parted on the *Privocean*. The remaining lines parted or paid out under “tremendous strain” during the next 3 minutes, and the bulk carrier drifted across the river.

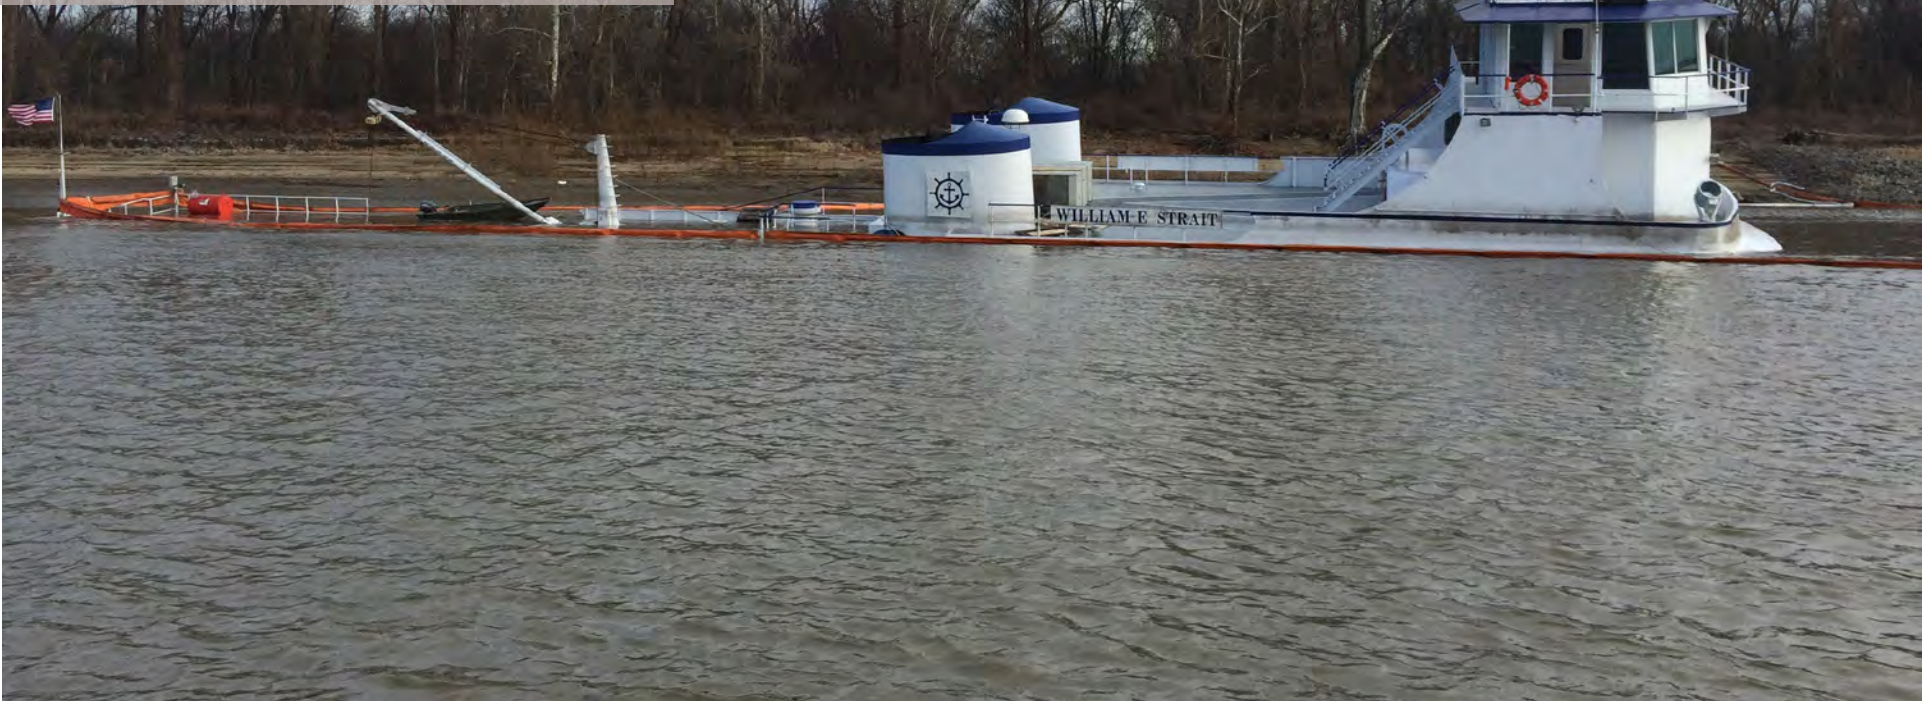
**Figure 34: Partially submerged towing vessel
William E Strait shortly after the collision.**

The *Margaret Ann*'s lead barge sustained a hull penetration and broke free from the tow string, while the second barge received damage to its bow and forward deck area. The *William E Strait* sustained a 6-foot by 5-foot opening in its hull, which allowed rapid flooding of the engine room. Additionally, the force of the collision pushed the port bow of the *William E Strait* into the last row of its tow flotilla, holing a stern void in one of its barges.

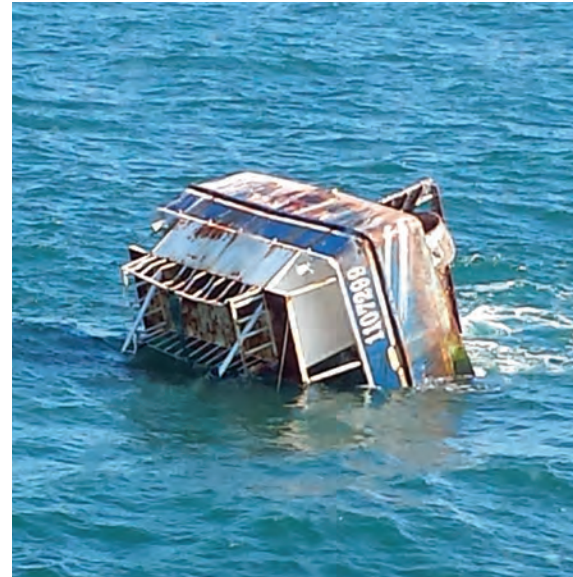
■ The National Transportation Safety Board determined that the probable cause of the accident involving the commercial fishing vessel *Miss Eva* was an engine room fire that began from an undetermined source followed by downflooding and the eventual sinking of the vessel.

Figure 41: Fishing vessel *Miss Eva* sinking bow down.

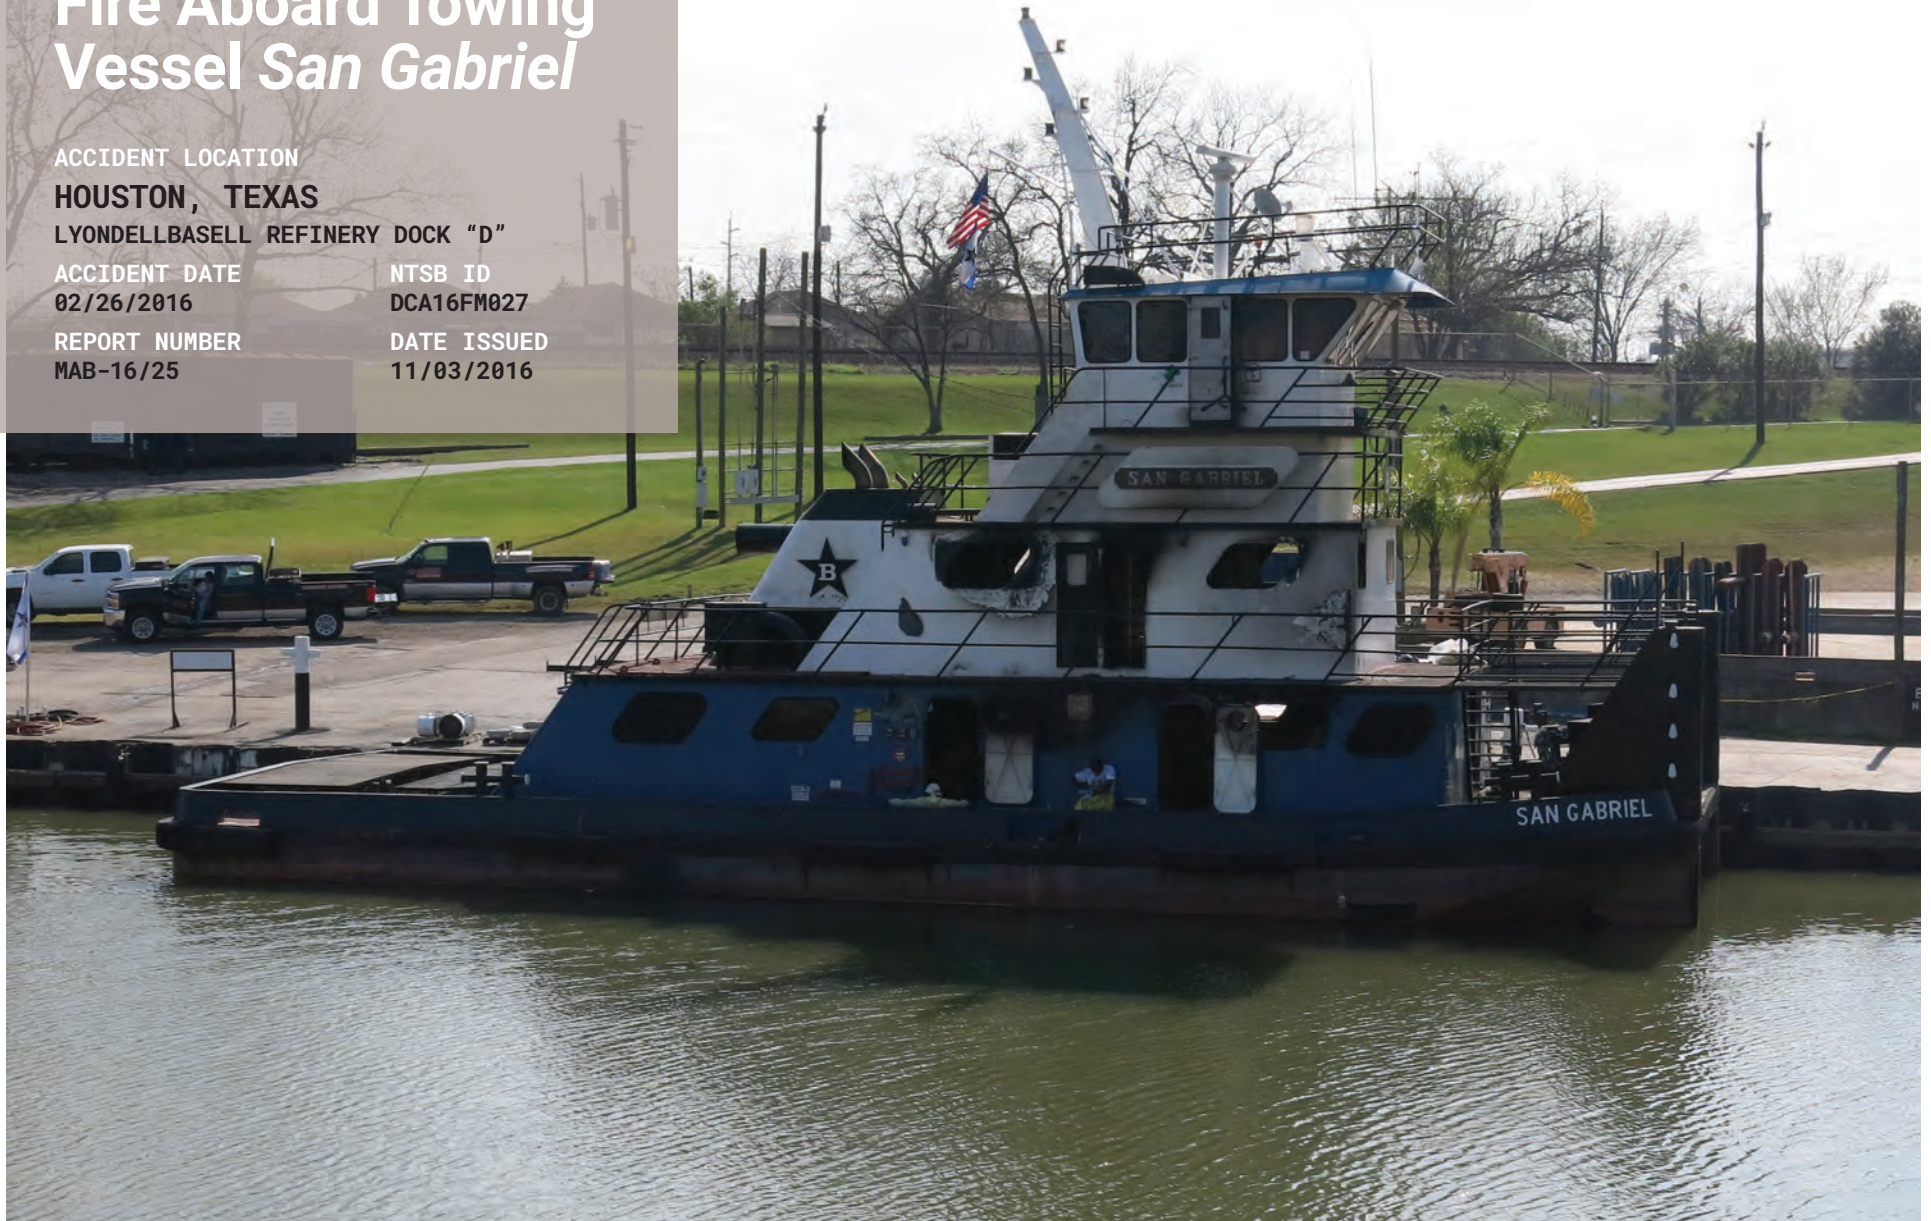
Figure 46: Fire damage to the towing vessel *San Gabriel*.

Another crewmember attempted to use a fire-hose to assist, but the fire pump would not start due to electrical short-circuits in the system wiring resulting from the fire.

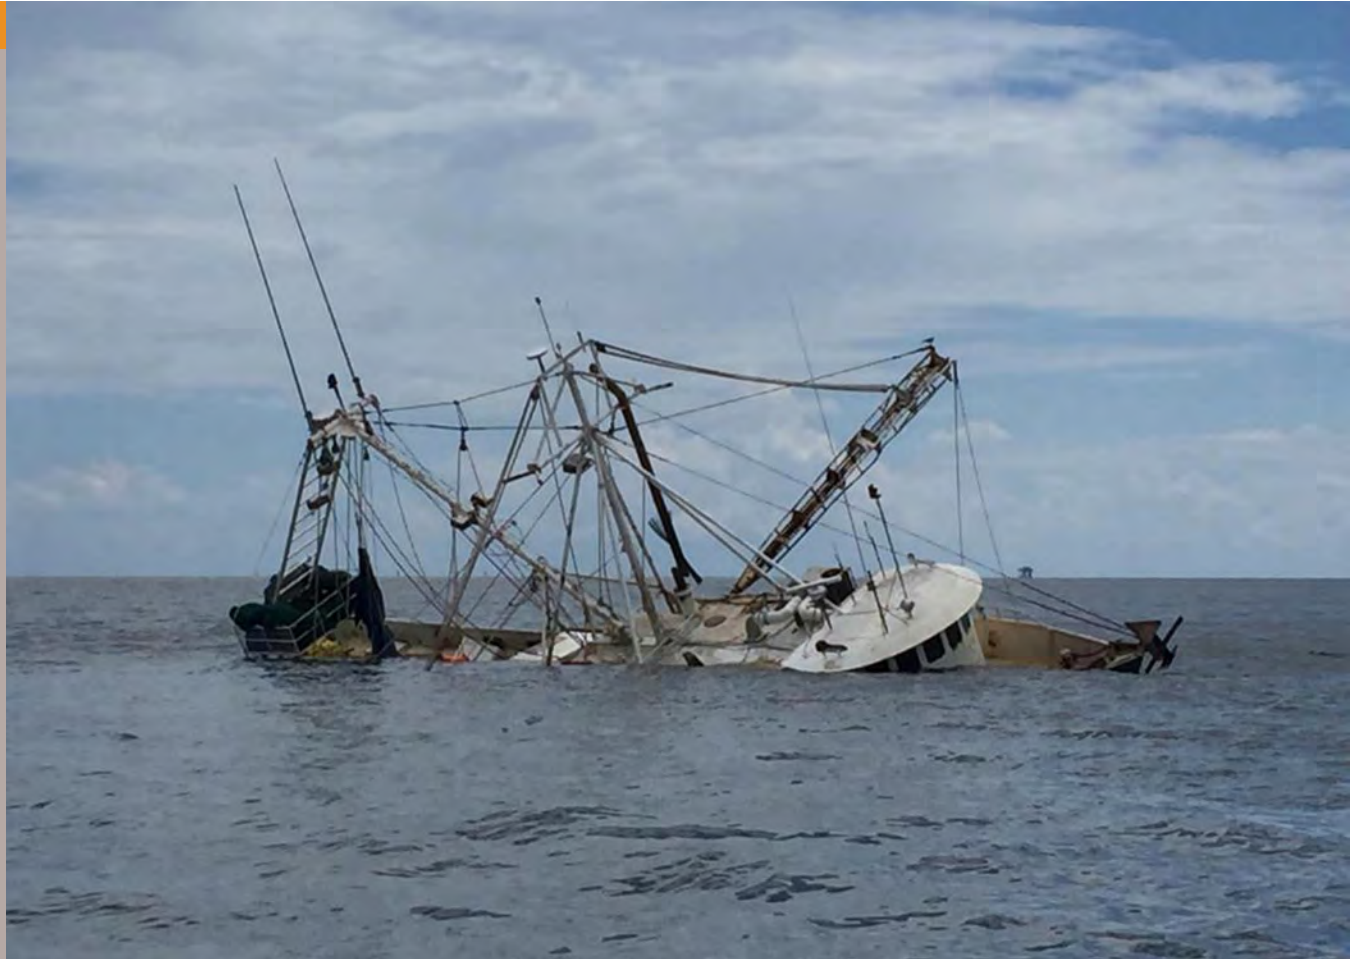
Figure 48: Fishing vessel *Capt Richie Rich* listing to starboard, lying on the bottom.

■ The National Transportation Safety Board determined that the probable cause of the sinking of fishing vessel *Capt Richie Rich* was a collapse of the port outrigger and a hull penetration resulting in uncontrolled flooding in the engine room.

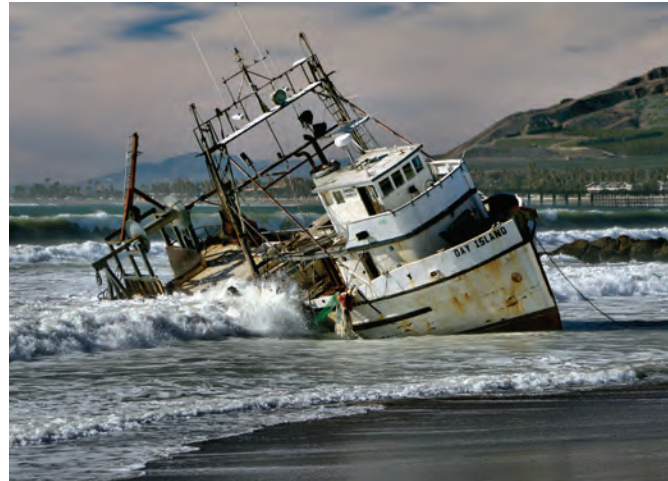
Figure 55: Fishing vessel *Day Island* on Ventura Beach, California, after the grounding. PHOTO COURTESY OF MICHAEL GORDON

■ The National Transportation Safety Board determined that the probable cause of the grounding of fishing vessel *Day Island* was the captain falling asleep while operating it due to the effects of his acute fatigue. Contributing to the grounding was the captain’s use of medication that may have been sedating.
