# Analysis of Asset 459 Cell 5

CORPORATE RESEARCH

PROJECT: 13CA50802 (Extend)

May 31, 2014

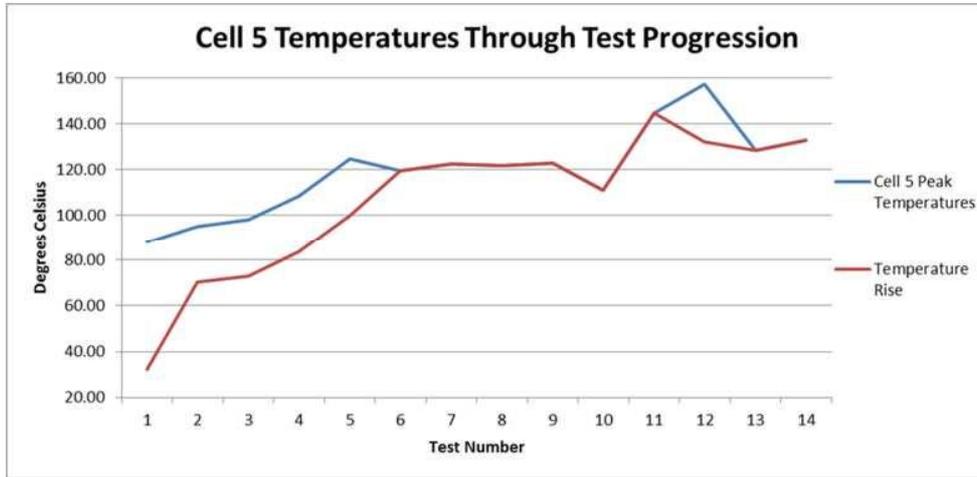
Figure 2. Temperature record of Battery 459 Cell 5

Cell 5 Peak Temperature	Temp Rise
Task A.1.B, 25 C, 1 of 5	88.2 °C	63.2 °C
Task A.1.B, 25 C, 2 of 5	95.2 °C	70.2 °C
Task A.1.B, 25 C, 3 of 5	98.1 °C	73.1 °C
Task A.1.B, 25 C, 4 of 5	108.5 °C	83.5 °C
Task A.1.B, 25 C, 5 of 5	124.8 °C	99.8 °C
Task A.1.B, 0 C, 1 of 5	119.7 °C	119.7 °C
Task A.1.B, 0 C, 2 of 5	122.4 °C	122.4 °C
Task A.1.B, 0 C, 3 of 5	121.6 °C	121.6 °C
Task A.1.B, 0 C, 4 of 5	123.0 °C	123.0 °C
Task A.1.B, 0 C, 5 of 5	111.0 °C	111.0 °C
Task B, Cell Level Test, 0 C	144.7 °C	144.7 °C
Task B, Battery Level, 25 C	157.3 °C	132.3 °C
Task B, Battery Level, 0 C, 1 of 2	128.3 °C	128.3 °C
Task B, Battery Level, 0 C, 1 of 2	132.9 °C	132.9 °C

Since the peak temperatures on the 459-5 cell's rivet has been detected to reach over 130°C several times during APU start simulations (Figure 2), some irreversible damages might occur on the materials once the heat passed along with the current collector and down to the winding. A physical inspection was conducted to review the unwound jelly rolls. From the photos shown in Figure 7, few spots with shrunk or melted separators could be observed from visual inspection. The spots were about 1 to 2 mm wide and less than 1 mm tall. Such shrinkage might be resulted from the separator in contacting with the hot current collectors.
