Loss of Control at Takeoff
Air Methods Corporation
Airbus Helicopters AS350 B3e, N390LG
Frisco, Colorado
July 3, 2015

Accident Report

NTSB/AAR-17/01
PB2017-101425

Aircraft Accident Report

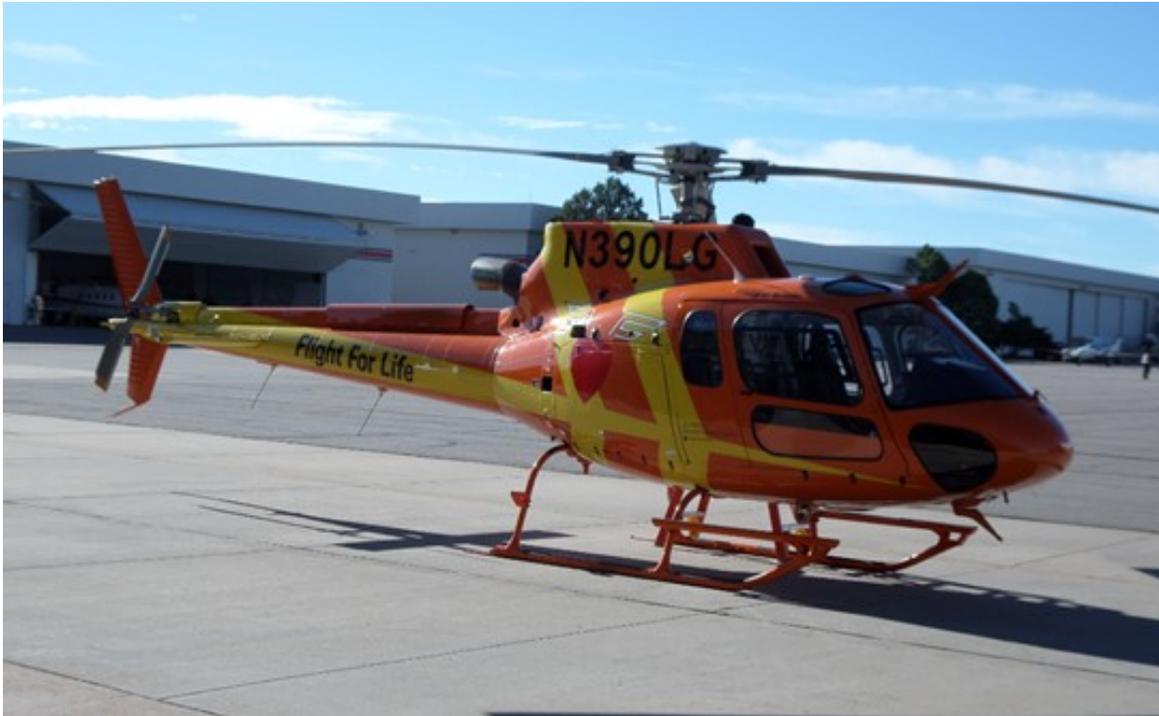
Figure 2. N390LG upon delivery to Air Methods.

The accident helicopter, serial number 7595, was manufactured in March 2013. Figure 2 shows the helicopter at the time of delivery to Air Methods.¹⁵ At the time of the accident, the helicopter had a total time of about 487 flight hours. The helicopter was equipped with a Turbomeca Arriel 2D turboshaft engine, which had a total time of about 481 hours. (See section 1.3.2 for more information about the engine.) The helicopter’s weight at the time of the accident was about 4,717 pounds, which was based on the operating conditions that day and included the weights of the occupants, fuel, and medical equipment.
