Inadvertent Activation of the Fuel Shutoff Lever
and Subsequent Ditching
Liberty Helicopters Inc., Operating a FlyNYON Doors-Off Flight
Airbus Helicopters AS350 B2, N350LH
New York, New York
March 11, 2018

NTSB/AAR-19/04
PB2020-100100

Aircraft Accident Report

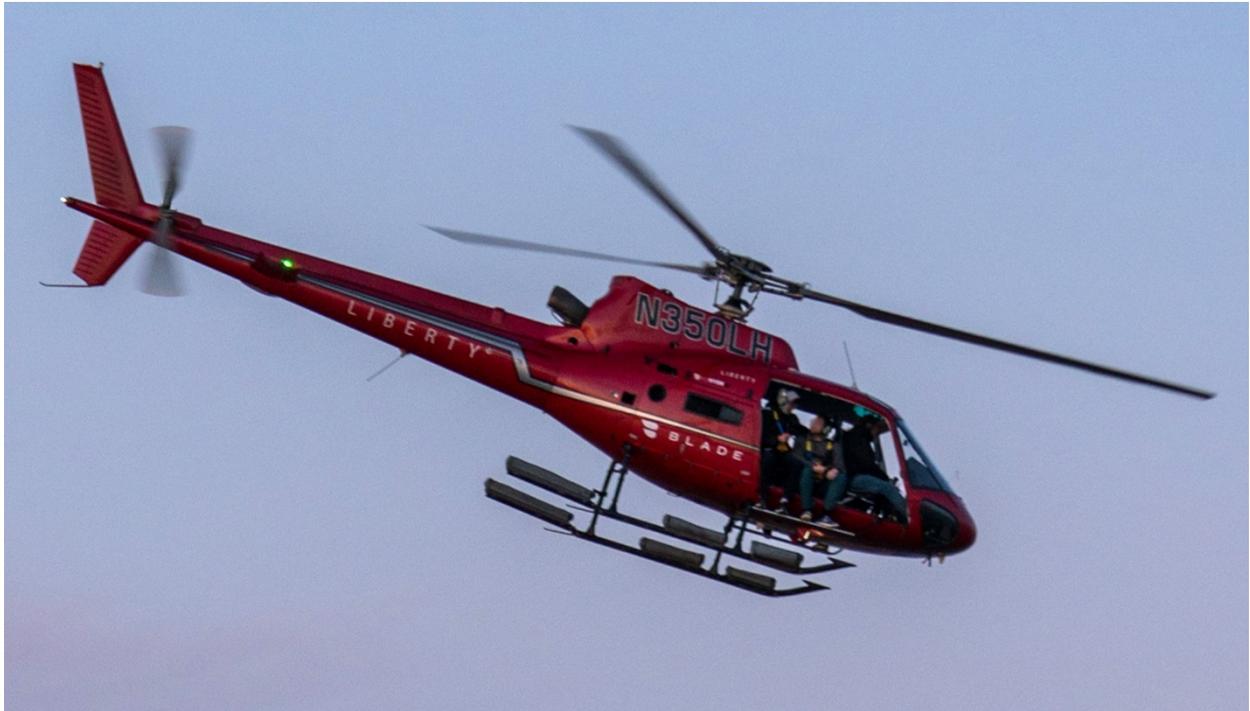
The accident flight (like other FlyNYON doors-off flights) was marketed by NYONair as an aerial photography flight in which passengers were allowed to take photographs while extending their feet outside of the helicopter's open doorways during portions of the flight. For the accident flight (and other FlyNYON flights Liberty operated per contract with NYONair), Liberty removed the helicopter's two right doors and front left door and locked the left sliding door in the open position (see figure 1).

Figure 1. Accident helicopter configured for FlyNYON doors-off operations.

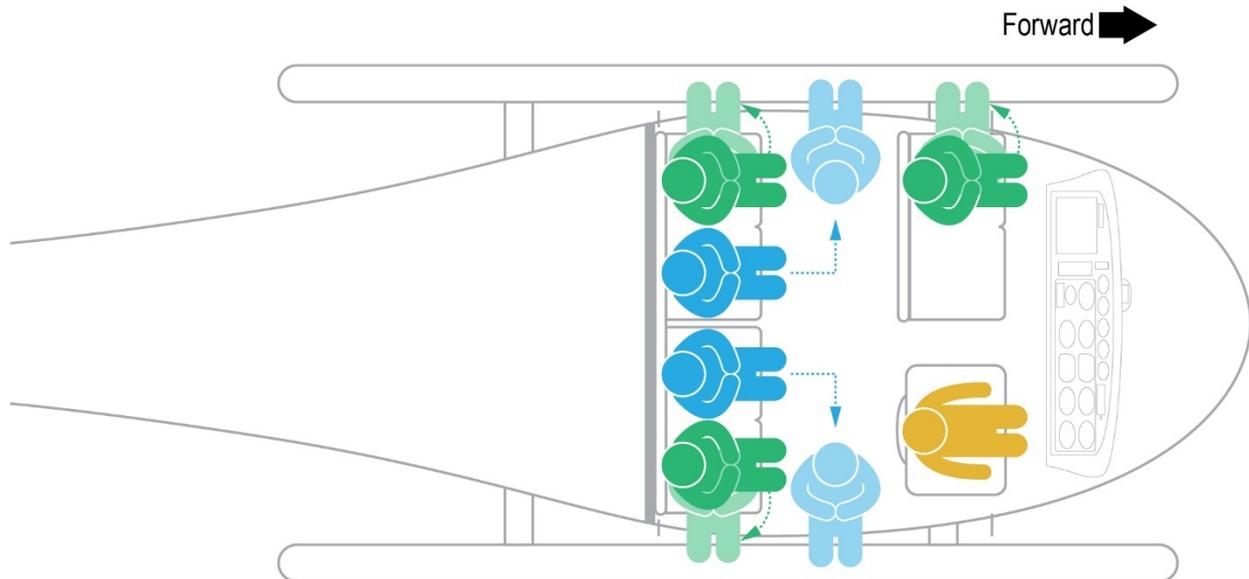
the cabin floor, and sit on the door sills (see section 1.10.5.2). Per the SOPs, passengers in the front and rear outboard seats were allowed to rotate outboard in their seats (see figure 2).⁷

Figure 2. Diagram showing relative locations for helicopter occupants.

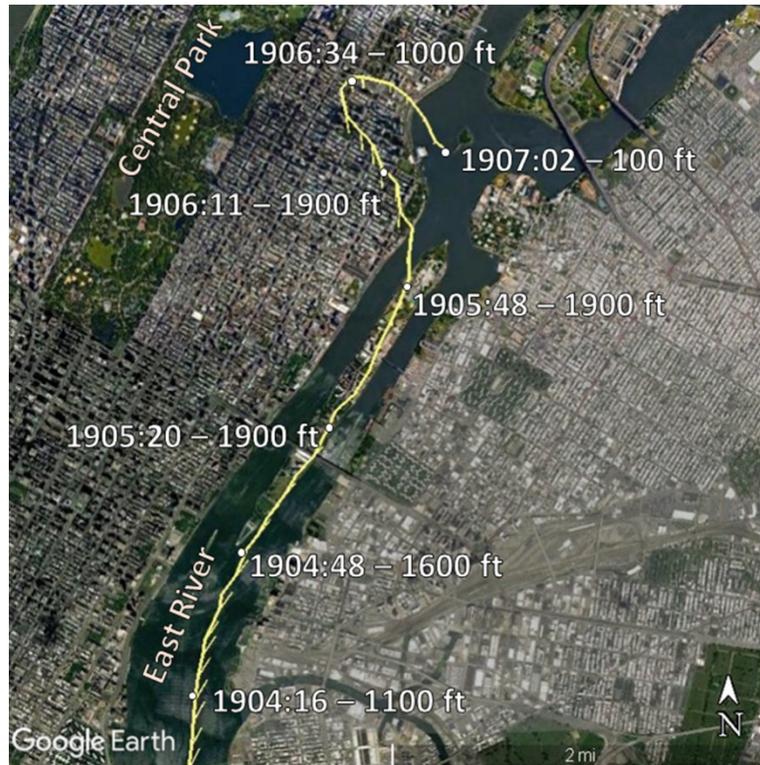
ATC radar data showed that the helicopter then proceeded north along the East River and climbed to an altitude of 1,900 ft msl. At 1905:44, the flight track turned left then proceeded northwest over Manhattan (see figure 3).

Figure 3. Accident flightpath over the East River.

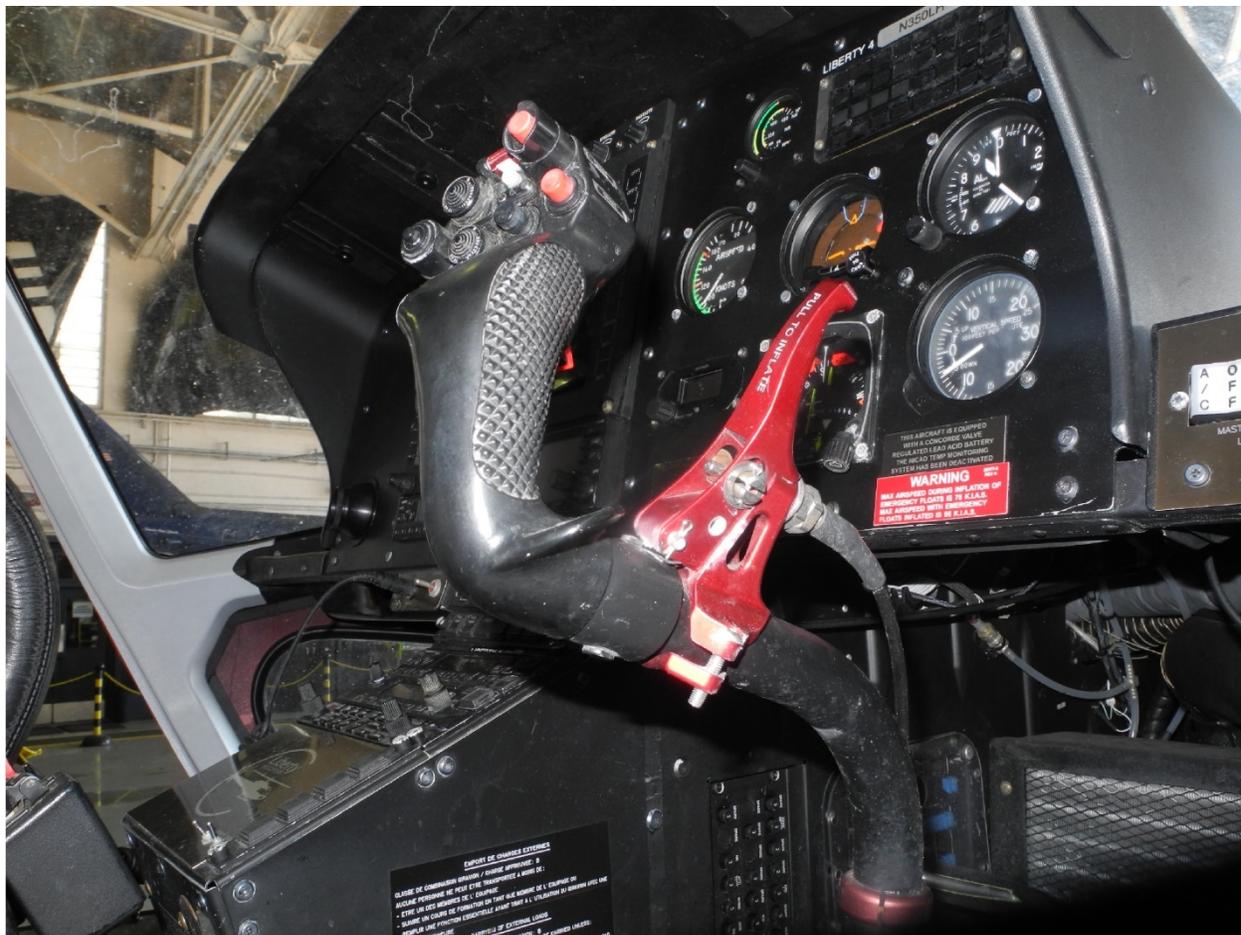
The activation handle was equipped with a shear pin (designed to break under about 12 lbs of force) to help prevent inadvertent activation. According to the FAA Los Angeles Aircraft Certification Office (ACO) project manager for the review and approval of STC SR00470LA, the applicant (Apical) had proposed (and the ACO had accepted) a 30-lb pull-force limit for the activation handle (that is, the maximum allowable force needed to pull the handle to successfully deploy the floats). A review of the STC and related documents found that none specified a pull-force limit for the activation handle.¹⁶ On the accident helicopter, the activation handle alignment was offset from the cyclic grip about 32° to the right (as specified in the installation instructions) to prevent interference with the cyclic grip (see figure 6).

Figure 6. Float activation handle (red) installed on the accident helicopter's cyclic control.

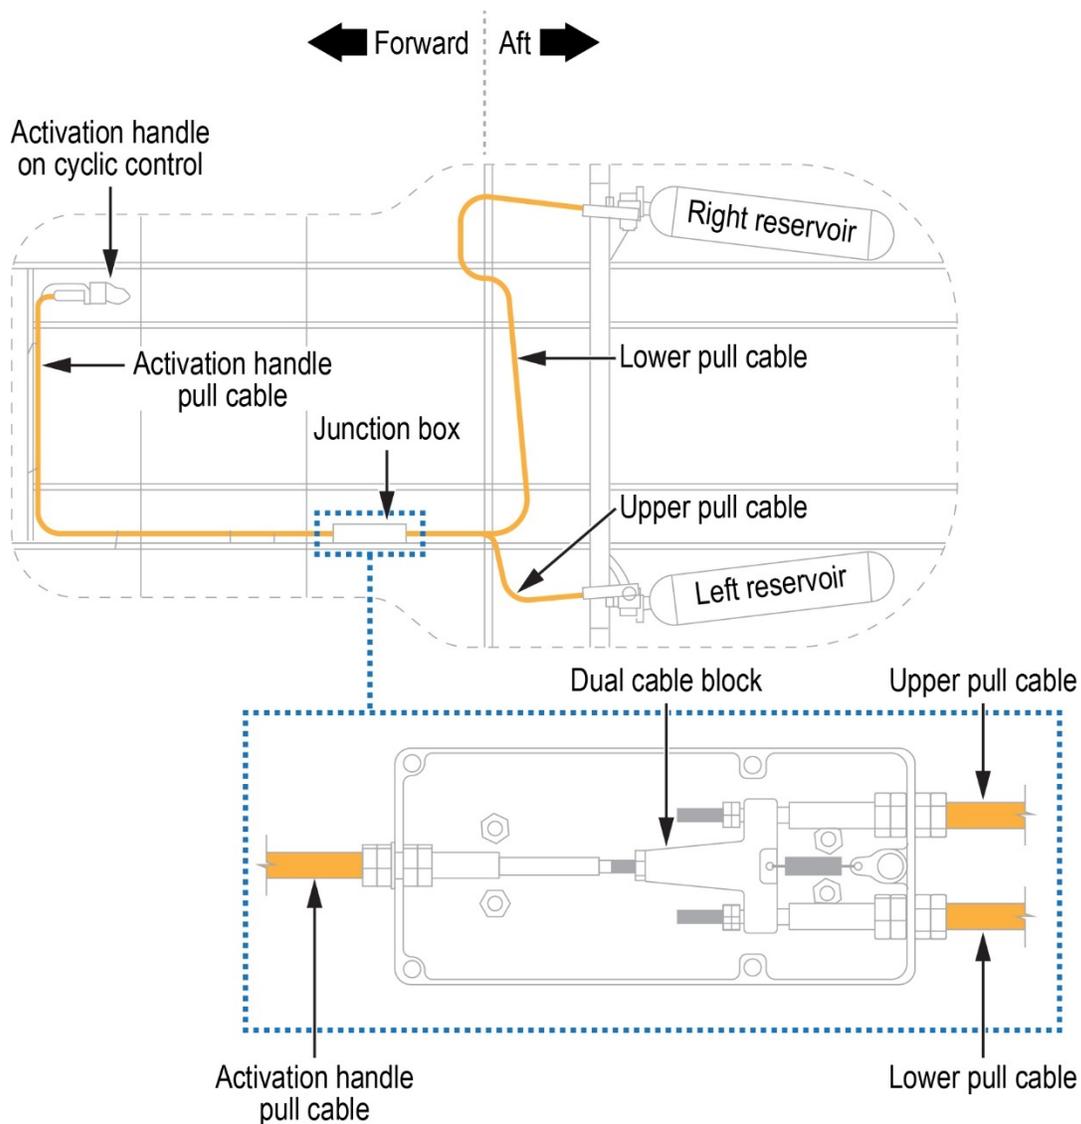
mounted on the helicopter's left frame rail. The junction box contained a dual cable block designed to transmit the motion of the activation handle's single pull cable (attached to the forward end of the block) to the pull cables for each reservoir assembly. The aft-upper and aft-lower pull cables, which extended forward from the left and right reservoir assemblies, respectively, passed through the dual cable block and terminated at jam nuts that abutted the dual cable block's forward surface. By design, pulling the activation handle would move the dual cable block forward (by means of the activation handle pull cable), which would pull the aft-upper and aft-lower pull cables forward by means of the cable block's contact with each cable's jam nut. Thus, when the activation handle is pulled to full travel, the resulting movement of the dual cable block and the aft-upper and aft-lower pull cables would result in activation of the valves to discharge each reservoir assembly (see figure 7).

Figure 7. Top-down view of helicopter showing basic routing of the pull cables for the emergency flotation system and inset showing side view of components inside the junction box.

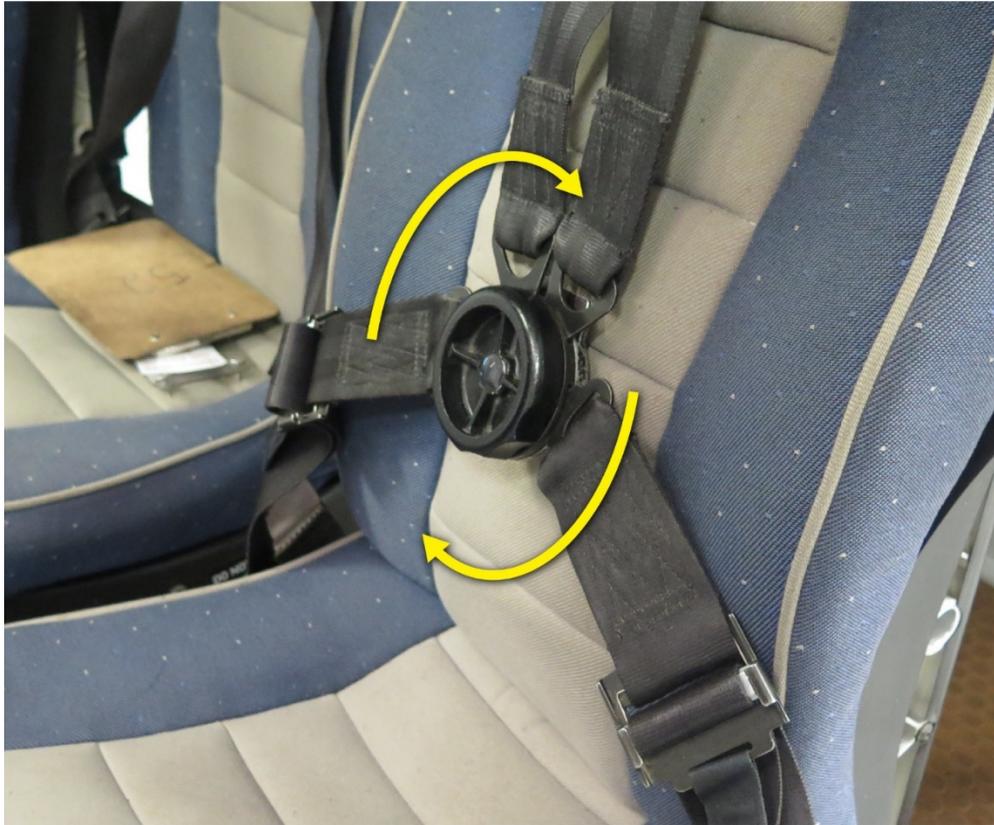
The pilot's seat had a four-point system that consisted of an adjustable-length lap belt and two-strap shoulder harness (one strap over each shoulder) that fastened into a single rotary buckle. By design, rotating the buckle would release the lap belt and both shoulder harness straps (see figure 9).

Figure 9. Exemplar four-point system with a rotary buckle.

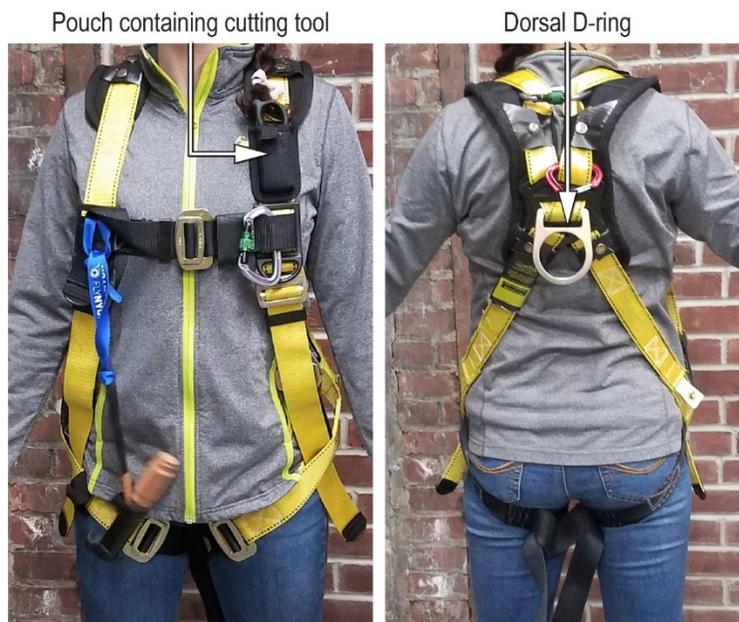
The harness that NYONair provided for each passenger on the accident flight (referred to as the "yellow" harness by Liberty and NYONair personnel due to their color) was designed to protect users from workplace fall hazards.²⁷ The harness included interconnected shoulder straps and leg straps, a chest strap that spanned the two front shoulder straps, and a dorsal D-ring (used on the accident flight for attaching a tether) between the wearer's upper shoulder blades. NYONair attached a pouch containing an emergency cutting tool on either the right or left upper shoulder strap of each harness (see figure 10).²⁸

Figure 10. Front and rear views of a person wearing an exemplar yellow fall-protection harness with a pouch containing a cutting tool attached to the upper left shoulder strap.

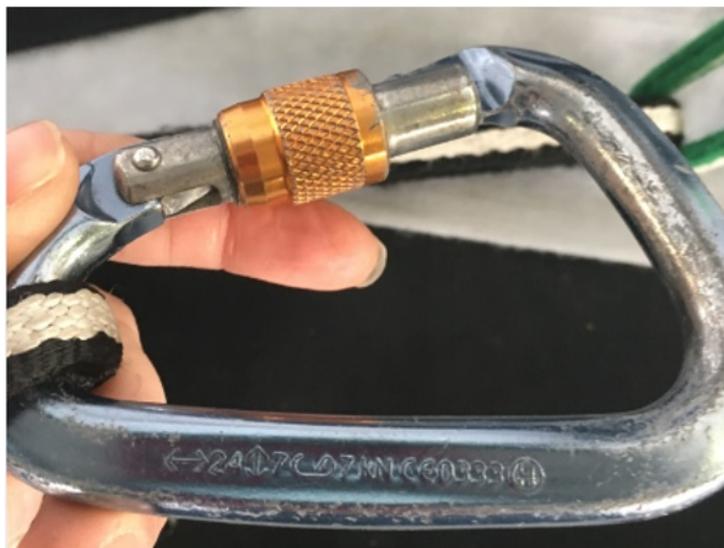
- Liberty Helicopters Inc.'s and NYONair's decision to use locking carabiners and ineffective cutting tools as the primary means for passengers to rapidly release from the harness/tether system was inappropriate and unsafe.

Three different models of locking carabiners were used on the accident helicopter, each of which featured a similar type of gate and locking mechanism. The gate could be opened by pushing it inward when not locked. The locking mechanism featured a screw-type, threaded locking sleeve that was operated by manually rotating multiple turns to lock or unlock the gate (depending on the direction of rotation) (see figure 12).

Figure 12. An exemplar locking carabiner used on a tether on the accident helicopter.

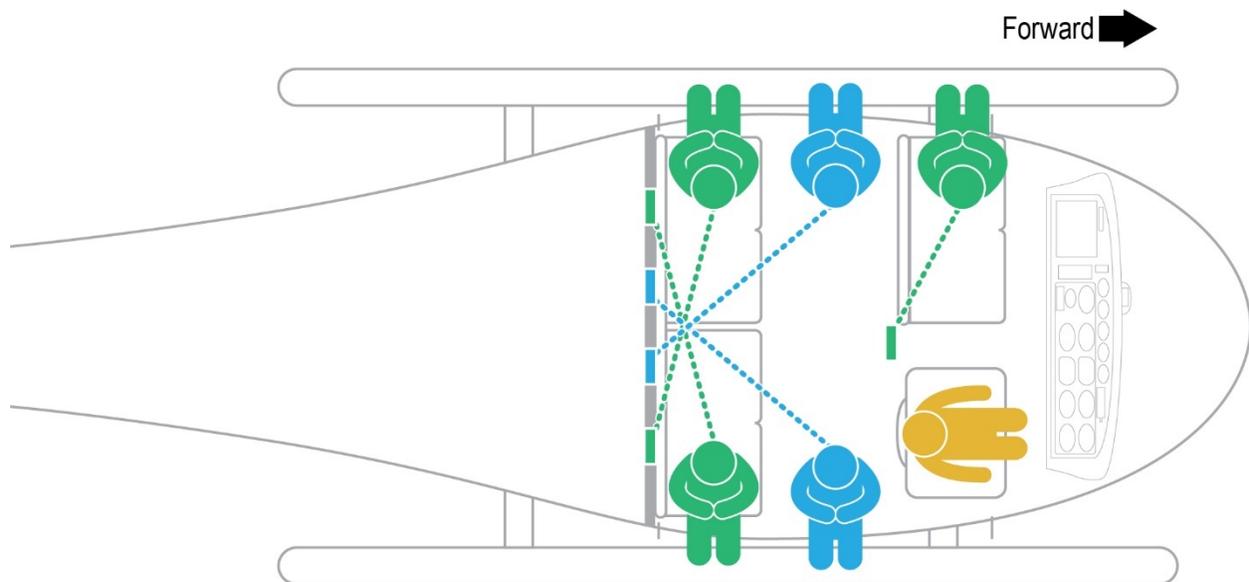
The onboard video showed that the front passenger's tether was routed under the armrest of his seat and to a floor anchor located aft of the helicopter's floor-mounted controls. According to Liberty personnel, each rear seat passenger's tether was routed such that it was secured to an anchor point located behind a different passenger. That is, the right outboard passenger's tether was secured to an anchor point (on the aft bench bar) behind the left outboard passenger (and vice versa), and the right inboard passenger's tether was secured to an anchor point behind the left inboard passenger (and vice versa). (See figure 13.)

Figure 13. Diagram showing the tether routing for each passenger to the respective anchor point in the cabin.

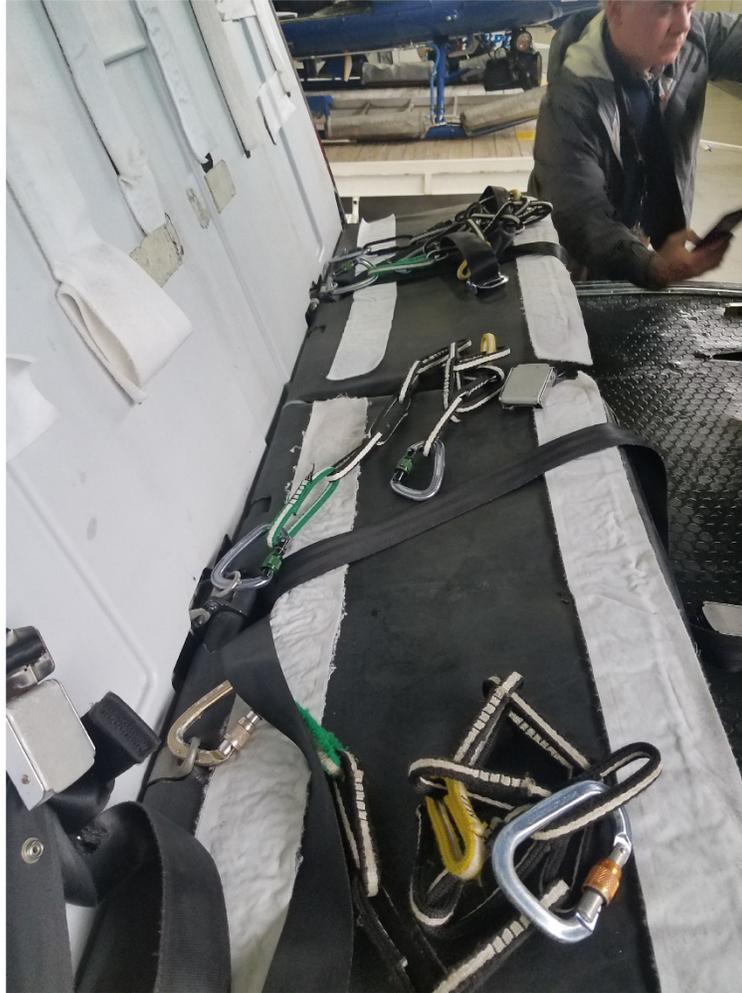
The tethers for the four rear passengers each consisted of multiple loops of webbing secured to an anchor point with a locking carabiner.³¹ The anchor end of each tether was secured through a terminating loop. When examined by investigators (after passenger recovery), the top (occupant end) of each rear tether had a locking carabiner inserted through a loop such that excess tether loops hung from the carabiner as a tail. Each tether (from the anchor point to the D-ring attachment) was between 39 and 41 inches long (see figure 15).

Figure 15. Rear passengers' tethers from the accident flight secured to anchor points on the aft bench bar with locking carabiners.

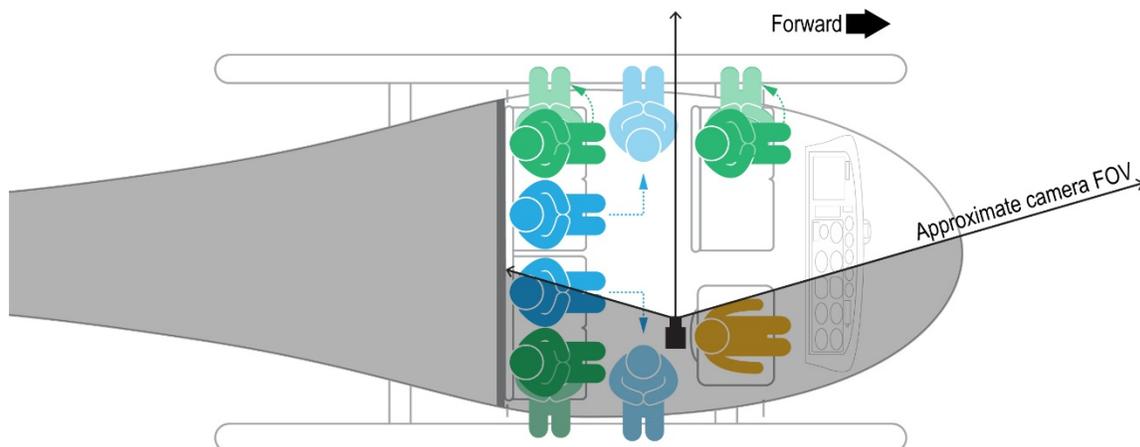
The digital camera was mounted on the helicopter's ceiling just aft of the front seats and faced to the left. It was enclosed in a ruggedized housing and included a wide-angle glass lens. The camera's FOV included (for much of the flight) the helicopter's center pedestal area, left windscreen, left open doorway, front left bench, and rear left bench (see figure 17).³⁴

Figure 17. Diagram showing ceiling-mounted camera's approximate FOV.

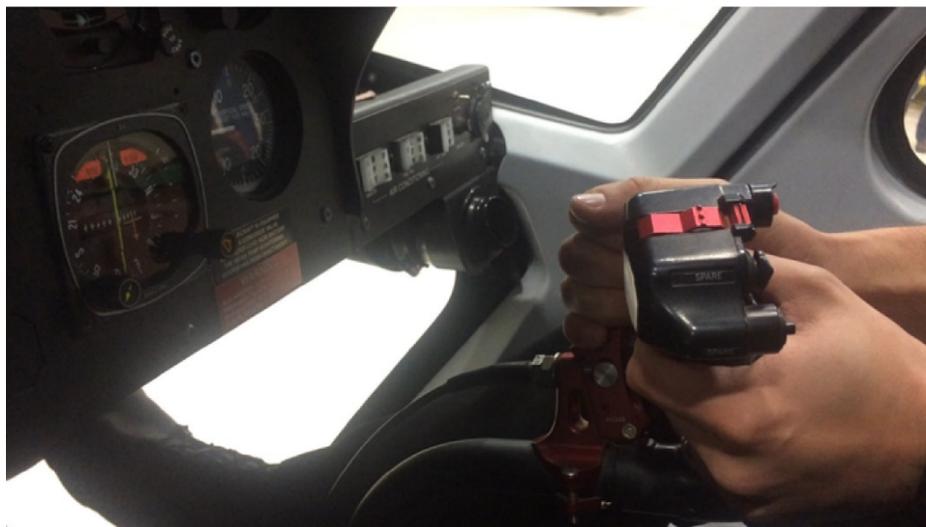
During the investigation of this accident, Liberty provided several videos of inflation tests performed as part of the 36-month float inspections of its helicopters equipped with the Dart emergency flotation system.³⁸ In every video, a participant seated in the right seat braced the cyclic control with the left hand and pulled the activation handle with the right hand (see an example in figure 18).

Figure 18. Screen capture from a Liberty-provided video of a test activation of the Dart emergency flotation system.

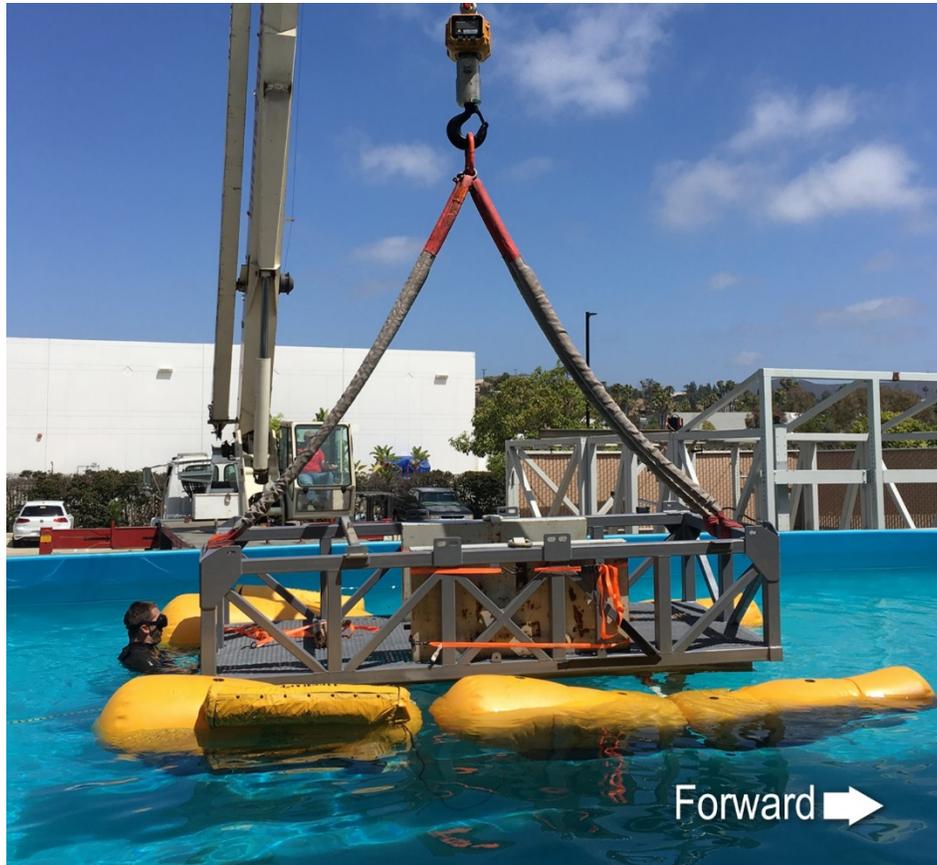
For the tests described below, the test rig weighed about 5,220 lbs (the maximum gross weight for the AS350 B2) and was suspended from a crane above a pool. Investigators used one gas reservoir to partially and symmetrically inflate the floats, then slowly lowered the rig into the pool to observe its buoyancy stability (see figure 19).

For another test, air from a shop compressor was added to increase the partial inflation pressure in each float chamber to about 1 psi (the designed minimum operating pressure of the floats). Once the test rig was lowered into the pool, it floated with no evidence of listing after several minutes. None of the six floats became completely submerged.

Figure 19. A test rig with partially, symmetrically inflated floats is shown suspended by a crane and lowered into a pool.

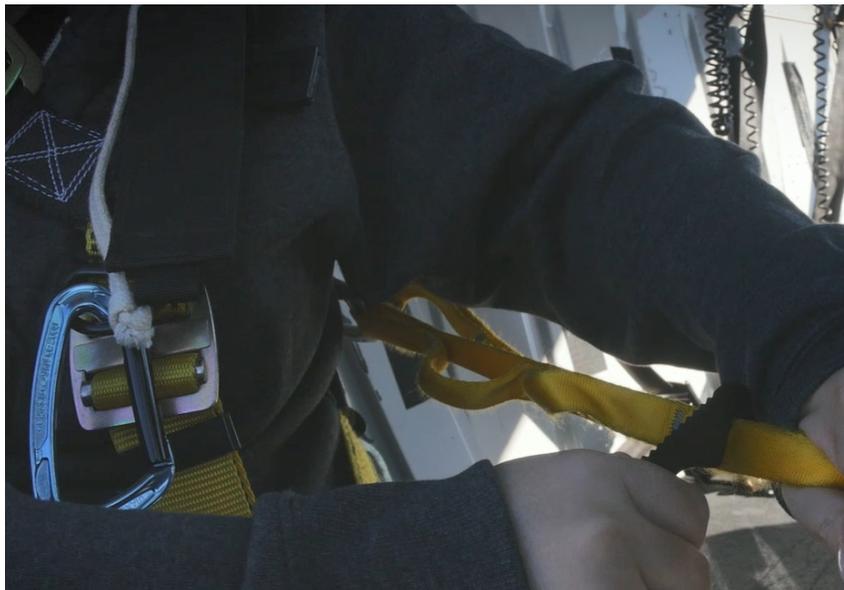
The video also instructed passengers that "a cutter [cutting tool] is also secured to one of your chest straps and will allow you to quickly cut through the harness if you are unable to reach the quick release clip." The visual that accompanied this narrative showed a tether made of a different webbing than the tethers provided to the accident passengers. It showed a person (seated alone in the back of a helicopter) grasping the tether with one hand and applying the cutting tool with the other, successfully cutting through the tether with one pull of the tool (see figure 20).⁵⁸

Figure 20. Screen capture from the safety video shown to the passengers before the accident flight showing a person using a cutting tool on a type of tether.
