Auxiliary Power Unit Battery Fire
Japan Airlines Boeing 787-8, JA829J
Boston, Massachusetts
January 7, 2013

Incident Report

NTSB/AIR-14/01
PB2014-108867

**National
Transportation
Safety Board**

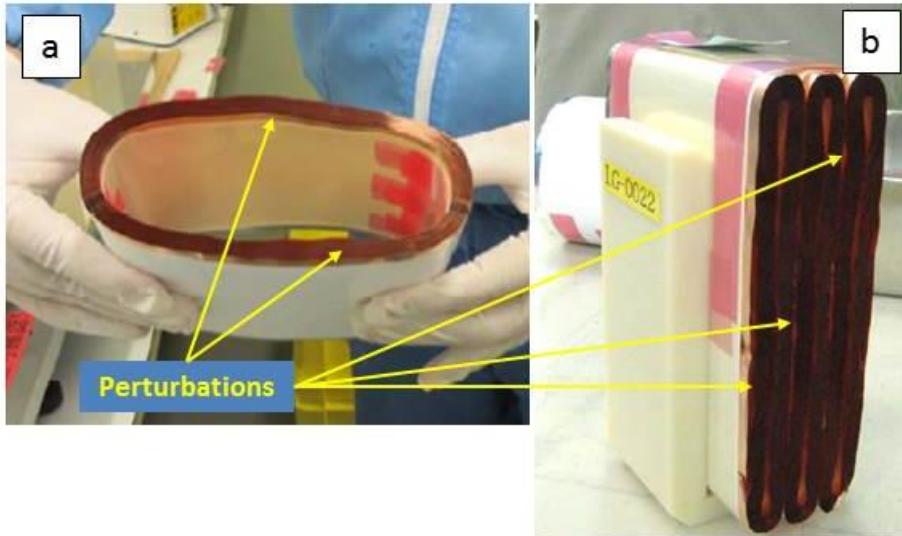
Figure 16. Winding flattening process.

Another machine used a cylindrical winding mandrel to wind the cathode and anode foils together with the separator sheets to create the cell windings. Afterward, the machine operator measured the alignment and weight of each winding. The machine operator then partially flattened each winding by hand compression, as shown in figure 16a, and positioned the three windings for final flattening. The final flattening process was accomplished using a compression jig with two flat plates facing the three windings. After final flattening, the machine operator attached heat-resistant plastic tape to the ends of the cell where the curves of the windings were located, as shown in figure 16b. Figures 16a and 16b also show perturbations of the electrode foil that were created during the flattening process.⁹²

Note: Figure 16a shows an electrode being hand flattened after winding and removal from the mandrel, and figure 16b shows the three-electrode assembly after final flattening and taping.

First, the manual cell winding flattening process can create perturbations (that is, electrode foil buckling) in the windings. Such perturbations (see figure 16) were visually consistent with the wrinkles found in the CT scans of LVP65-8-402 exemplar batteries and those
