Aviation Investigation Report AIR-24-04

Collision with Powerlines and Terrain during Forced Landing

MARPAT Aviation

Bell Helicopter UH-1B, N98F

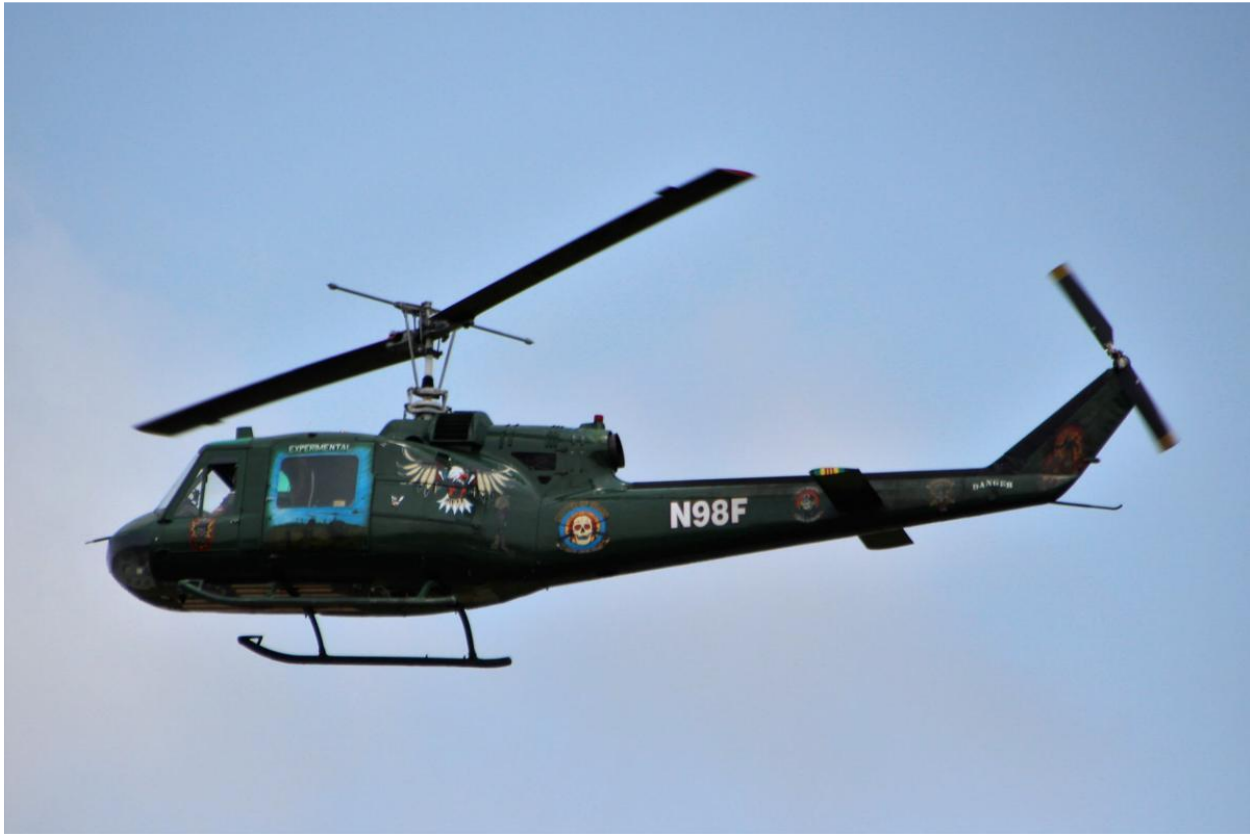
Figure 1. Accident helicopter (Source: [The Logan Banner](#)).

The accident helicopter (see figure 1) was manufactured for the US military by Bell Helicopter in 1962. According to MARPAT Aviation, the helicopter was flown in Vietnam from 1962 to 1971 and was subsequently sold to a civilian entity. The helicopter had a two-bladed main rotor system that provided lift and thrust and a two-bladed tail rotor system that provided lateral thrust for directional control. The helicopter was also equipped with a skid-type landing gear. The registered owner of the helicopter (since November 2003) was a friend of the owner of MARPAT Aviation; the helicopter owner was not affiliated with the operator.

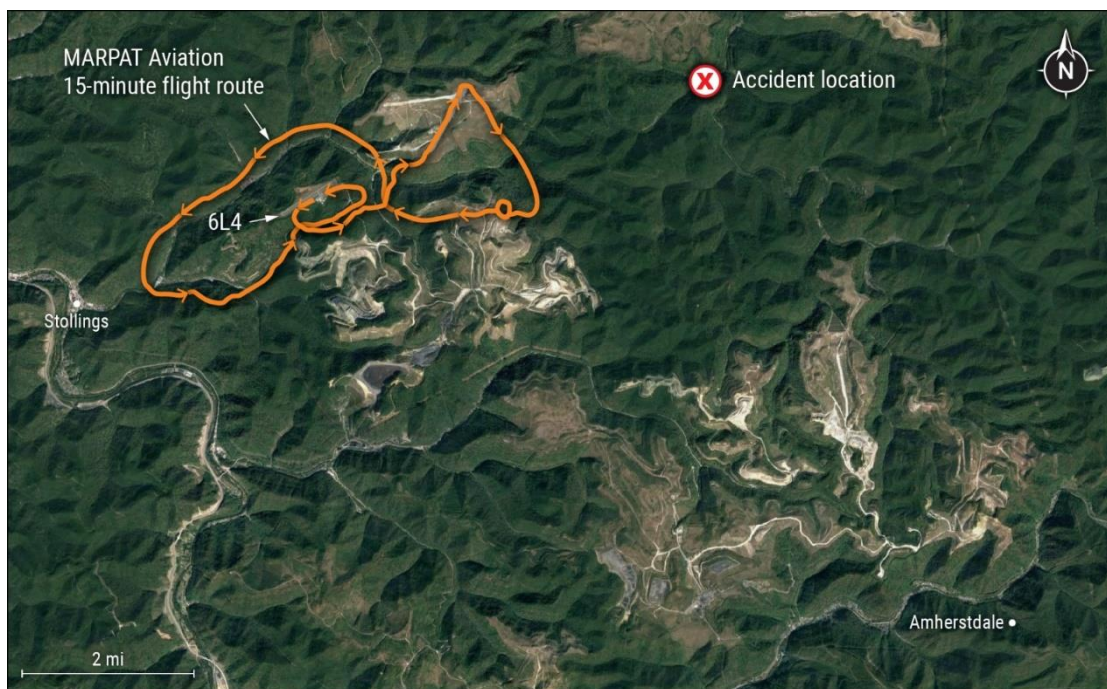
Figure 8. Estimated location of the flight route in relation to the accident site.

For the 30-minute flights, the pilot-in-command and the right-seat passenger would typically fly a 15-minute route twice. Figure 8 shows the estimated flightpath of the 15-minute route according to a map that MARPAT Aviation provided during the investigation. Postaccident statements from passengers who were previously aboard the accident helicopter indicated that the helicopter would sometimes be flown off course (that is, beyond the 15-minute flight route).

The accident site was located away from the flight route shown in figure 8 (section 1.7.1.1), but the investigation was unable to determine, based on the available evidence, why the helicopter was operating off the planned course. Postaccident examination of the engine found static damage in the compressor section; rotational damage in the gas-producer turbine; and additional damage to the exhaust diffuser, rear bearing cover, No. 2 bearing, and two power turbine blades.³⁶
