National Transportation Safety Board

Highway Accident Brief

Accident Number: HWY-05-MH-006
Accident Type: Motorcoach run-off-the-road and rollover
Location: Interstate 55, near Turrell, Arkansas
Date and Time: October 9, 2004, 5:02 a.m. central standard time
Vehicles: 1988 Motor Coach Industries, Inc., 47-passenger motorcoach
Owners/Operators: Walters Bus Service, Inc.
Fatalities/Injuries: 15 fatalities
13 serious injuries
2 minor injuries

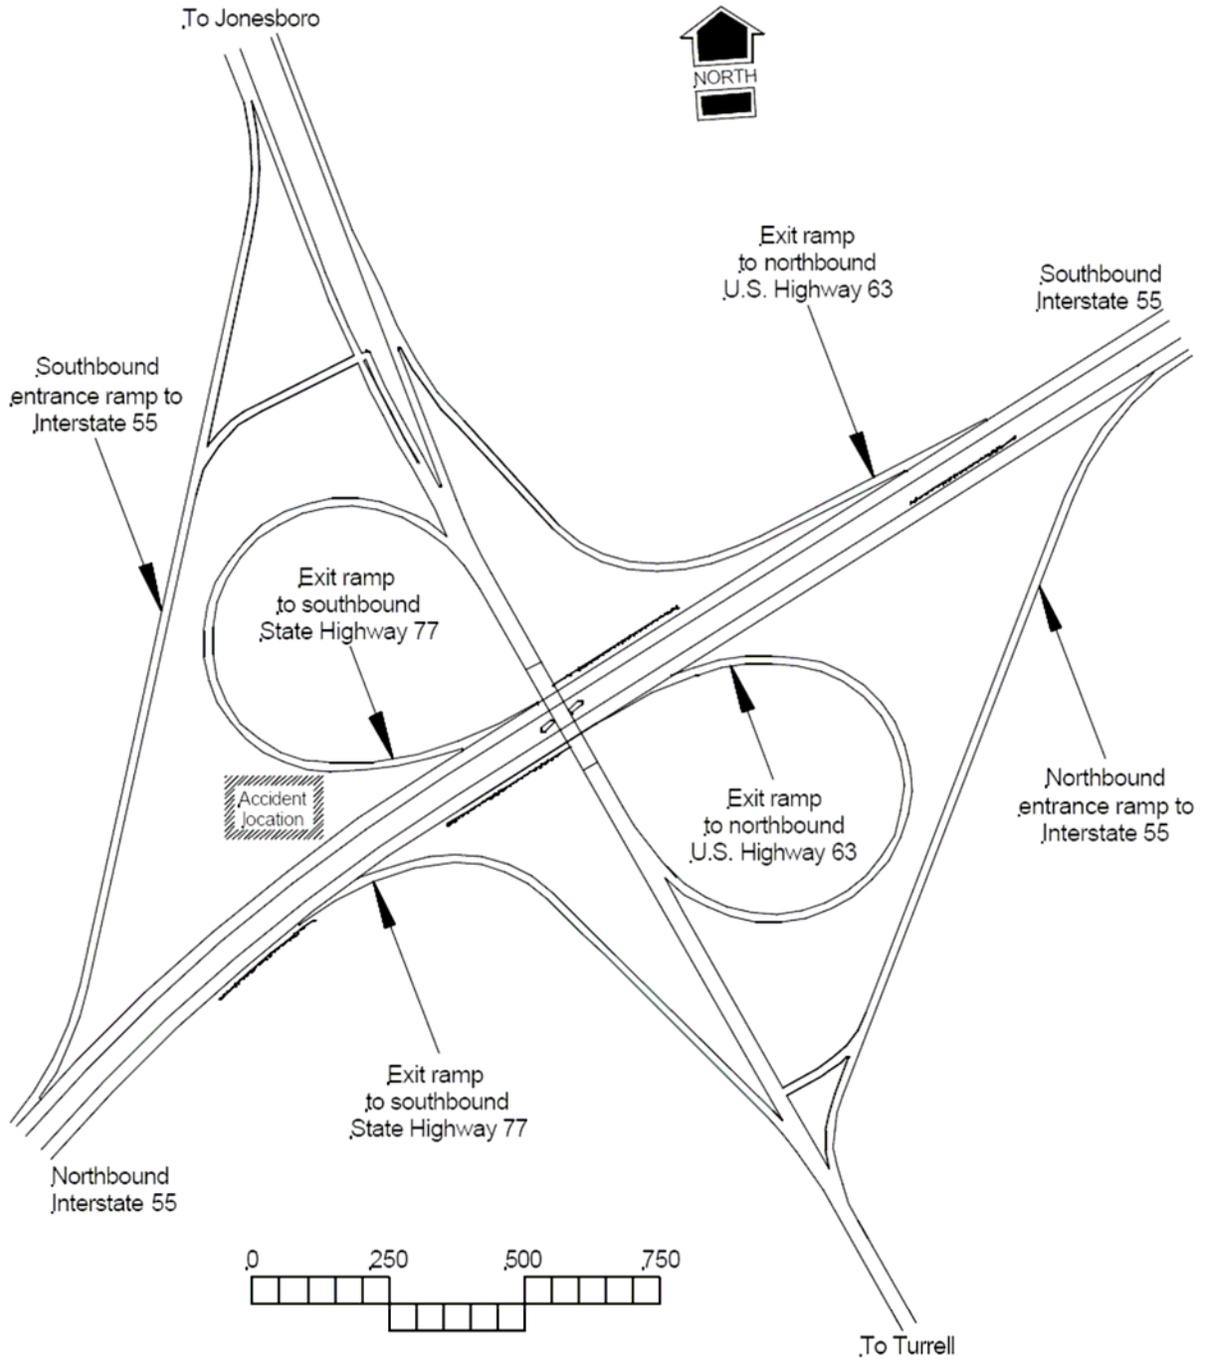
Figure 4. Layout of I-55 accident interchange.

The exit 23A interchange, the scene of the accident, is a four-leg partial cloverleaf, incorporating two looped ramps in diagonally opposite quadrants. (See figure 4.) Entrance and exit maneuvers are restricted to the right side of I-55. Southbound motorists approaching the interchange encounter a diagonal exit ramp before the crossroad's overpass. A looped exit ramp is located on the other side of the overpass, and a diagonal entrance ramp is located beyond the first two exit ramps.
