National Transportation Safety Board

Highway Accident Brief

Collision Between Passenger Train and Refuse Truck at Active Grade Crossing, Crozet, Virginia, January 31, 2018

Accident Number:	HWY18MH005
Accident Type:	Train and refuse truck collision at active grade crossing
Location:	Lanetown Road at Buckingham Branch Railroad, milepost 195.85, near Crozet, Albemarle County, Virginia
Date and Time:	January 31, 2018, about 11:16 a.m. eastern standard time
Vehicle 1:	2018 Freightliner refuse truck
Operator 1:	Time Disposal, LLC
Vehicle 2:	Amtrak train P923-31 (Congressional Special Train)
Operator 2 (railroad):	Buckingham Branch Railroad
Operator 2 (train):	Amtrak
Fatalities:	1
Injuries:	9

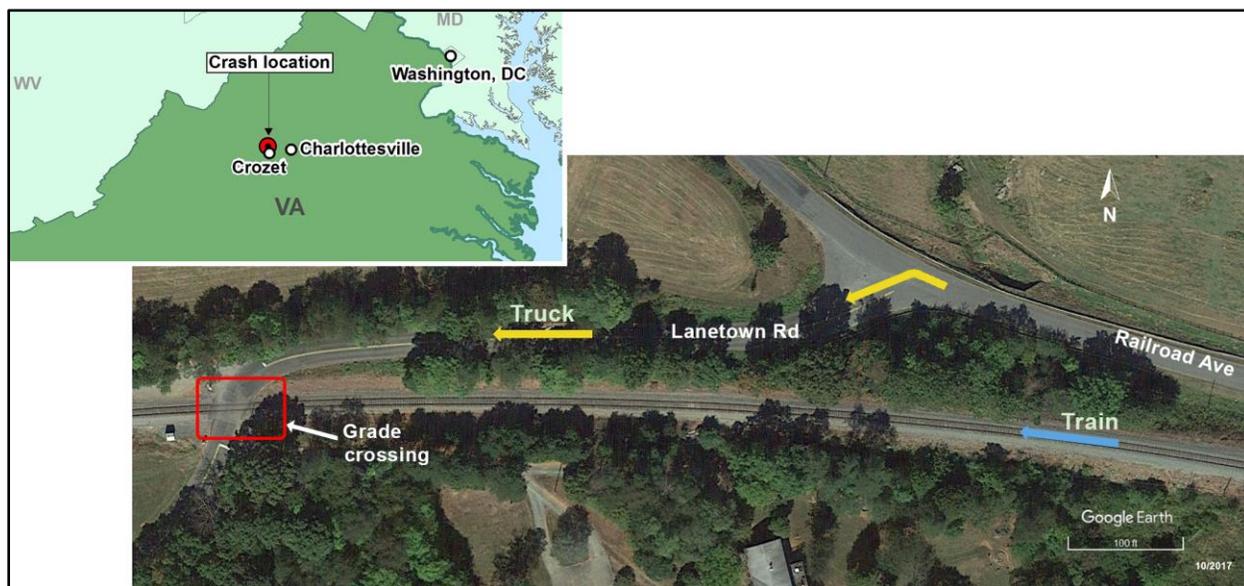
Figure 1. Aerial view of grade crossing and paths of train and truck, with inset map of crash location. (Source: Adapted from Google Earth)

The southbound approach to the Lanetown Road grade crossing has pavement markings and roadway signs to inform roadway users of the crossing. The markings and signs are found on Lanetown Road and on Railroad Avenue, the road the truck driver was on before he turned onto Lanetown Road (refer to figure 1). Along northwest-bound Railroad Avenue, the truck driver would have encountered three grade-crossing-related signs, including a low-ground-clearance grade crossing (LGCGC) warning sign.¹³ Along southbound Lanetown Road, the driver would have encountered another LGCGC warning sign and three other signs related to the grade crossing (table).

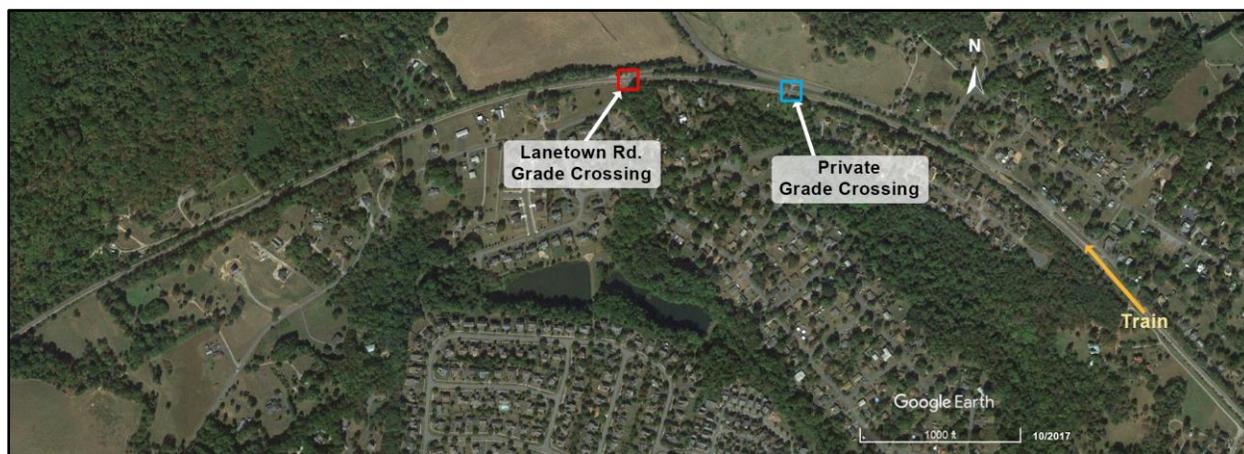
The section of the railroad tracks where the crash occurred is configured as a single main track and uses a traffic control system to detect the presence of trains and communicate signals. The maximum authorized speed is 60 mph for passenger trains and 40 mph for freight trains. The grade crossing is on a wide curve, where vegetation grows along both sides of the track (figure 3).

Figure 3. Overhead view of railroad tracks in crash area, showing grade crossings and track geometry. (Source: Adapted from Google Earth)

In his postcrash interview, the engineer said that he first sounded the train's horn for a private grade crossing about 1,000 feet east of the Lanetown Road crossing (refer to figure 3). He said he continued sounding the horn as the Lanetown Road grade crossing entered his view. At that point, he saw the refuse truck driving around the gates, which he reported were already lowered. He believed the truck had time to clear the crossing and at first was not concerned. Then he saw the truck stop and remain stopped. When he determined that the truck would not clear the tracks, the engineer engaged the train's emergency brake. The road foreman of engines also told investigators that he saw the truck drive around the lowered north gate and stop on the tracks.
