Highway Accident Report

**Collision Between Truck-Tractor  
Semitrailer and School Bus  
Near Mountainburg, Arkansas  
on May 31, 2001**

NTSB/HAR-02/03  
PB2002-916203  
Notation 7490  
Adopted September 4, 2002

The major safety issues discussed in this report are the poor condition of the tractor semitrailer brakes, inadequate motor carrier inspections and oversight, the use of propane tanks on school buses, and occupant protection within school buses.

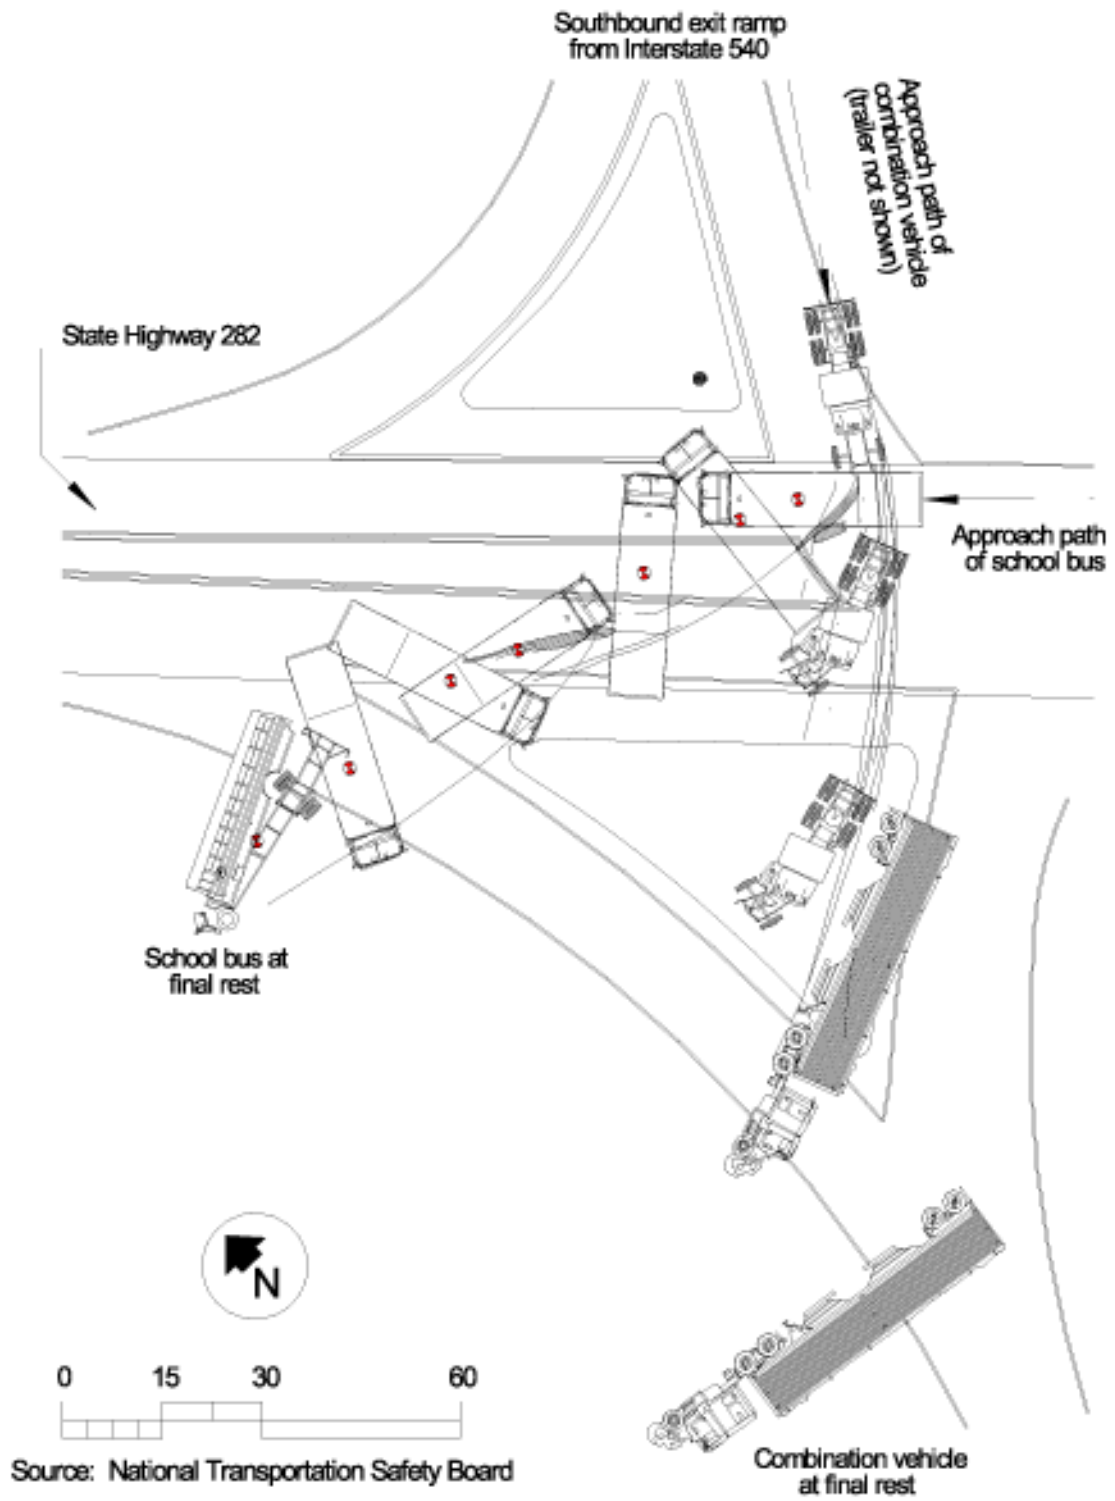
Figure 2. Postcrash accident scene.

The tractor semitrailer hit the bus on the right side in the area of the rear axle. The truck continued south across SH-282, traveled 73 feet from the point of impact, rolled on its left side, and traveled an additional 78 feet, rotating about 60 degrees clockwise (see figures 2 and 3). The school bus traveled 96 feet southwest from the area of impact, rotating about 300 degrees clockwise. The body, which partially separated from the chassis, rolled onto its right side, while the chassis remained partially upright (see figure 4).

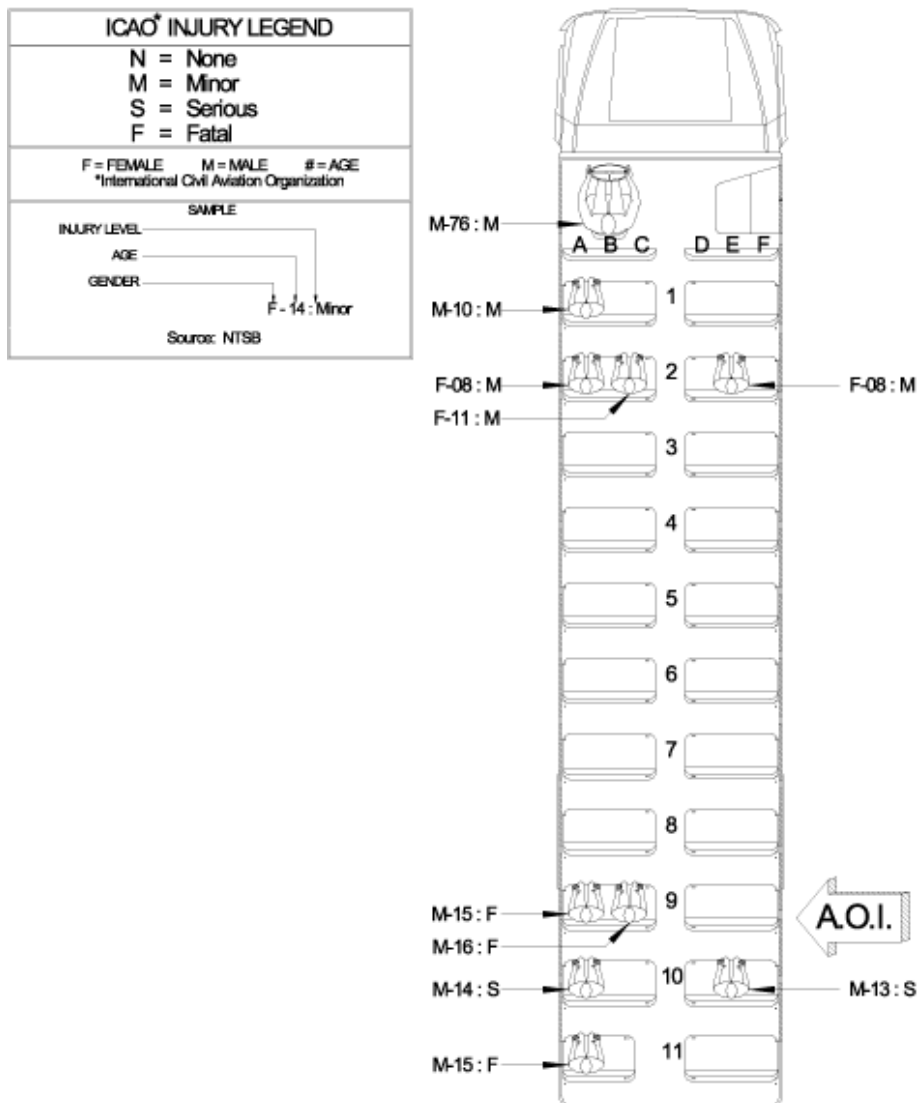
Figure 5. Mountainburg school bus seating chart.

The passengers who sustained minor injuries were seated in seats 1A, 2A, 2C, and 2E (see figure 5). The passenger in seat 1A sustained a contusion on the left side of his scalp. The passenger in seat 2A sustained a contusion on the left side of her scalp and a possible contusion or laceration of the spleen. The passenger in 2C sustained lacerations and contusions on the right elbow, and the passenger in seat 2E had lacerations and contusions on her right elbow and on the back of both knees.

Two seriously injured passengers were seated in the rear of the bus. One was seated in the area of impact (seat 10E) and sustained lacerations to his head and elbow and a closed head injury. The other, seated across from the area of impact (seat 10A), sustained multiple spinal fractures and a fractured right arm and leg.

The three fatally injured passengers were seated across from the area of impact. The passenger in seat 9A sustained a fractured skull, fractured left clavicle, three fractured ribs, and a compound fracture of the left leg; the passenger in 9C sustained multiple lacerations and contusions, a right pelvic fracture, a liver laceration, a right renal laceration, ruptured right hemidiaphragm, and vena cava injury; the passenger in 11A, who was partially ejected, had a skull fracture, multiple spinal fractures, and a fractured left tibia.

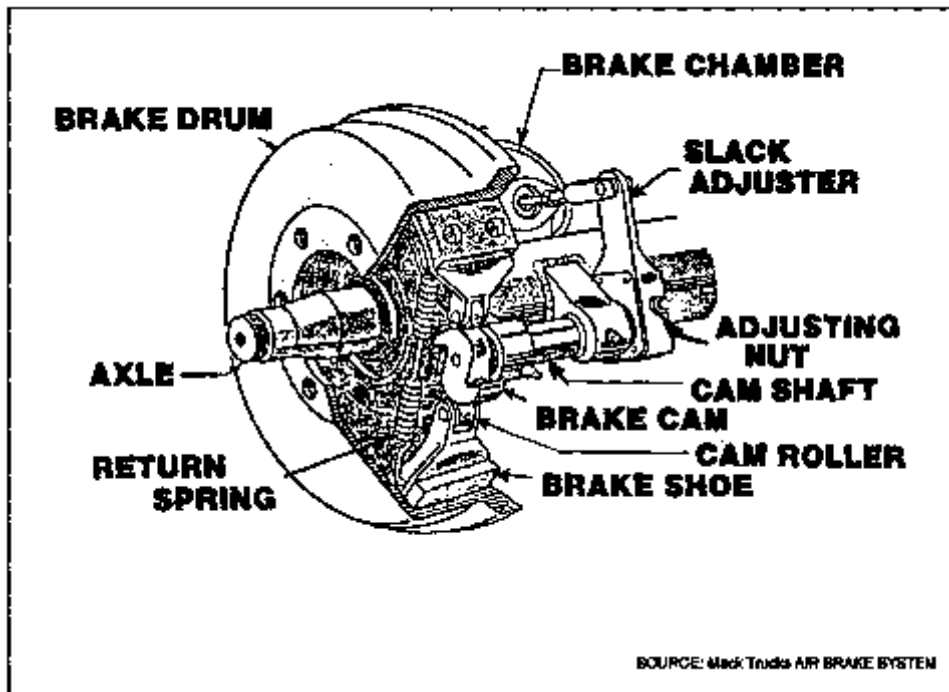
Figure 6. Brake diagram.

**Brakes.** A Safety Board postaccident examination revealed that all three tractor axles had air brakes (see figure 6) with standard S-cam/drum foundation (service) brakes (see figure 7) fitted with manual slack adjusters.<sup>8</sup> The semitrailer (hopper) had air brakes with standard S-cam/drum foundation brakes; its two axles had automatic slack adjusters. The third axle of the tractor and both trailer axles had emergency-parking spring brakes.

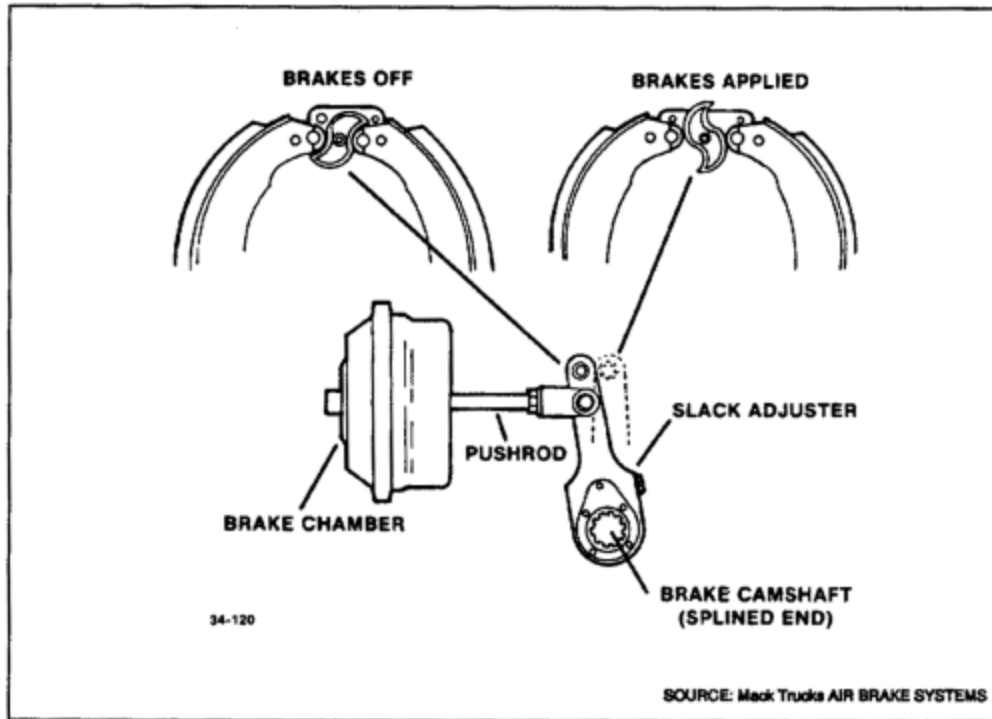
**Figure 7.** S-cam diagram.

In an S-cam air brake system, the pushrod is attached to one end of a lever called a slack adjuster (see figure 7). The slack adjuster multiplies and converts the force from the pushrod into torque on the shaft running perpendicular to the brake drum. As the pushrod is extended from the brake chamber, the slack adjuster rotates, in turn rotating the shaft connected to it. The S-cam also rotates, spreading the brake shoes inside the brake drum. When the brake shoes are spread apart, the brake linings (riveted to the shoes) come into contact with the inside of the brake drum. The friction created slows the rotation of the brake drum and, thus, the wheel and the vehicle.

Air brakes, when heated due to repeated applications, can also cause bottoming out, resulting in loss of braking capability. When heavy vehicle air brakes heat up, several components can be adversely affected. Heated brake drums expand, thereby increasing the distance that the brake shoes must move so that the lining contacts the drum; as a result, the S-cam must be rotated farther, requiring an extra, or reserve, pushrod stroke. (The reserve stroke refers to the distance remaining before the pressure plate in the brake chamber contacts the bottom of the chamber at the time of brake application.) If little reserve stroke remains on a cool brake (when brakes are out of adjustment), a hot brake can easily use up the small amount of extra stroke. If the brakes become too hot and do not have enough reserve stroke left, the pressure plate can bottom out in the chamber and the shoes will not contact the brake drum. Bottoming out causes an air-braked vehicle to lose its braking capability when descending a grade. It usually takes place when brakes near the limit of adjustment are repeatedly applied during a long descent.

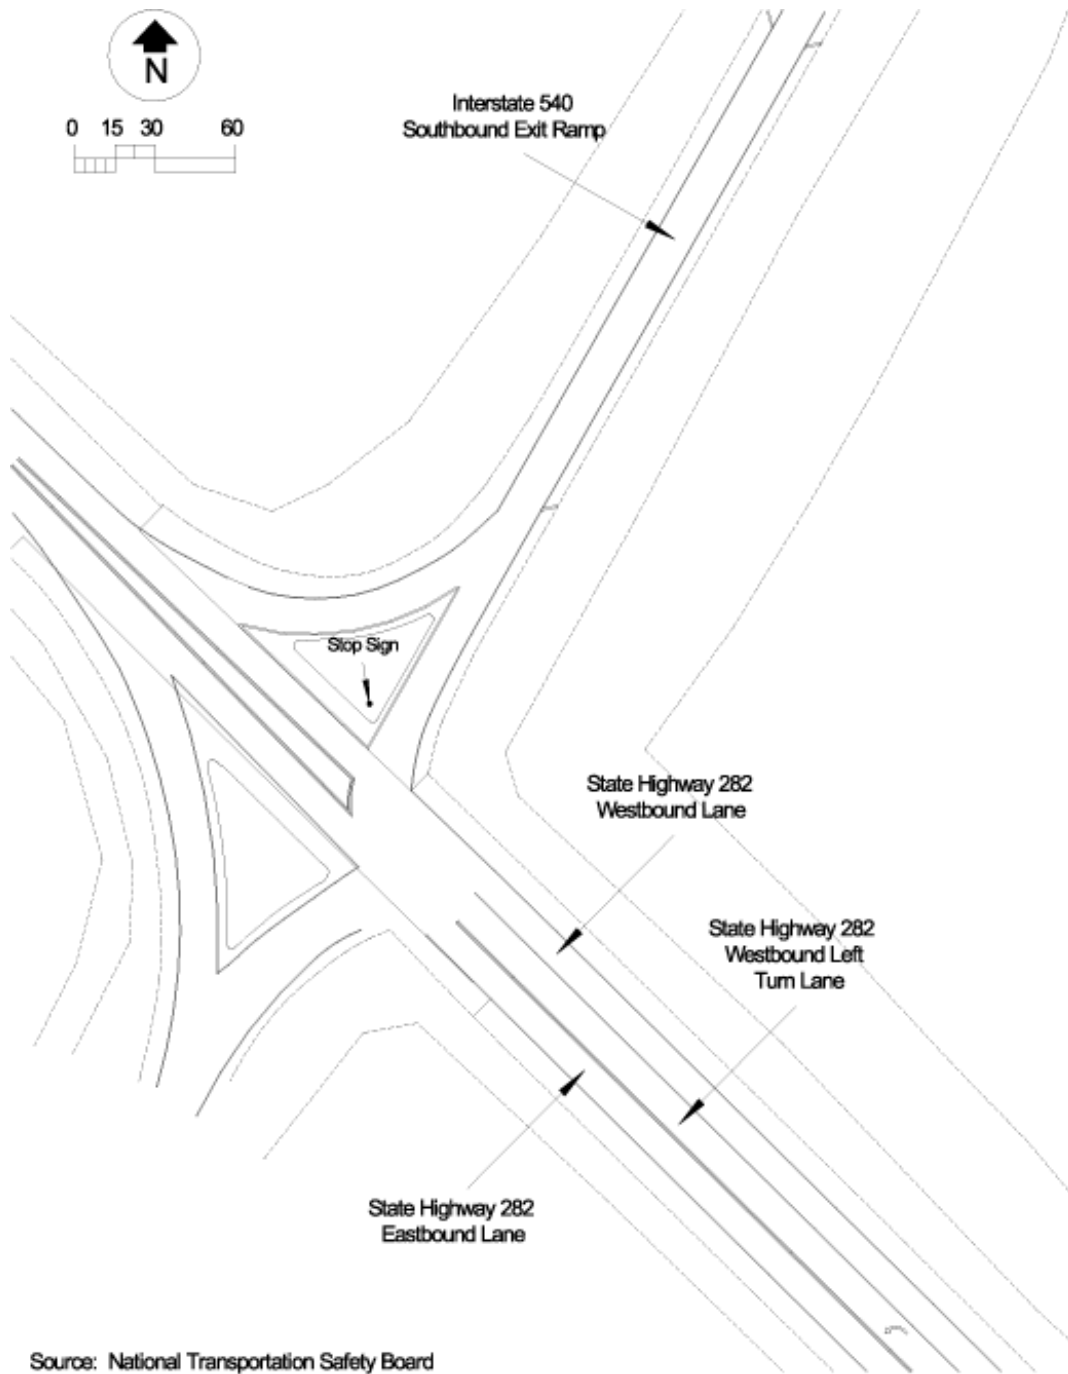
**Figure 10.** Intersection of ramp from I-540 south and SH-282.

The accident occurred at the intersection of SH-282 and the exit ramp from southbound I-540 (see figure 10). Construction on this part of I-540 began in January 1987, and it opened to traffic in January 1999. The exit ramp from southbound I-540 to SH-282 was completed summer 1999. Arkansas State Highway and Transportation Department (ASHTD) records show that no accidents were reported in the intersection for the 2 years that it had been open.

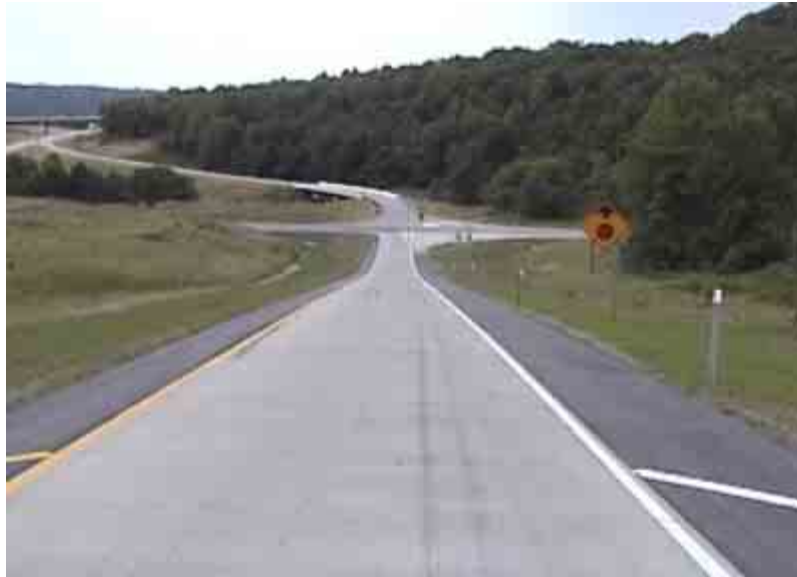
**Figure 11.** Exit ramp from I-540 south to SH-282.

The exit ramp (see figure 11) from I-540 is a 15-foot-wide paved concrete lane, with tined surface texture, bordered by 6-foot paved asphalt shoulders to the west and 4-foot paved asphalt shoulders to the east, each delineated with thermoplastic edge lines. The exit ramp, as measured from the gore area<sup>22</sup> to the intersection curb line of SH-282, is approximately 1,342 feet long, with a difference in elevation of about 85 feet. The only ramp curvature is a horizontal curve as the ramp transitions from the interstate. The average grade of the ramp is about 6 percent; the steepest grade is 9.42 percent, encompassing a distance of about 293 feet and ending about 413 feet from the end of the ramp, after which the ramp transitions to a 0.03 percent grade 69 feet before the intersection, as measured on scene.

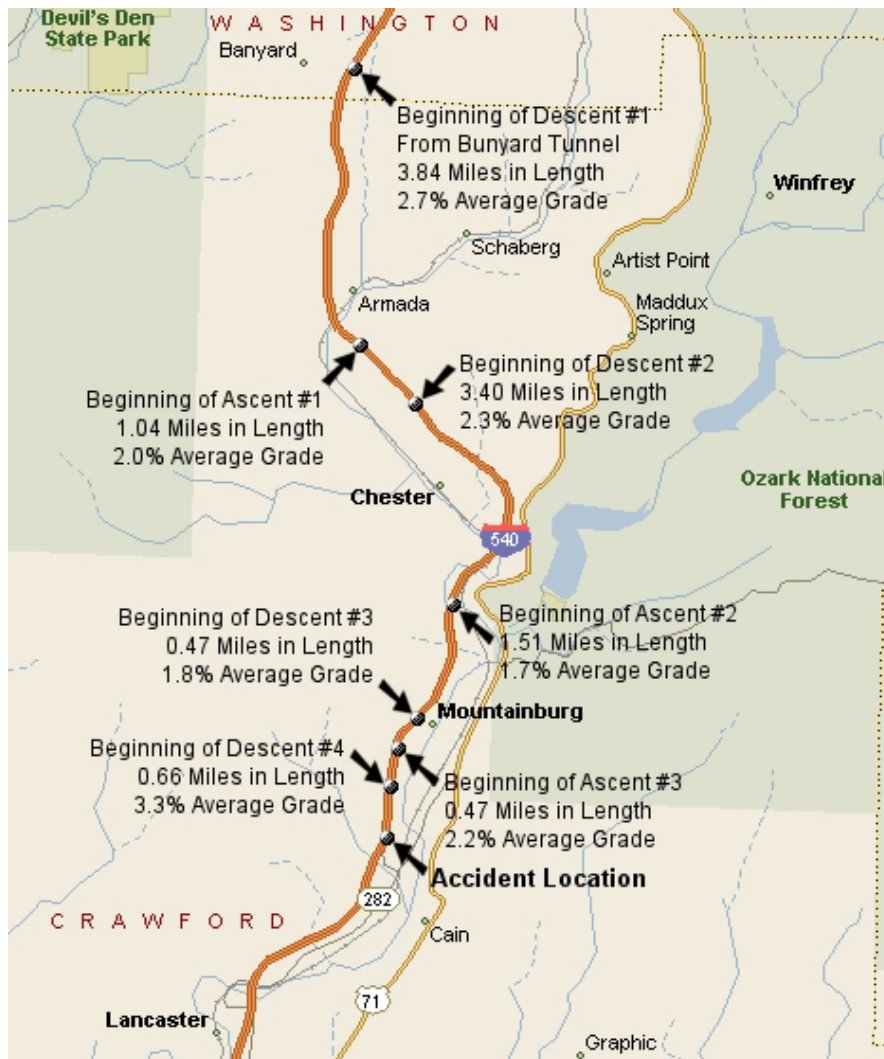
Figure 12. Grade map.

figure 12). While traveling southbound from the tunnel, the truck descended an average grade of 2.7 percent (steepest grade was 4.9 percent) over 3.84 miles; an average grade of 2.3 percent (steepest grade, 4.1 percent) over 3.40 miles; and an average grade of 1.8 percent (steepest grade, 2.5 percent) over 0.47 mile. On its approach to the ramp, the truck was descending an average grade of 3.3 percent (steepest grade, 4.4 percent) over 0.66 mile.

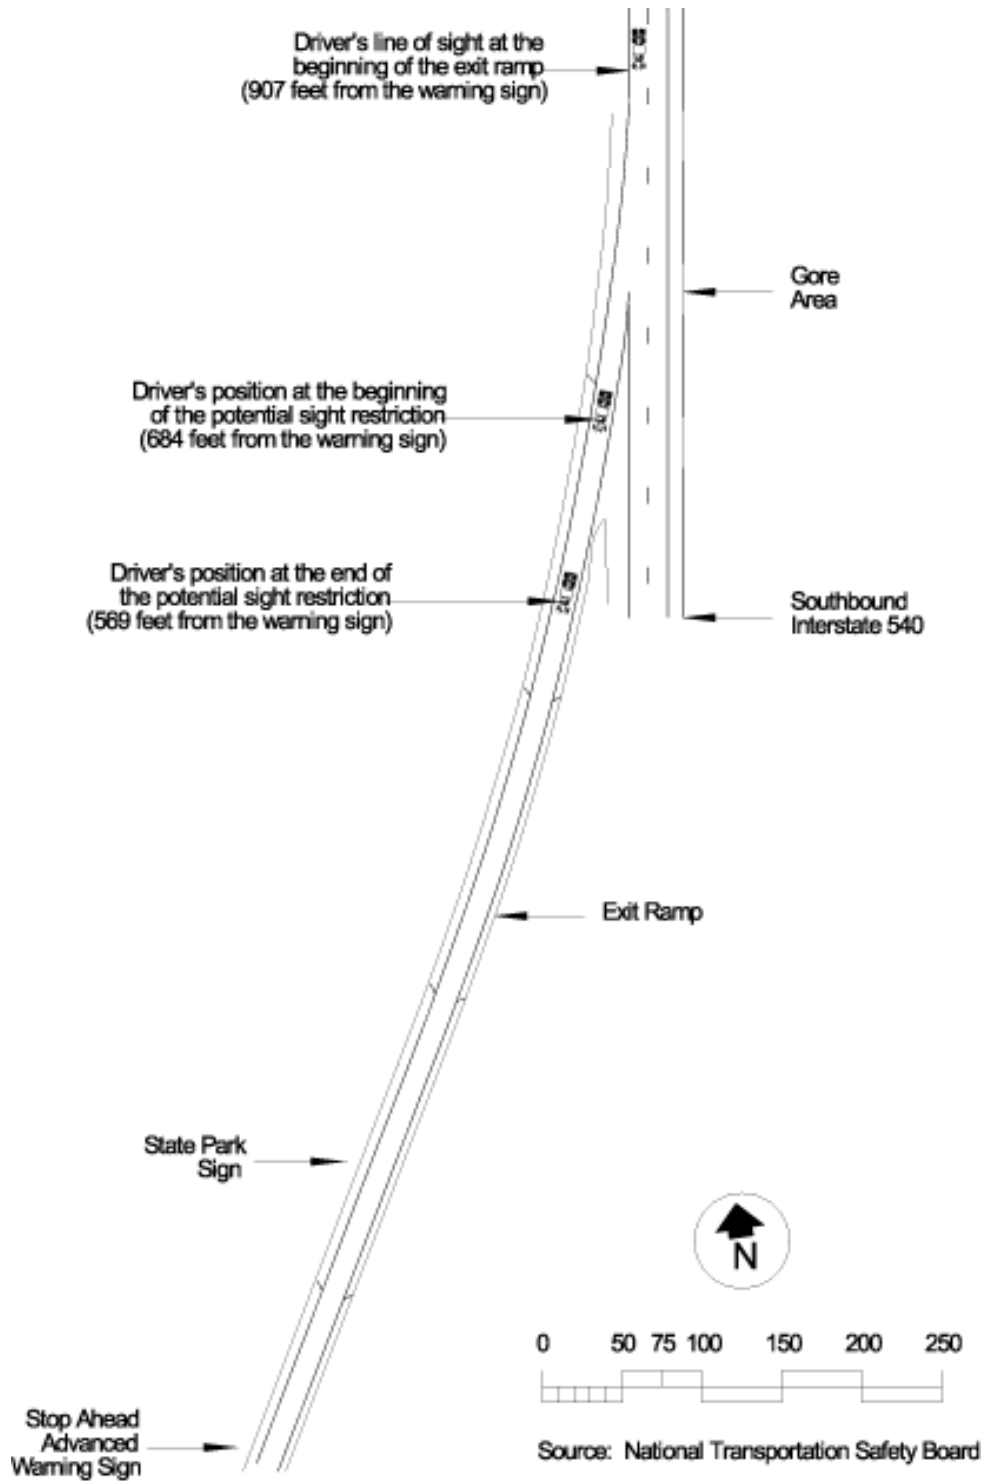
Figure 13. Ramp sight distance.

Safety Board investigators conducted sight distance tests after the accident. At a driver eye height of 74 inches<sup>35</sup> above the pavement, a motorist could see the stop sign from the transition area<sup>36</sup> to the end of the ramp, a distance greater than that prescribed by the American Association of State Highway and Transportation Officials (AASHTO). The “State park” sign then in place north of the “stop ahead” sign could impede a motorist’s view of the “stop ahead” sign from a distance of 684 feet until the driver was about 569 feet from the “stop ahead” sign (see figure 13). Since the accident, Arkansas has moved the “State park” sign to the other side of the ramp, where it does not impede a driver’s view of the “stop ahead” sign, and has added “stop ahead” signs. When the ramp was constructed, it was cut into existing terrain, and a grass berm runs parallel to and east of the ramp. A stop sign for traffic exiting I-540 onto SH-282 is in place at the intersection. Safety Board visibility test results showed that, when stopped at the intersection, a driver has a clear line of sight to the east exceeding 582 feet. A driver on westbound SH-282 is not able to see traffic on the exit ramp until the driver is 51 feet east of the intersection.
