Truck-Tractor Semitrailer Rollover and
Motorcoach Collision With Overturned Truck
Interstate Highway 94
Near Osseo, Wisconsin
October 16, 2005

ACCIDENT REPORT

NTSB/HAR-08/02
PB2008-916202

Highway Accident Report

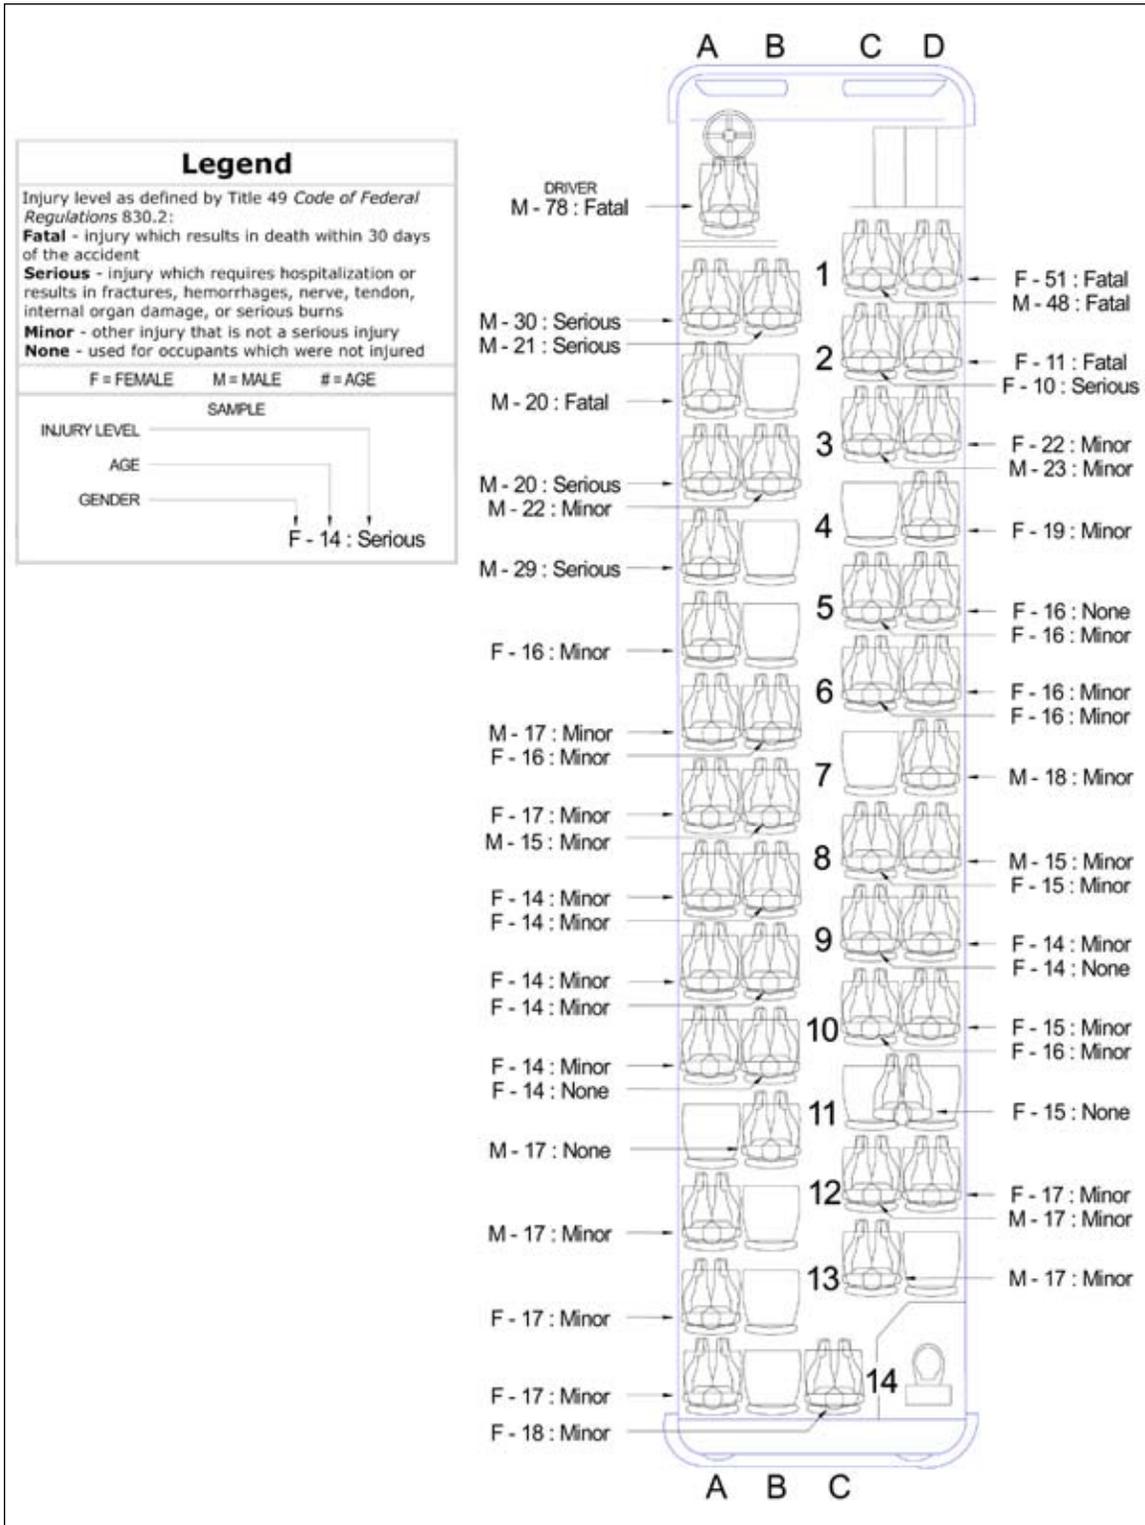
Figure 4. Osseo motorcoach seating chart

The four motorcoach passengers who received fatal injuries were seated in the first two rows of seats. All the seriously injured motorcoach occupants were seated in the first four rows of the motorcoach. In the area of the occupant compartment that included the driver's station and first four rows of double passenger seats, the survivable space was reduced by 70 percent. The preaccident seating positions of the motorcoach occupants appear in figure 4.

The accident motorcoach sustained extensive damage to the front of the vehicle with approximately 10 feet of crush. Interior damage extended rearward to between rows 4 and 5. Forward of row 5, passenger injuries ranged from minor to fatal, depending on seating location. Rearward of row 5, passengers either sustained minor injuries or were uninjured.

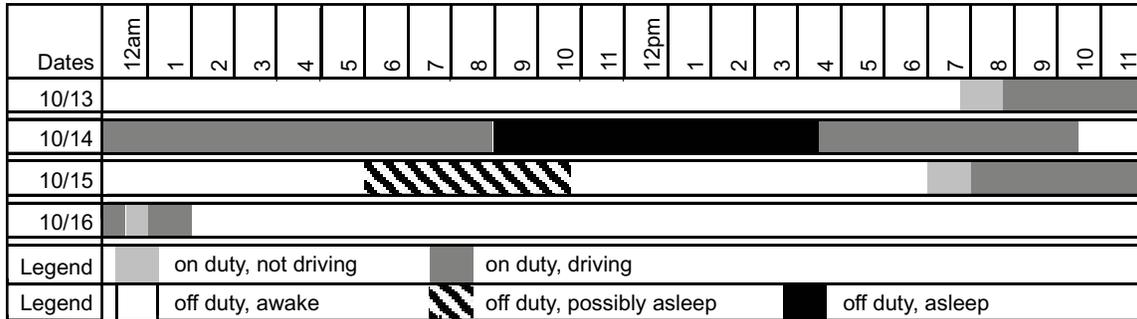
Figure 8. Truck driver’s work/rest history.

The driver stated that he drove for about an hour, stopped briefly for a soda and to use the restroom, and then drove continuously until the accident occurred. Police subsequently determined that the truck driver made a stop of 39 minutes duration in Tomah, Wisconsin, about 12:30 a.m. Figure 8 shows the reconstruction of the truck driver’s work/rest history.

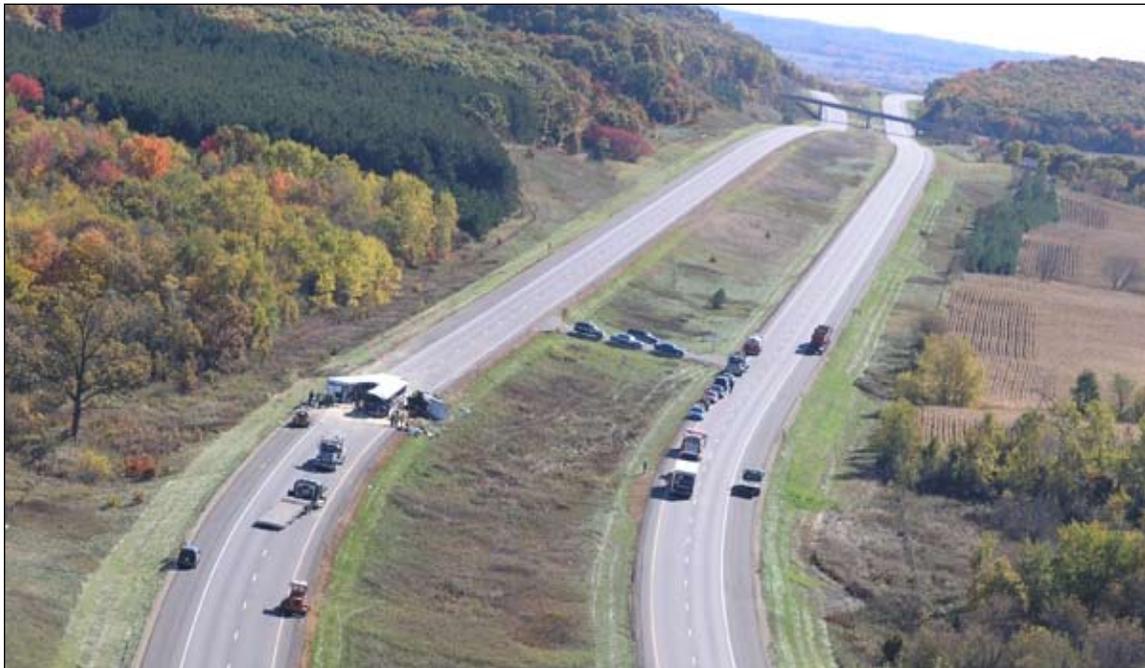
Figure 10. Accident site. (Courtesy of the Minnesota State Patrol)

The posted speed limit for I-94 in the vicinity of the accident is 65 mph. On October 19, 2005, between 12:15 p.m. and 1:15 p.m., the Safety Board and WISDOT conducted a speed study on I-94 at the Ryder Road overpass near milepost 85.7. The 85th percentile speed was 73 mph for passenger cars and 68 mph for tractor-semitrailers. The grade of the westbound lanes of I-94 from the apex of the crest vertical curve to the accident site was -3.1 percent (see figure 10), and this distance was approximately 2,300 feet. The crest vertical curve consisted of a negative 3.1-percent downgrade slope and a positive 2.4-percent upgrade slope. The two grades were connected by a 1,400-foot-long crest vertical curve. The crest vertical curve on the westbound lanes of I-94 conformed to a 70-mph design speed, in accordance with AASHTO criteria.

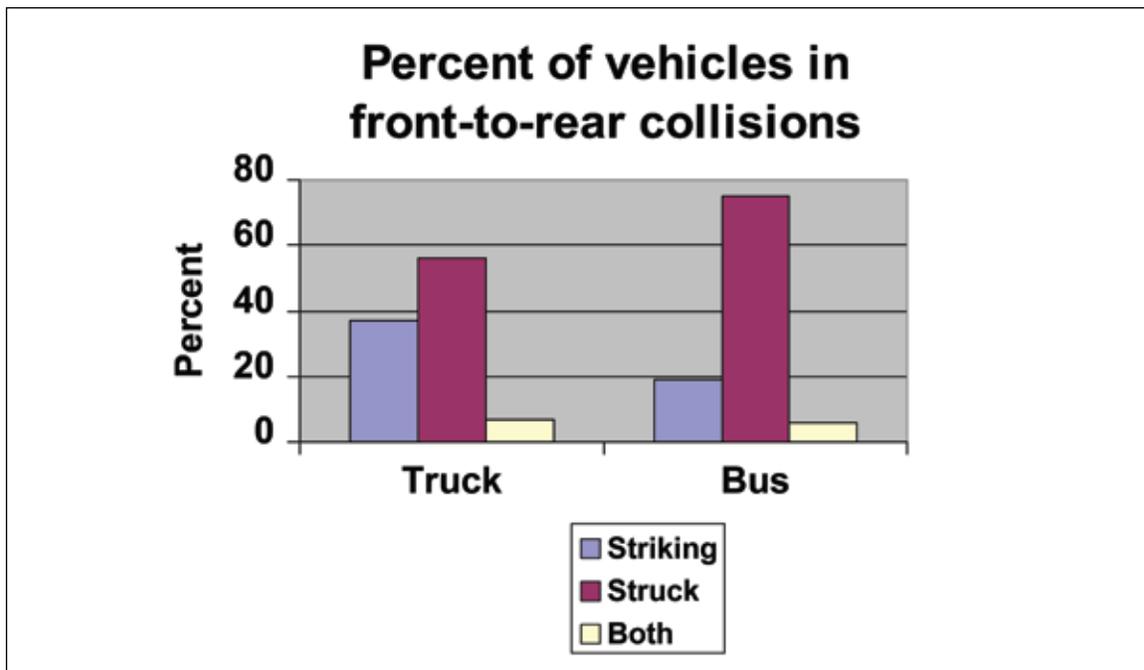
Figure 13. 2006 FARS data on front-to-rear collisions.

According to FARS data, in 2006, there were 2,339 crashes including a front-to-rear collision; the crashes involved 47 buses, 1,008 trucks, and 4,436 passenger cars and other vehicle types. Thirty-seven percent of the trucks involved in these accidents struck another vehicle, and 19 percent of the buses struck another vehicle. (See figure 13.)

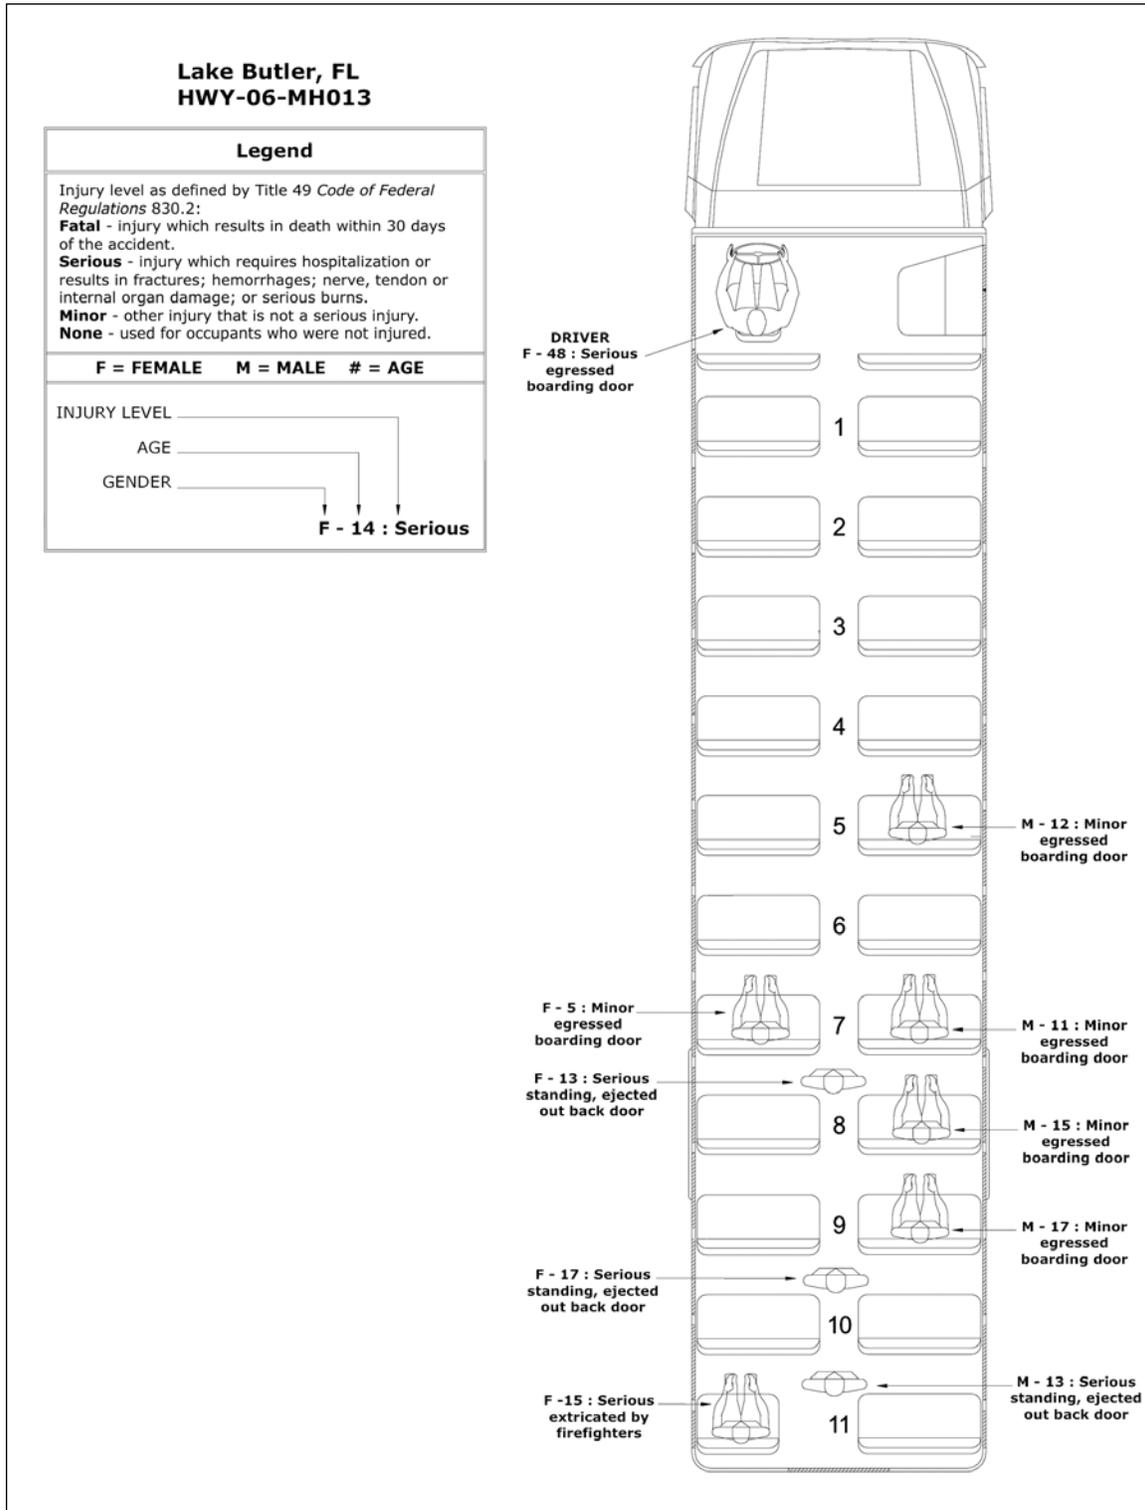
Figure 1. Seating chart, Union County school bus.

All seven occupants of the Pontiac were killed. Three of the nine students on the school bus were ejected from the rear of the vehicle and landed on highway pavement, seriously injured. One other student sustained serious injuries and was extricated from the bus by firefighters. The school bus driver, who was wearing a lap shoulder belt, also sustained serious injuries. Five students and the truck driver received minor injuries. The students who had been discharged from the bus just before the accident were not injured. Figure 1 shows the seating chart for the school bus, and table 1 provides injury information.

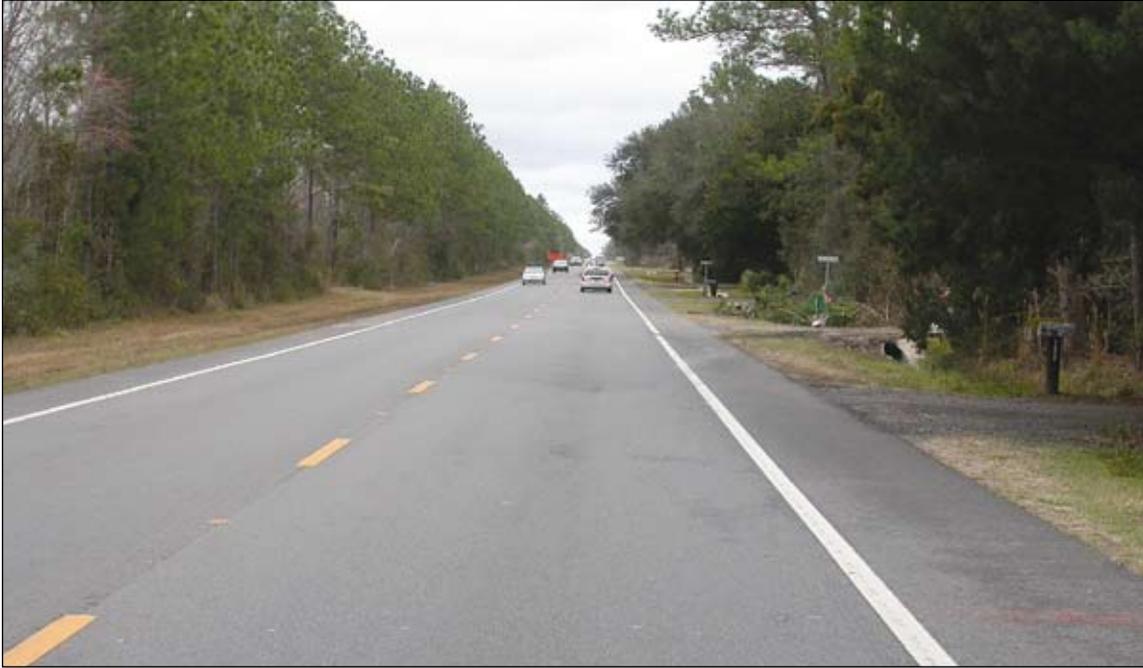
Figure 2. SR 121 approaching accident location.

At the accident location, SR 121 is a two-lane undivided asphalt roadway running north-south. The paved area consists of two 12-foot-wide main travel lanes, marked by solid 6-inch white lines, with a 5-foot-wide shoulder on either side. The paved shoulders border 3-foot-wide grass areas. A 6-inch yellow dashed centerline separates the northbound and southbound lanes. The speed limit was 60 mph, and speed limit signs were located 2.7 miles prior to the accident scene.² Figure 2 presents a view of SR 121 northbound, 375 feet prior to the accident location.

The 2003 *Manual on Uniform Traffic Control Devices* (MUTCD) recommends that *School Bus Stop Ahead* signs be installed in advance of school bus stops where the bus is not visible to road users for a distance of 500 feet.³ FDOT provides similar guidance.⁴ No school bus signs were located in the vicinity of the accident. The Safety Board conducted a sight distance test on January 31 and February 1, 2006, assisted by the Florida Highway Patrol, which showed that the school bus was visible for a distance of 3,087 feet, far above the recommended 500-foot distance. The alternating red warning lights on the rear of the school bus were visible at 1,382 feet. A regulatory sign stating *All Traffic Both Directions STOP While School Buses Load or Unload* was located about 4 miles in advance of the accident site.

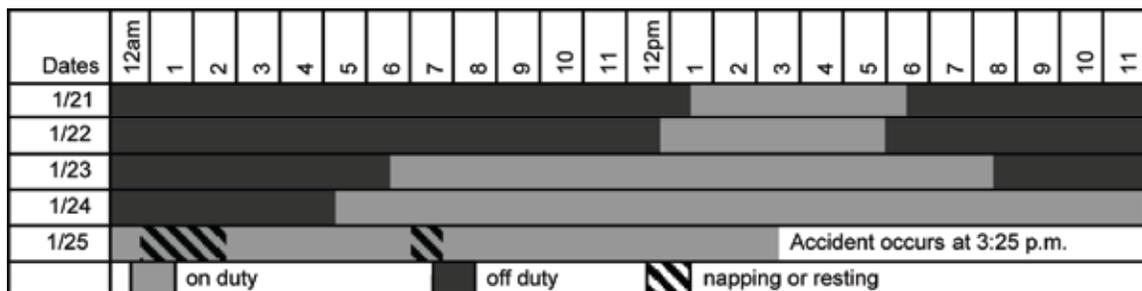
Figure 7. Duty status of Freightliner driver, January 21–25, 2006.

Data from the DDEC indicated that—in the 72 hours prior to the accident—the truck had been driven a total of 24 hours 57 minutes and had idled for 8 hours 38 minutes. The truck driver, through his lawyer, declined to be interviewed by Safety Board investigators. The following summary of his work–rest history is based on the truck driver’s statement taken on May 7, 2008.¹¹ Qualcomm¹² data supported his statement. He had been driving a regular route between Jacksonville and High Springs, Florida, for about 2 months prior to the accident. A round trip took about 5 hours—2 hours from Jacksonville to High Springs, 30–60 minutes loading or switching trailers, and 2 hours for the return trip.

On Saturday, January 21, the truck driver began driving at 1:27 p.m. and continued until 6:30 p.m. The following day, Sunday, he worked from 12:42 p.m. until 6:00 p.m. He was off duty until 6:29 a.m. on Monday, January 23, and worked until 8:23 p.m. that evening, a total of 14 hours. On Tuesday, January 24, he began driving at 5:19 a.m., making two round trips from Jacksonville to High Springs and a half trip back to High Springs shortly after midnight on January 25. The driver said he slept in the sleeper berth for a couple of hours while the truck was being loaded in High Springs. Then he made the return trip to Jacksonville. The driver said he “rested his head across the steering wheel” for an hour or two when he returned to Jacksonville. He made another trip to High Springs on the morning of January 25 and was on his way back to Jacksonville when the accident occurred, at 3:25 p.m. (See figure 7.)

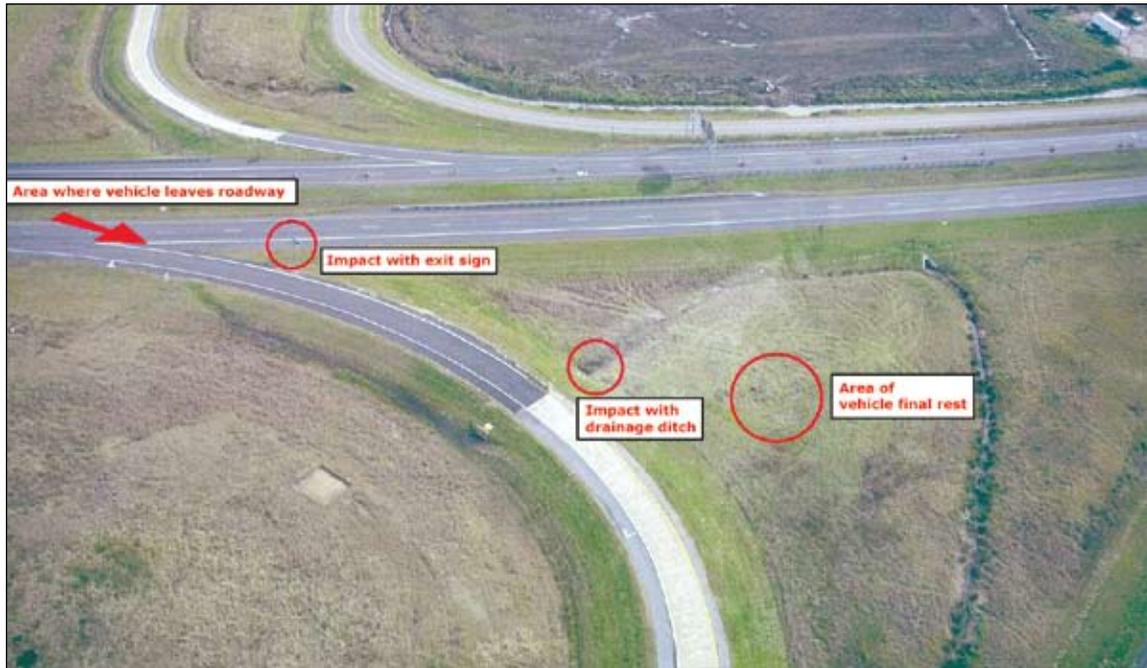
Figure 1. Path of motorcoach from I-55. (Courtesy of Arkansas Highway Police)

On October 9, 2004, about 5:02 a.m., a 1988 Motor Coach Industries, Inc. (MCI), 47-passenger motorcoach was southbound on Interstate 55 (I-55) near Turrell, Arkansas, transporting 29 passengers to a casino in Tunica, Mississippi. Witnesses following the motorcoach prior to the accident estimated that it had been traveling about 70 mph. At the exit 23A interchange, the motorcoach veered to the right and entered the grassy area between the exit ramp and the entrance ramp. (See figure 1.) As it rotated in a clockwise direction, the motorcoach struck an exit sign, overturning onto its left side and sliding in a southwesterly direction. The left side of the vehicle struck the westernmost side of a 2-foot-deep earthen drainage ditch, and the motorcoach continued to roll over. As it rolled, the roof opened up, allowing passengers to be thrown from the open top. The motorcoach landed 65 feet from the drainage ditch and came to rest upside down. Its roof was laying on the ground (top side up), still hinged to the right side of the vehicle.

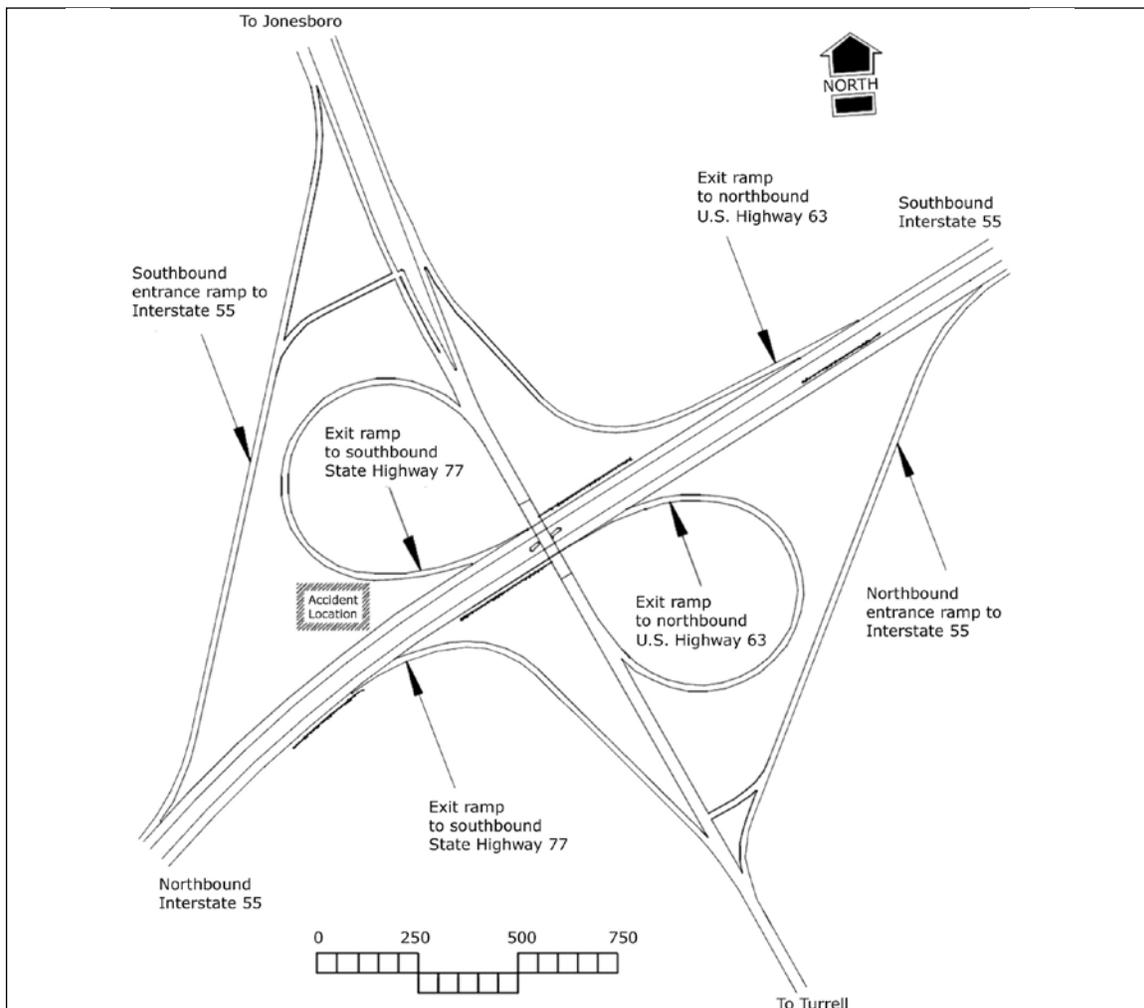
Figure 4. Layout of I-55 accident interchange.

The exit 23A interchange, the scene of the accident, is a four-leg partial cloverleaf, incorporating two looped ramps in diagonally opposite quadrants. (See figure 4.) Entrance and exit maneuvers are restricted to the right side of I-55. Southbound motorists approaching the interchange encounter a diagonal exit ramp before the crossroad's overpass. A looped exit ramp is located on the other side of the overpass, and a diagonal entrance ramp is located beyond the first two exit ramps.

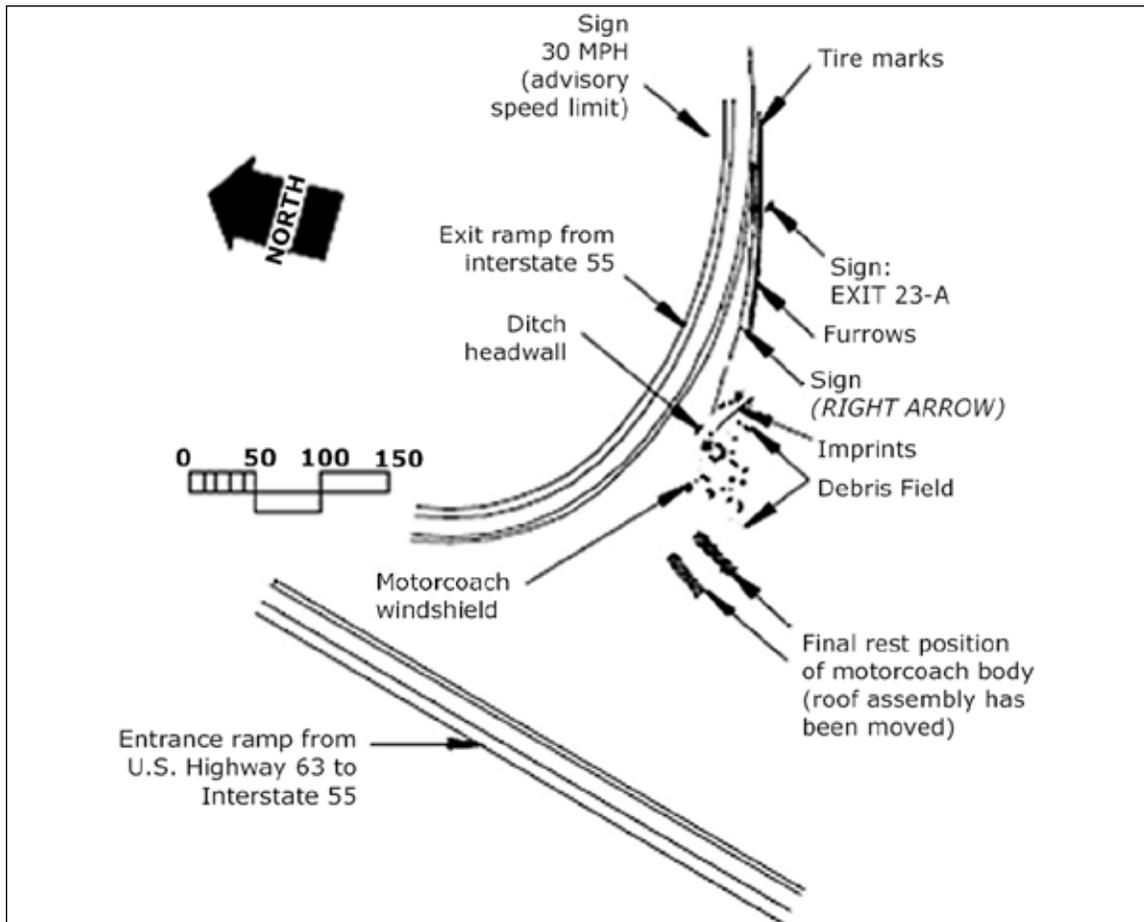
Figure 6. Accident scene diagram.

The furrow marks continued for an additional 97 feet until they went across a pair of posts supporting a right arrow sign. The accident motorcoach had overrun the sign, bent the posts forward until they became detached, and then traversed a drainage ditch, leaving a 6- by 8-foot scar. A debris field extended across both sides of the drainage ditch. The motorcoach came to rest about 65 feet south of the ditch. (See figure 6.)
