Collision Between Freight Train and Charter Motorcoach at
High-Profile Highway–Railroad Grade Crossing
Biloxi, Mississippi
March 7, 2017

Accident Report

NTSB/HAR-18/01
PB2018-101328

National
Transportation
Safety Board

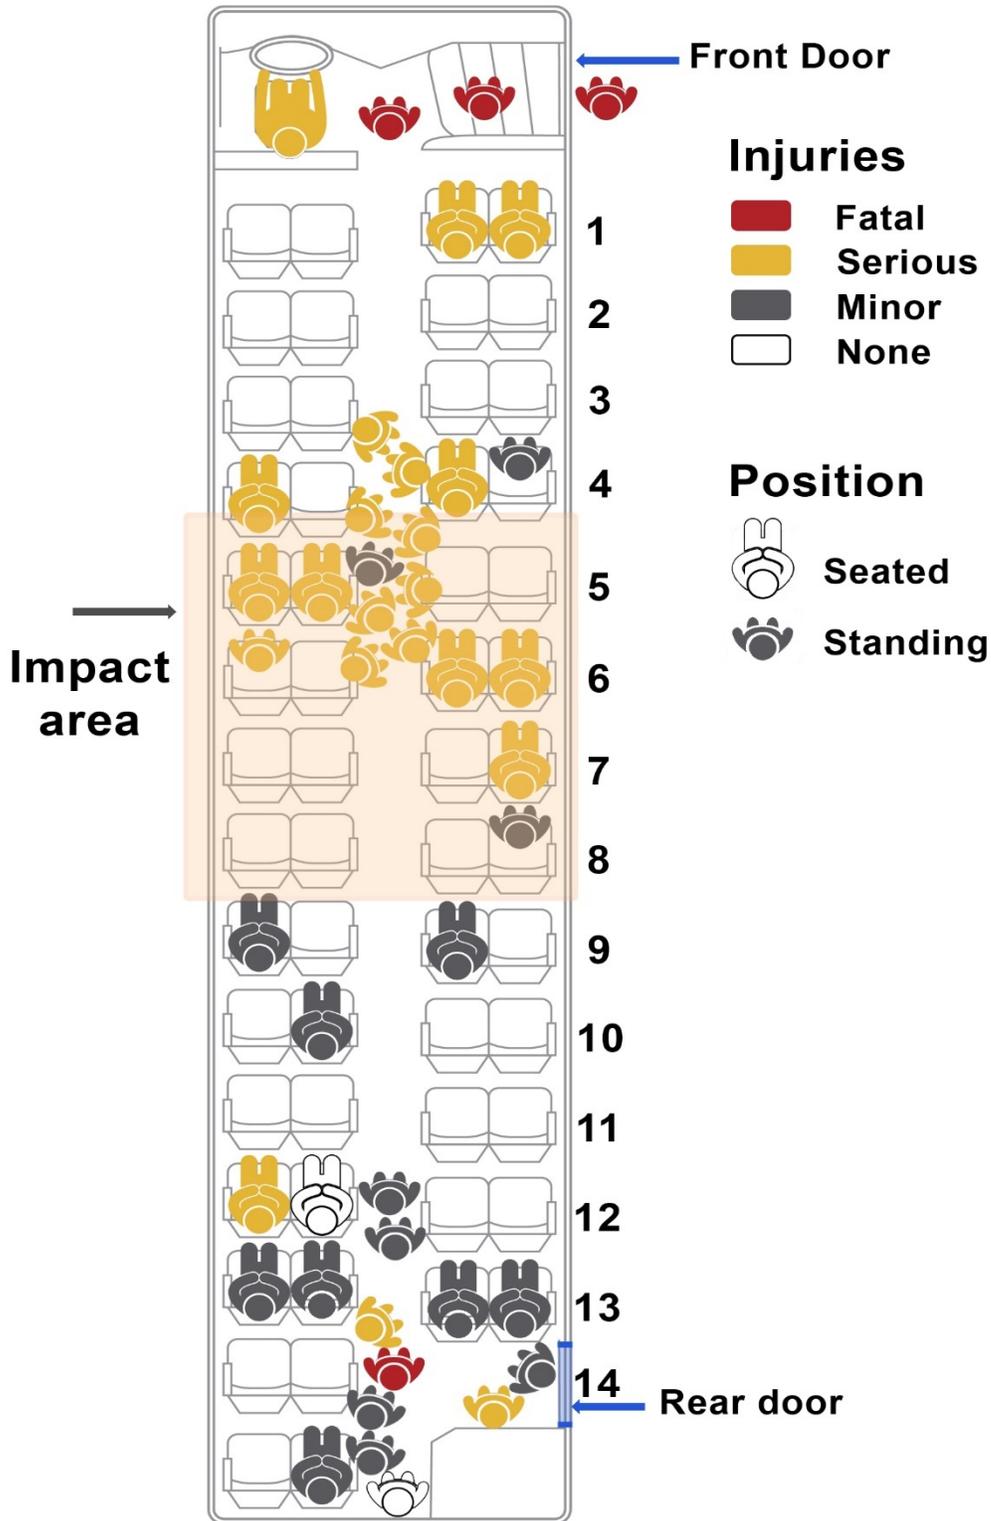
Based on interviews with the surviving passengers and video from the interior-facing onboard camera, at the time of impact, 42 passengers were on the motorcoach; 23 were standing and 19 were seated. One passenger had stepped off the motorcoach just before the train struck it. As indicated in figure 3, the distribution of nonfatal injuries was similar among the seated and standing passengers, but their location within the motorcoach had a much greater effect on the extent of their injuries. The distribution of injury severity shows that most of the passengers—18 of 21—who sustained serious injuries were located in the front half of the motorcoach (row 7 and forward). Of the 20 passengers who were in the rear half of the motorcoach, 1 died, 3 received serious injuries, 14 received minor injuries, and 2 were uninjured.

Figure 3. Motorcoach seating chart, showing the injury classifications and positions of the motorcoach driver and 43 passengers who were on or just outside the vehicle at the time of impact.

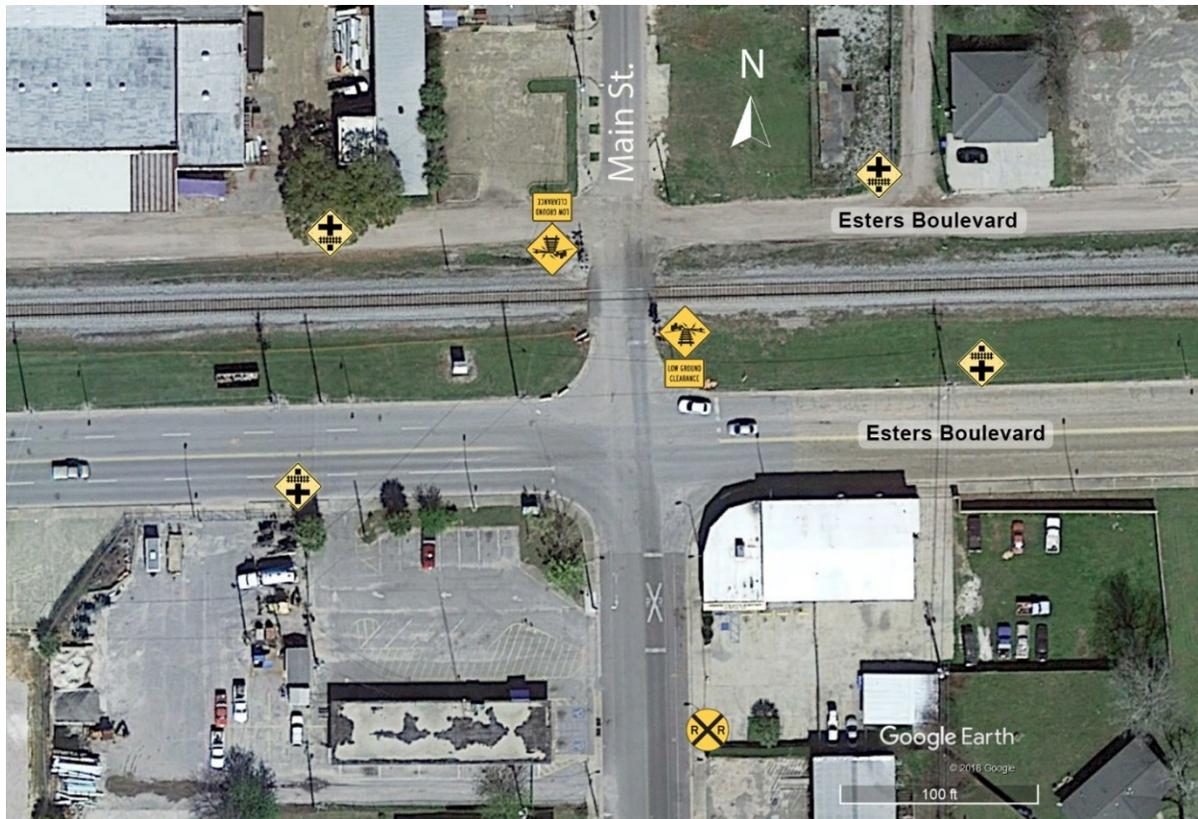
1.5.3.1 Pavement Markings. The northbound approach to the Main Street grade crossing is marked with a grade crossing pavement symbol, about 155 feet south of the railroad tracks (see figure 7). The southbound approach (north of the tracks) is not marked with a grade crossing pavement symbol. Both the northbound and southbound approaches to the crossing have worn, but visible, 2-foot-wide white stop lines. The line is located about 22.5 and 23 feet, respectively, from the nearest rail track on the northbound and southbound approaches.

Figure 7. Diagram of Main Street, grade crossing, and Esters Boulevard north and south of the crossing.

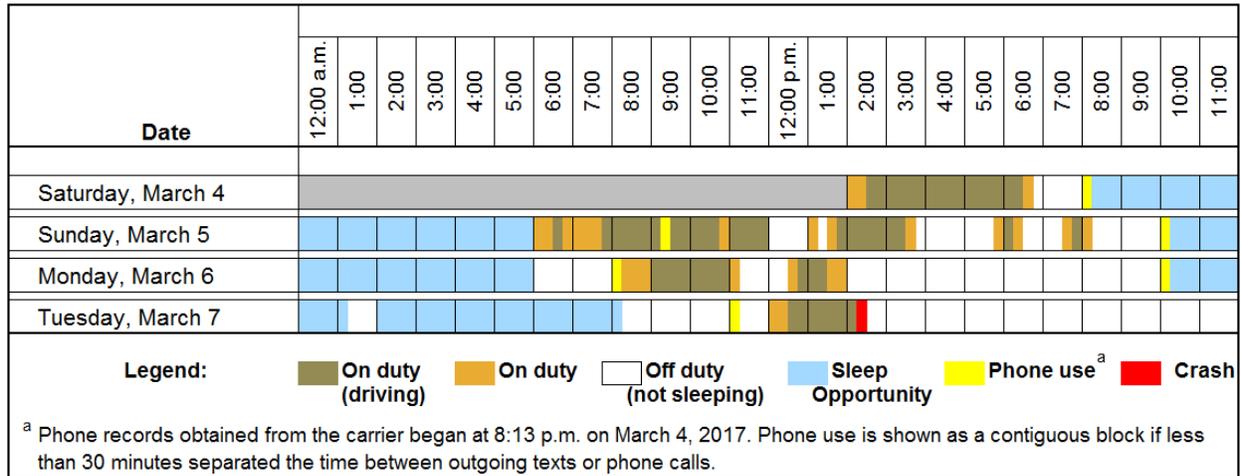
trip to Boomtown Casino in Biloxi. When the crash occurred, the driver had been on duty and driving for less than 2 hours. Figure 11 shows the driver’s activities for the 3 days before the crash.

Figure 11. Activities of the motorcoach driver, March 4–7, 2017. (Driver’s activity on March 4 before 2:00 p.m. is unknown.)

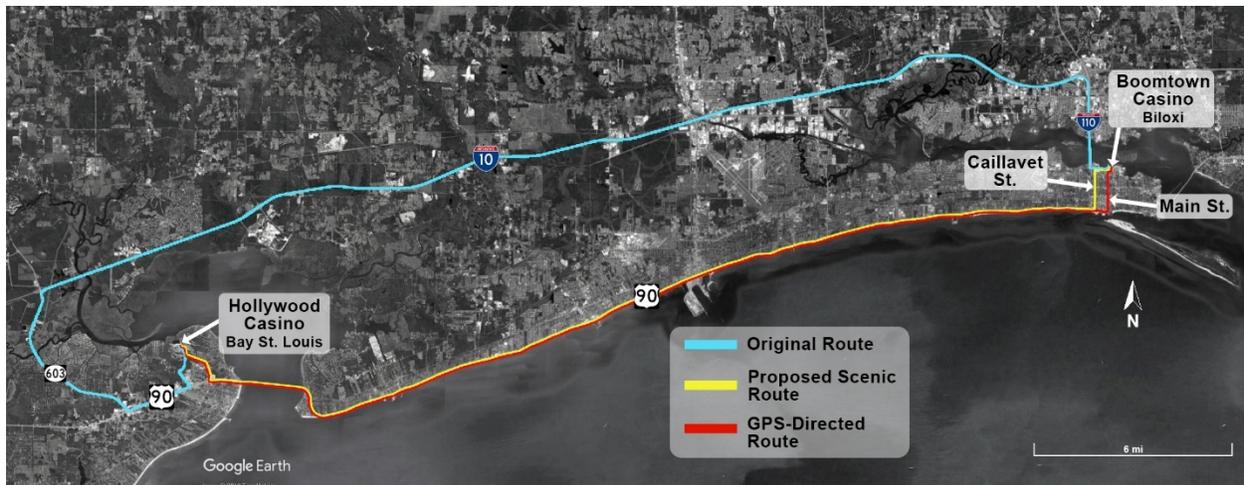
Soon after the ECHO Transportation motorcoach left Bay St. Louis, its group leader asked the driver if they could take a scenic route along US-90 to travel to the Boomtown Casino. In response, the driver began driving toward US-90. At that time, his GPS device recalculated its navigational instructions, which now directed the driver to Main Street in Biloxi and across the grade crossing. This GPS-provided scenic route, which the crash driver followed, was different both from the route included in the original Diamond Tours itinerary and from the optional scenic route with specific directions suggested by the Diamond Tours manager in her text message sent on the morning of the crash. (See figure 12 for a map showing the three routes from Bay St. Louis to Biloxi discussed above.)

Figure 12. Three alternative routes proposed for the motorcoach to travel from Hollywood Casino in Bay St. Louis to Boomtown Casino in Biloxi. The route in blue is the original planned route from the Diamond Tours itinerary; the route in yellow is the optional scenic route proposed by the Diamond Tours manager on the morning of the crash trip; and the route in red is the one indicated by the motorcoach driver's personal GPS device. The route in red is the crash route.
