Highway Accident Report: Multiple-Vehicle
Collisions and Fire in Fog, Interstate 15, Near
San Bernardino, California, November 10, 1980

(U.S.) National Transportation Safety Board
Washington, DC

10 Jun 81

1. Report No. NTSB-HAR-81-2		2. Government Accession No. PB81-218869		3. Recipient's Catalog No.	
4. Title and Subtitle Highway Accident Report-- Multiple-Vehicle Collisions and Fire, Interstate 15, Near San Bernardino, California, November 10, 1980				5. Report Date June 10, 1981

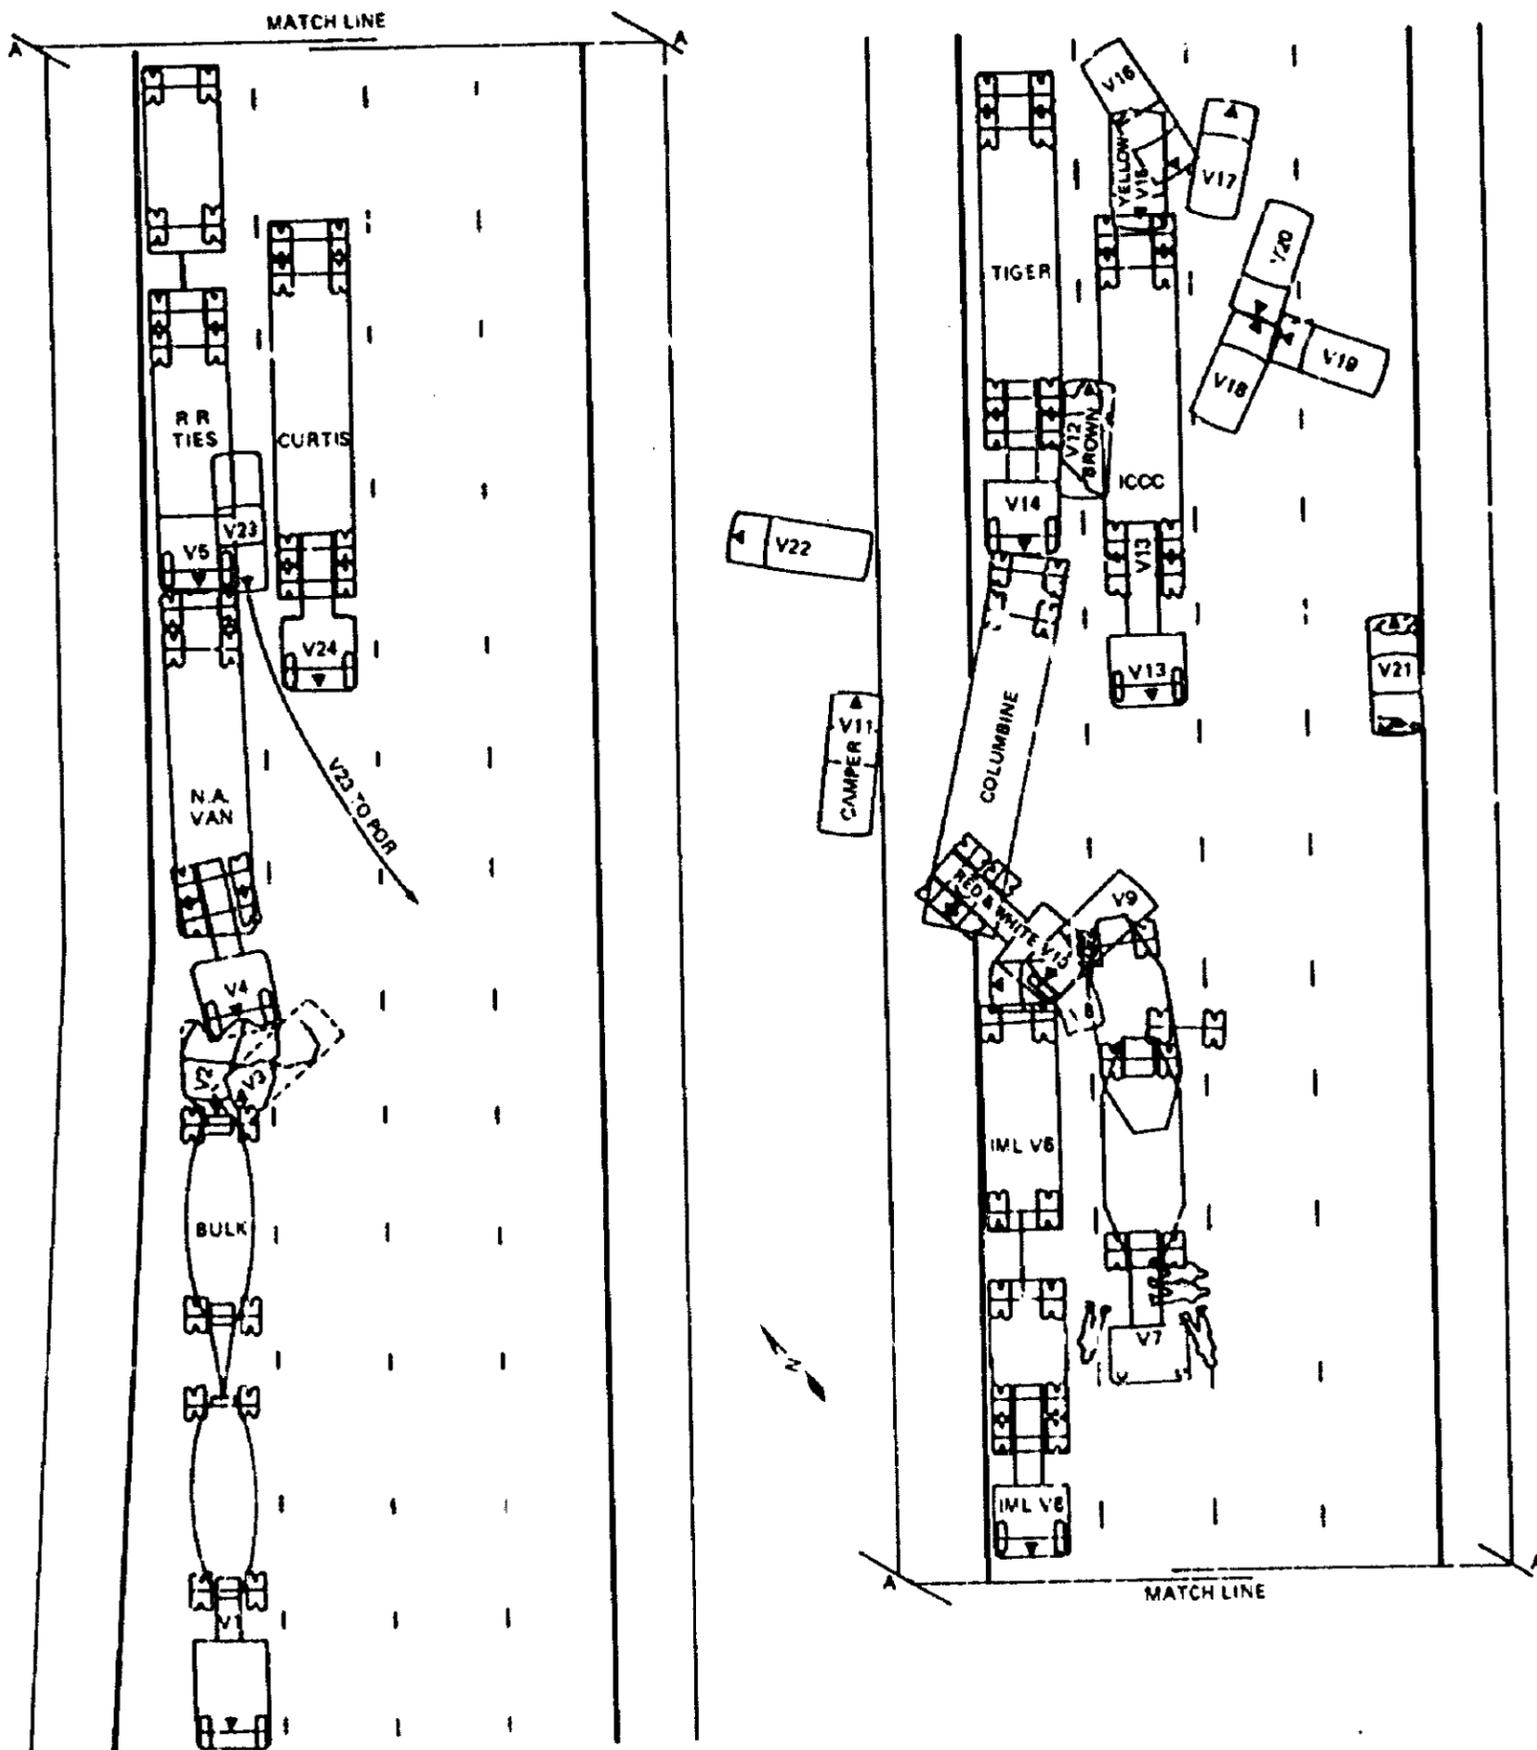
Figure 1.--Plan view of accident site showing sequence of collisions.

Later, during subsequent collisions (see appendix B for a chronology of vehicle collisions and more detailed information), a 1978 Ford Pinto (Vehicle 8) struck and underrode the rear of a tractor-semitrailer combination (Vehicle 6). It is presumed that the driver of Vehicle 8 died in this collision. Minutes later, Vehicle 8 was struck from the rear by a tractor-semitrailer combination (Vehicle 10), a 1979 Ford Fiesta (Vehicle 9), and another tractor-semitrailer combination (Vehicle 7). A 1976 Ford Pinto (Vehicle 12) struck a 1975 Honda sedan (Vehicle 15) and was then struck by Vehicle 9 as it glanced off of Vehicle 8. A passenger in Vehicle 12 was killed. Either before or after being struck by Vehicle 12, Vehicle 15 struck and underrode the rear of a tractor-semitrailer combination (Vehicle 13). The driver of Vehicle 15 died in this collision. Later, Vehicle 15 was struck by a 1980 Chevrolet pickup truck (Vehicle 16). Within the following 5 to 10 minutes, at least 13 more vehicles entered the limited visibility fog area and struck stopped vehicles; many were in turn struck by following vehicles. (See figure 1.)

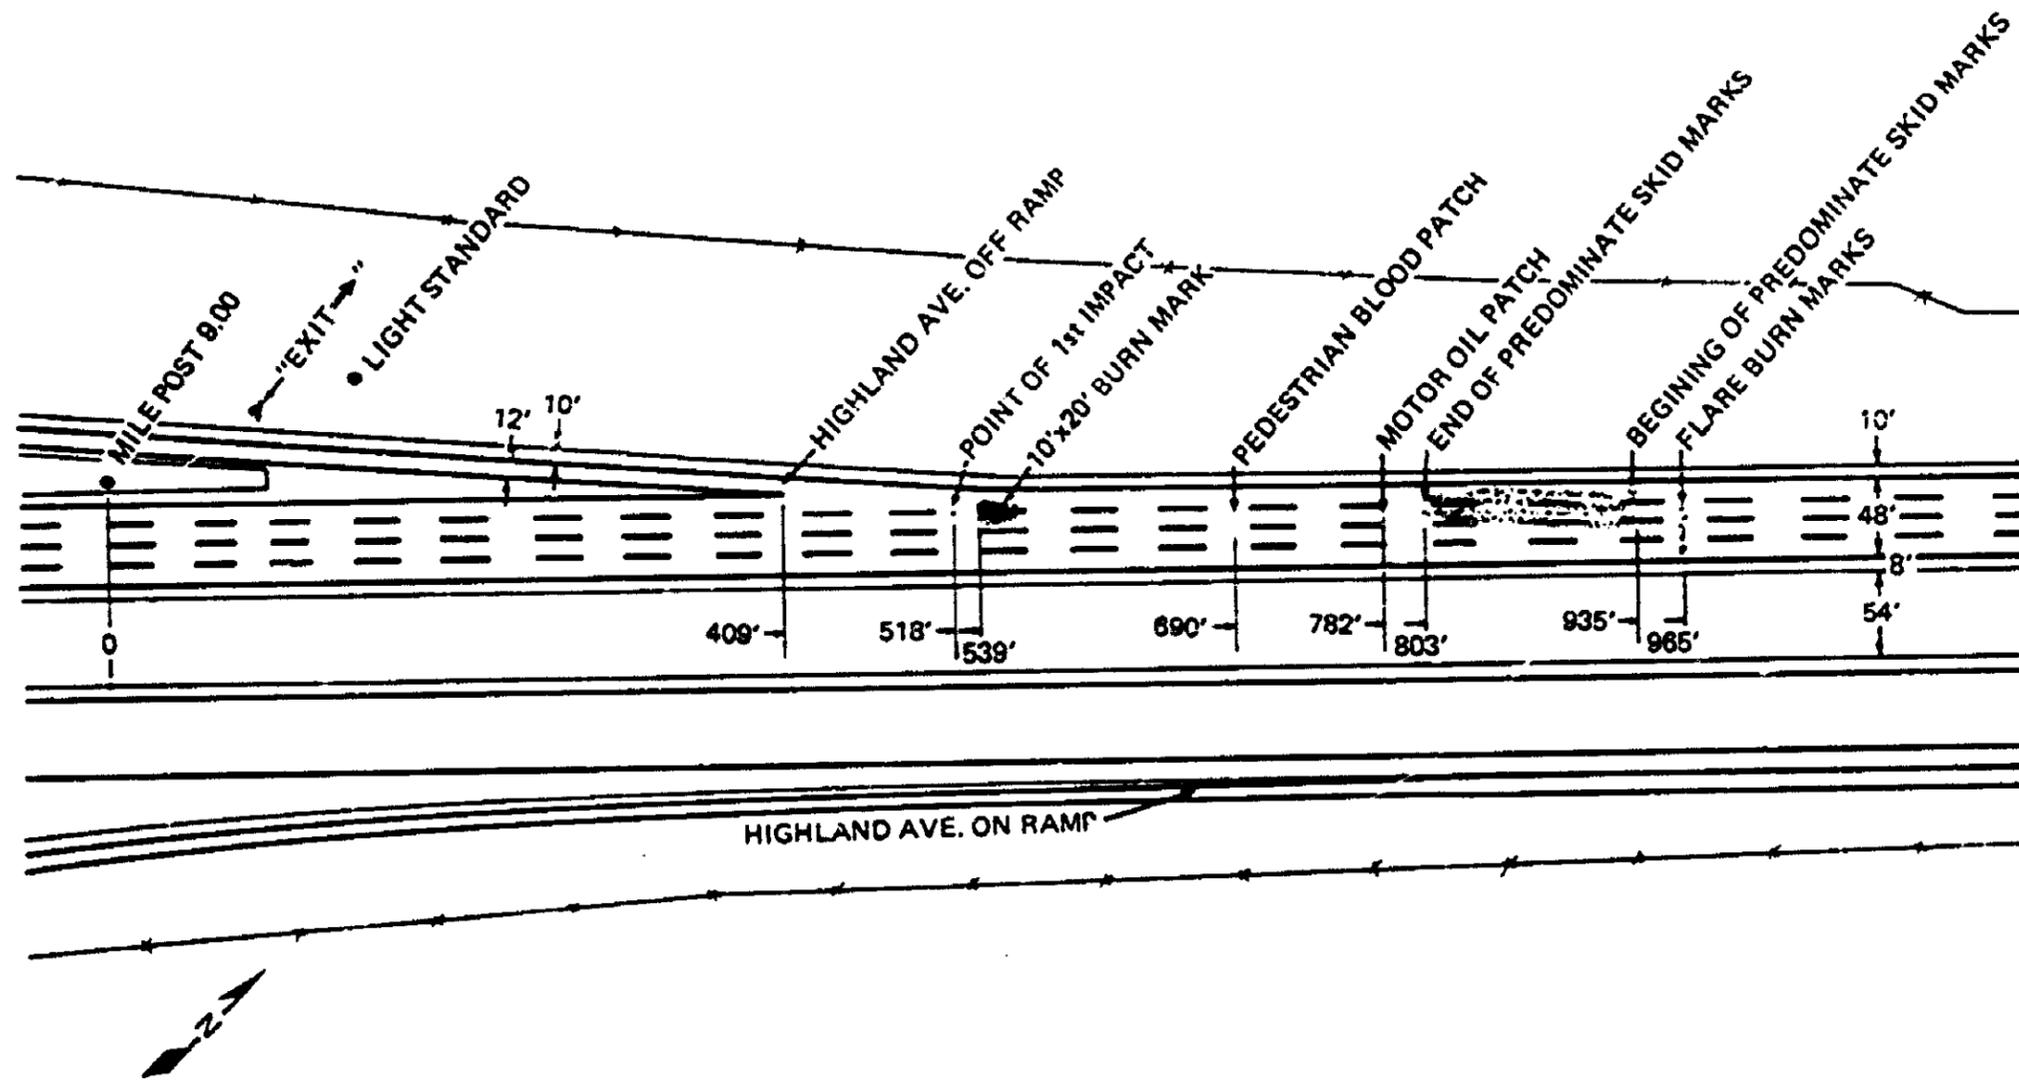
Figure 7.—Plan view of accident site.

The offramp to the Highland Avenue gore point marking was 409 feet north of milepost marker 9.00. A 10-foot by 20-foot burn area where the fire involving Vehicles 1, 2, 3, and 4 was centered was 539 feet north of the marker. At 690 feet, bloodstains remained on the roadway where Vehicle 7 ran over four persons. A large number of predominant skidmarks were visible, primarily in lanes Nos. 3 and 4, beginning at 803 feet and ending at approximately 935 feet. (See figure 7.)
