NATIONAL TRANSPORTATION SAFETY BOARD

HIGHWAY ACCIDENT REPORT

DIRECT TRANSIT LINES INC.,
TRACTOR-SEMITRAILER/MULTIPLE-VEHICLE
COLLISION AND FIRE,
U.S. ROUTE 40,
FROSTBURG, MARYLAND
FEBRUARY 18, 1981

NTSB-HAR-81-3

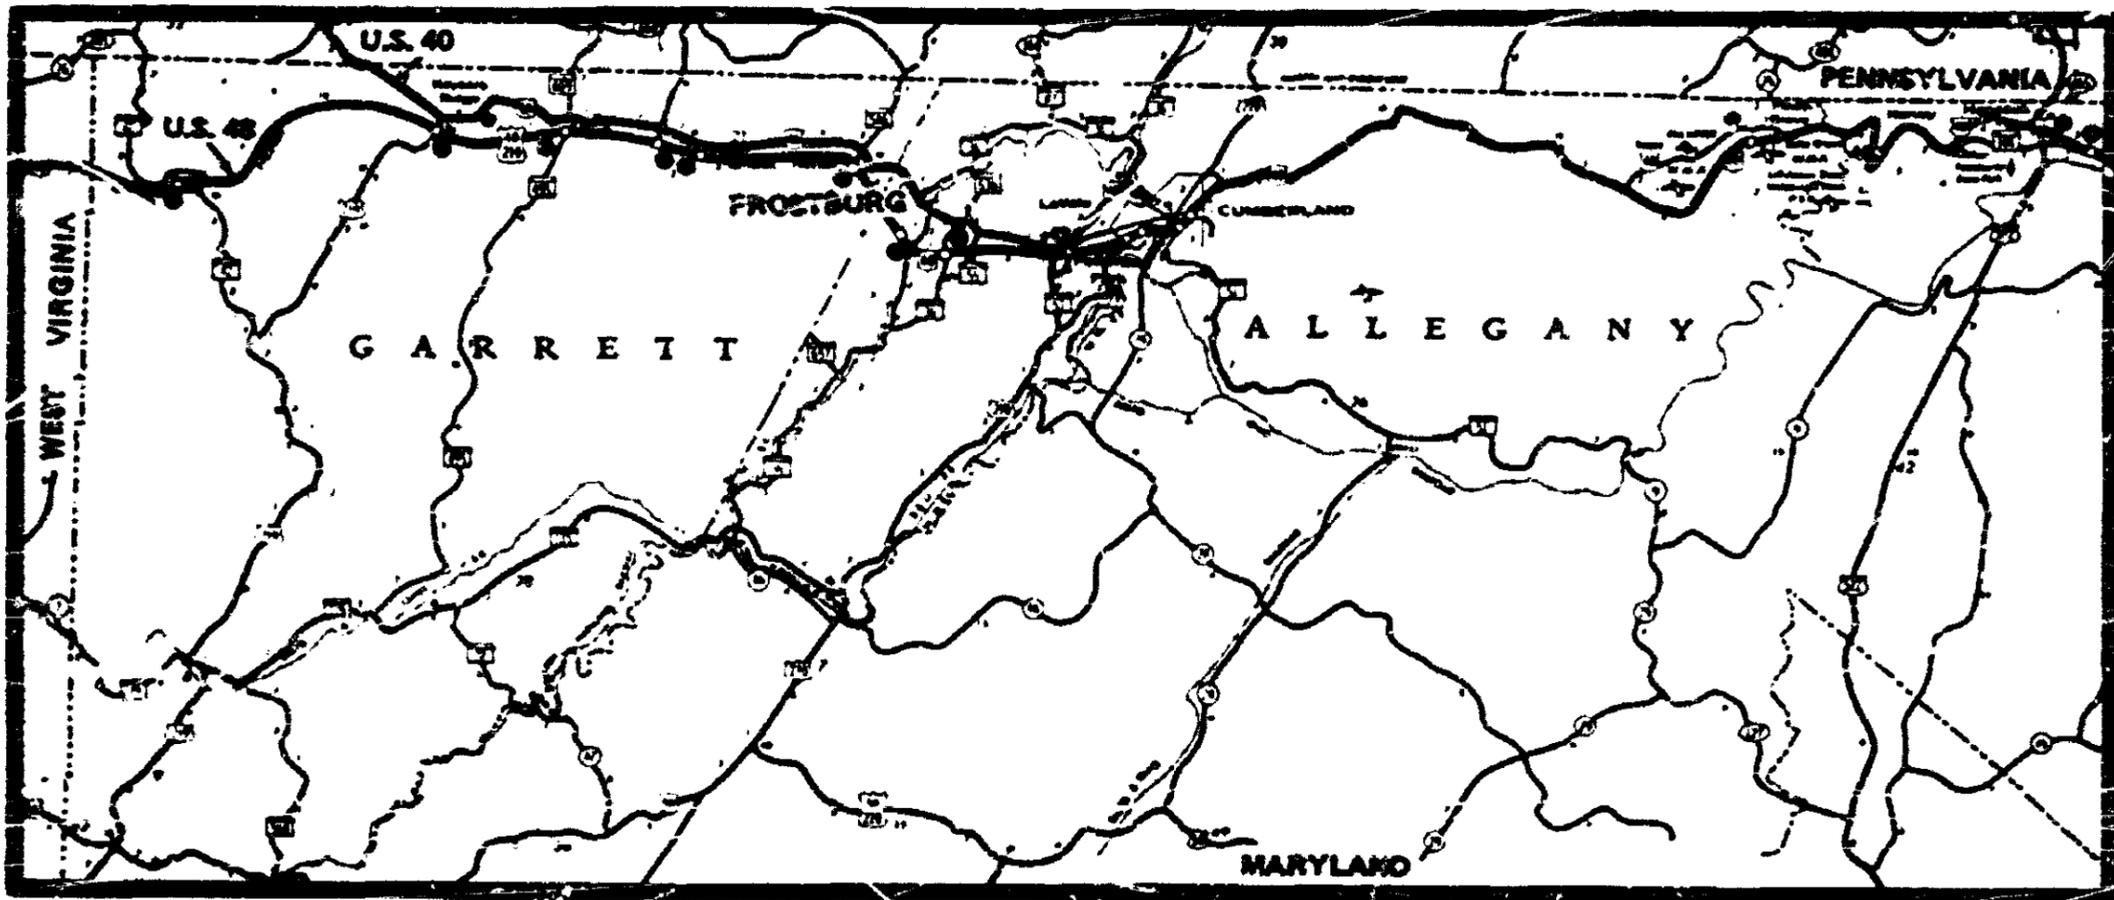
U. S. Route 48 runs parallel to U. S. Route 40 from Keyzers Ridge to Cumberland, Maryland, and bypasses Frostburg. U. S. Route 48 is a four-lane, divided, limited-access highway which is functionally classified as "rural principal arterial." The 1979 average daily traffic for U. S. Route 48 near Frostburg was 9,500 vehicles. Basically, the highway was built to interstate specifications--the maximum grade is 6.9 percent and the horizontal curves are long and gradual with maximum curvatures of 3° and minimum radii of 1,909 feet. The highway is relatively new; the last section was completed in 1976. Therefore, U. S. Route 48 appears only on recent road maps and atlases. (See figure 11.) The old atlas found in the tractor cab during postaccident inspection did not show Route 48.

Figure 11.--State map depicting U. S. Routes 40 and 48.
