## HIGHWAY ACCIDENT REPORT

EAST SIDE CHURCH OF CHRIST  
BUS SKID AND OVERTURN  
U.S. ROUTE 183,  
NEAR LULING, TEXAS  
NOVEMBER 16, 1980

NTSB HAR 81-4

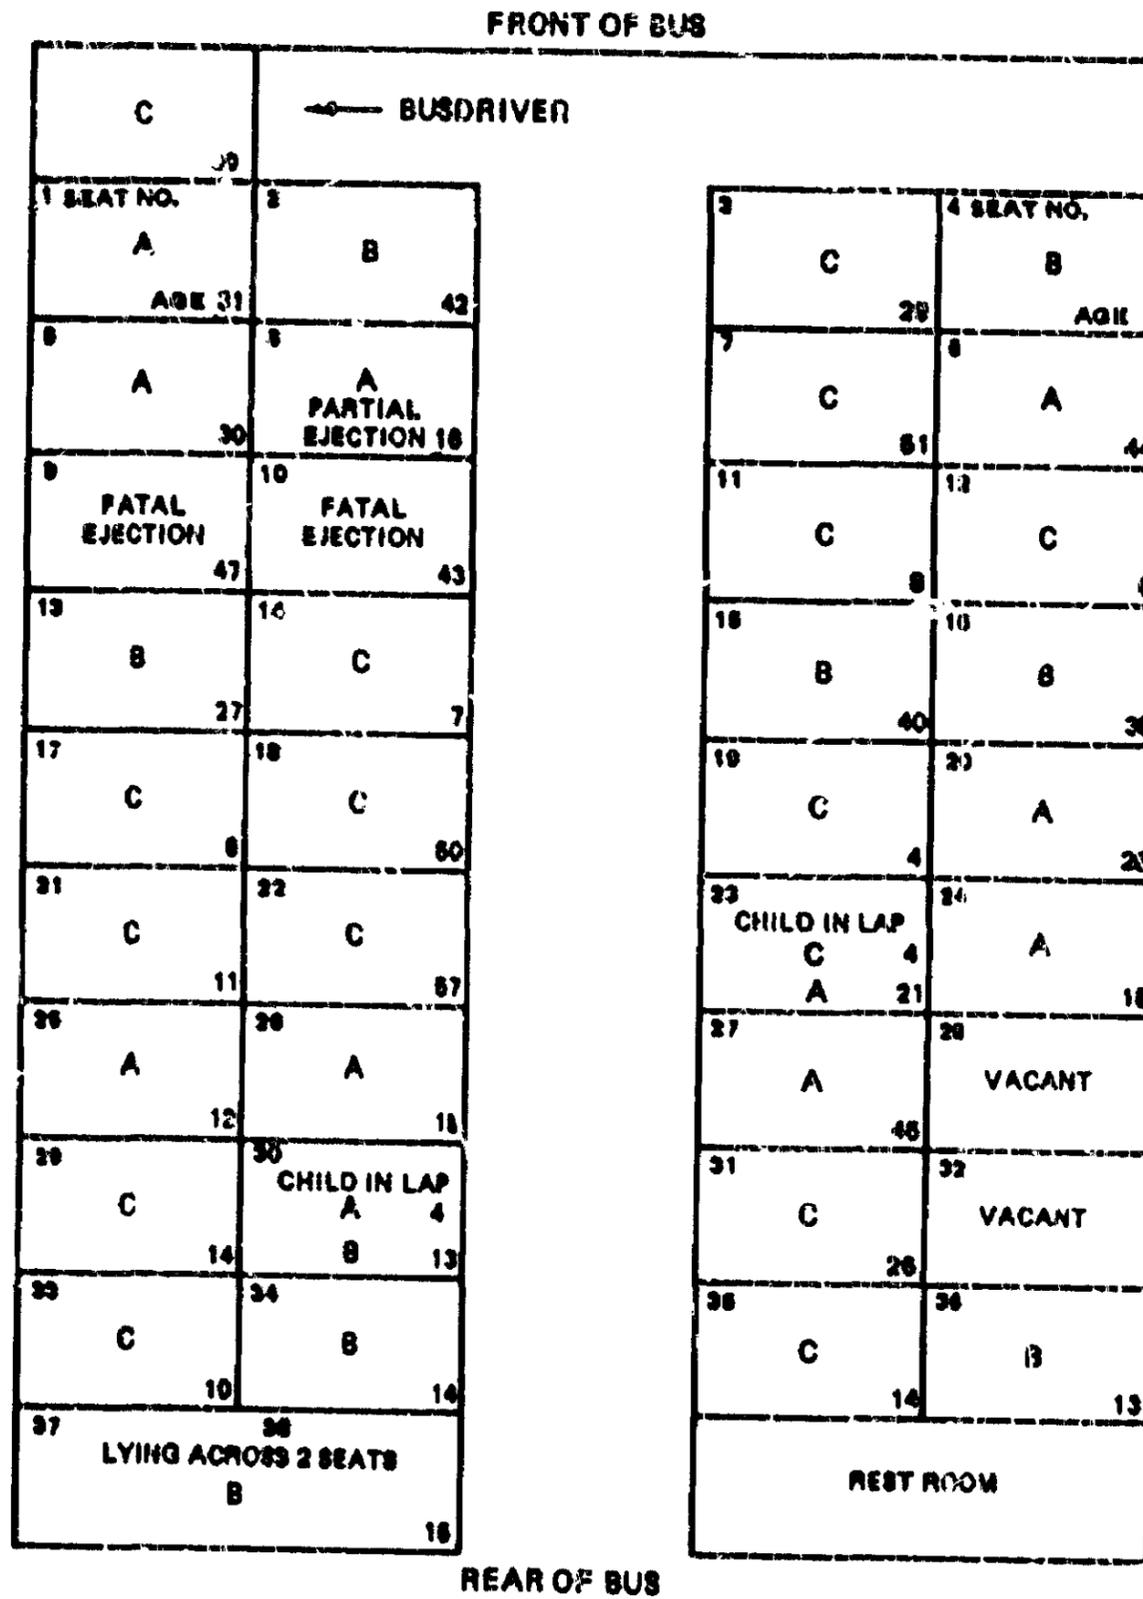
Figure 9.--Bus seating chart with occupant age and injury level.

No autopsies were performed on the two occupants who were killed; autopsies were neither required nor requested. The investigating officer reported that the passenger in the window seat had a severely crushed chest, and the passenger in the aisle seat had severe injuries to the head and neck. Figure 9 contains the seating position, police-reported level of injury, and age of the bus occupants.

A Level Injury    --    Incapacitating Injury  
 B Level Injury    --    Nonincapacitating Injury  
 C Level Injury    --    Possible Injury
