**CONTINENTAL TRAILWAYS, INC.  
SCHEDULED INTERCITY BUS/  
MULTIPLE-VEHICLE COLLISION AND FIRE  
INTERSTATE ROUTE 95  
NEAR BELTSVILLE, MARYLAND  
APRIL 20, 1981**

NTSB-HAR-81-5

**CONTINENTAL TRAILWAYS, INC., SCHEDULED INTERCITY BUS/  
MULTIPLE-VEHICLE COLLISION AND FIRE,  
INTERSTATE ROUTE 95, NEAR BELTSVILLE, MARYLAND  
APRIL 20, 1981**

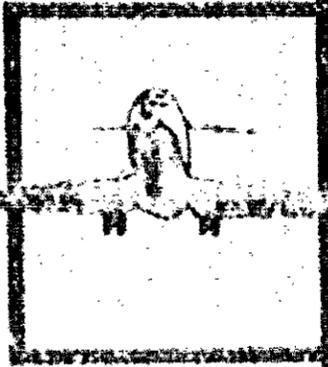
When the vehicles came to rest, the right front of the bus was on the right shoulder, and the Chevette, which was occupied by three persons, was crushed against the left front of the bus and was engulfed in flames. (See figures 1 and 2.) The left front of the bus also was on fire and, after about 10 minutes, the fire spread throughout the interior of the bus. The Colt, occupied only by its driver, came to rest on its left side about 15 feet south of the burning Chevette. The Colt also was on fire. The Aspen, with four occupants, was pushed forward, struck a Mustang, and came to a stop about 285 feet south of the Colt. Its front seat was tipped rearward at impact causing the driver to temporarily lose control of the vehicle. The Aspen's gas tank was punctured and leaked fuel, but there was no fire. The Mustang, which was slightly damaged, was driven onto the right shoulder and parked by its driver, the sole occupant.

Figure 2.--Bus, Chevette, and Colt burning after impact.
