Highway Investigation Report HIR-24-05

# Rear-End Collision Between Combination Vehicle and Medium-Size Bus

Williamsburg, Virginia  
December 16, 2022

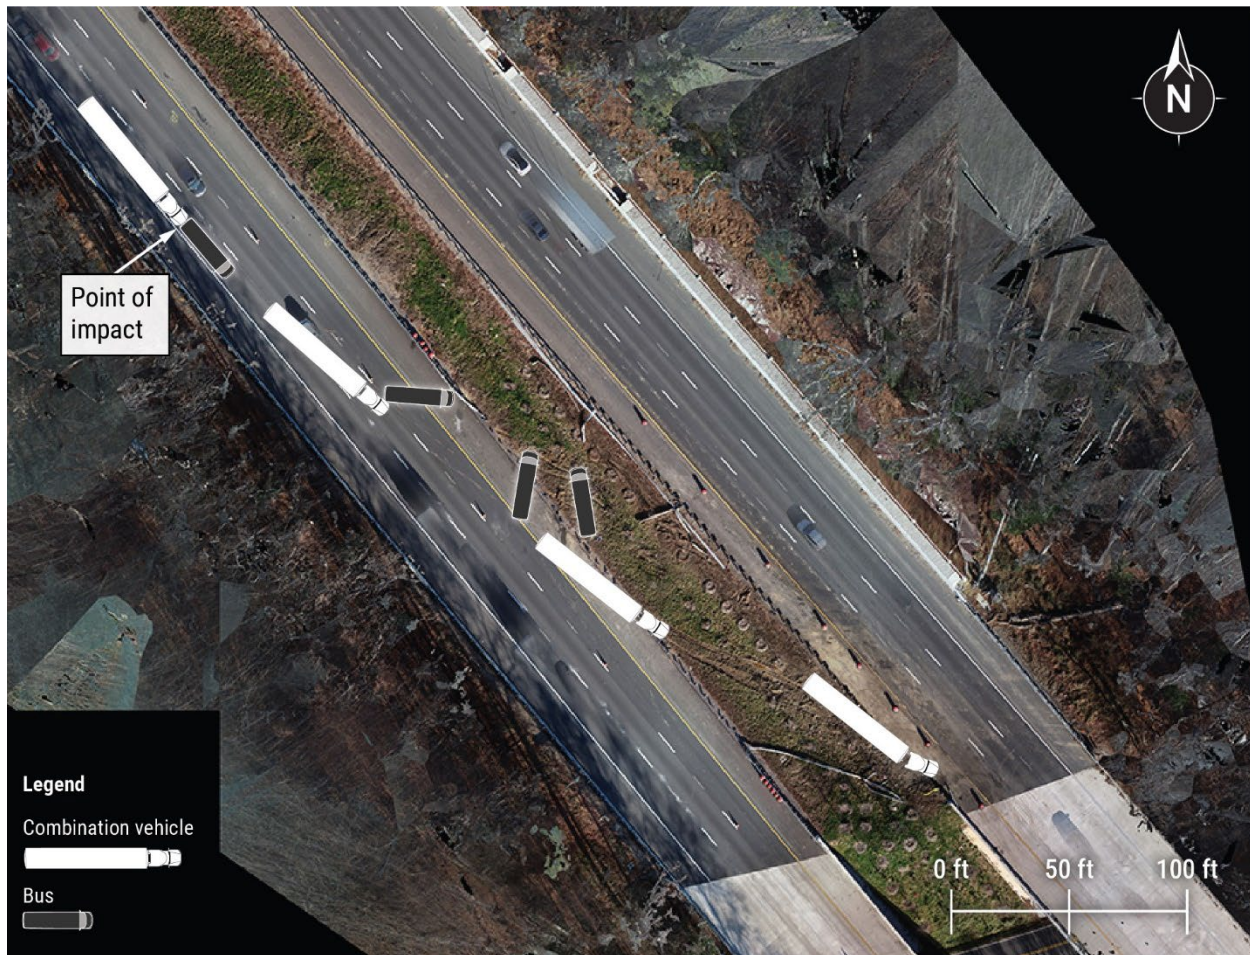
Figure 3 shows a diagram of the postimpact travel of each vehicle relative to the physical evidence.

**Figure 3.** Depiction of the postimpact paths of travel for the truck and bus relative to physical evidence as overlaid atop the scene (orthomosaic image).

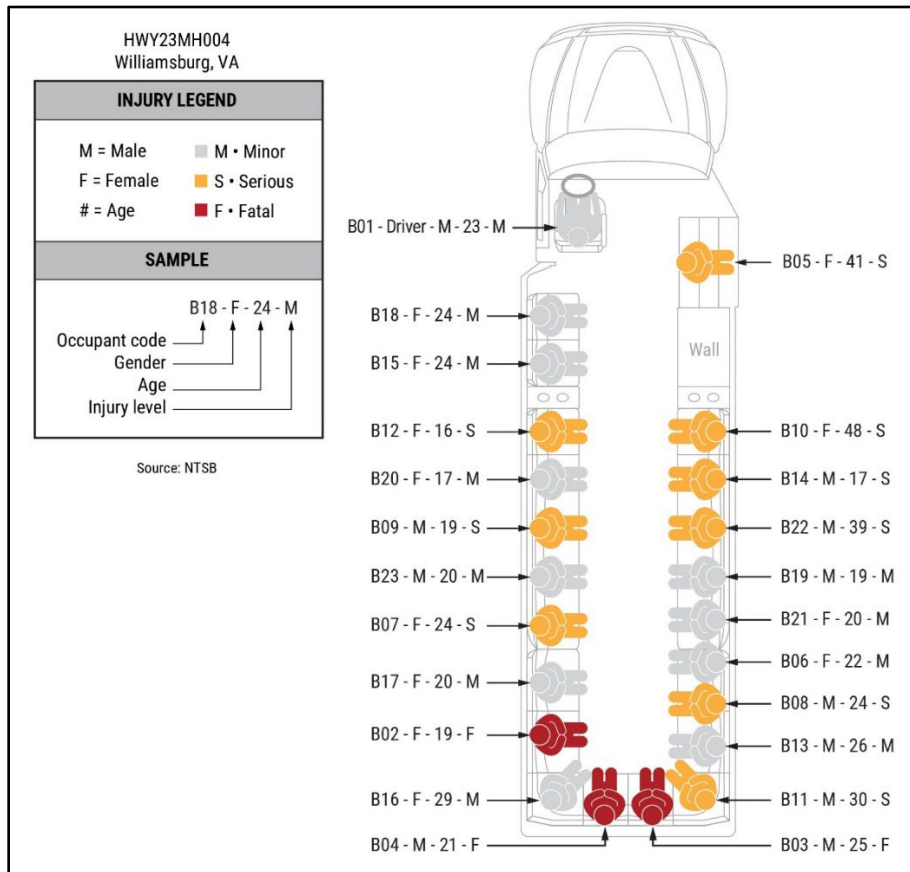
As a result of the crash, all of the bus occupants were ejected. Three of them died, 9 sustained serious injuries, and 11 sustained minor injuries. The approximate seating locations and injury severity of the bus occupants are shown in figure 4. Exact orientation and posture for each occupant was not known. The truck driver, who was the sole occupant of the combination vehicle, sustained serious injuries.

**Figure 4.** Seating locations and injury severity sustained by bus occupants.

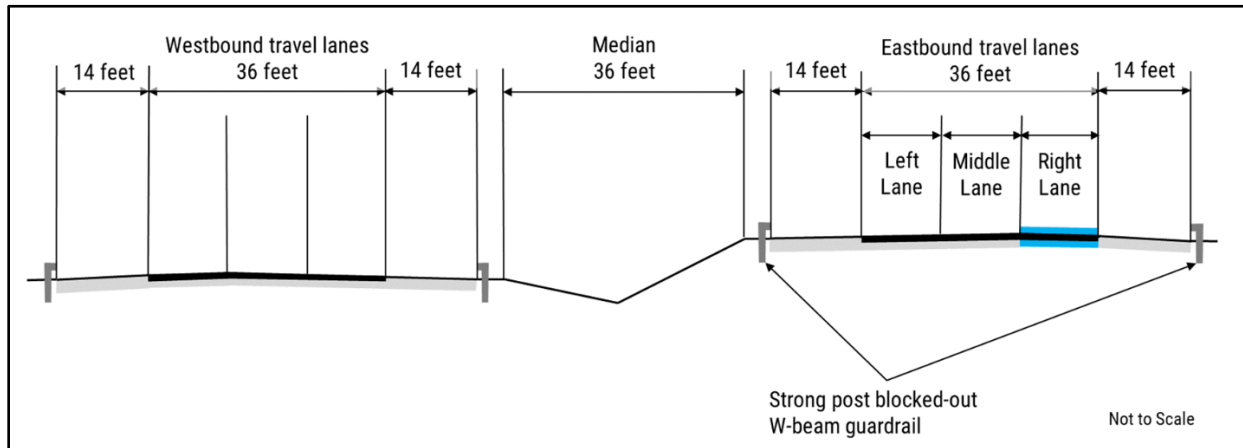
In the area of the crash, I-64 consisted of three eastbound and three westbound travel lanes. Each of the travel lanes was about 12 feet wide. The paved shoulders adjacent to the right and left travel lane were each about 14 feet wide. At mile marker 240, the eastbound roadway was straight with a 2.96% uphill grade. A 36-foot-wide median separated the eastbound travel lanes from the westbound travel lanes (figure 5). A strong-post, blocked-out, W-beam guardrail was continuous along

**Figure 5.** Cross-section of I-64 at the crash location. The collision occurred in the eastbound right lane (highlighted in blue).

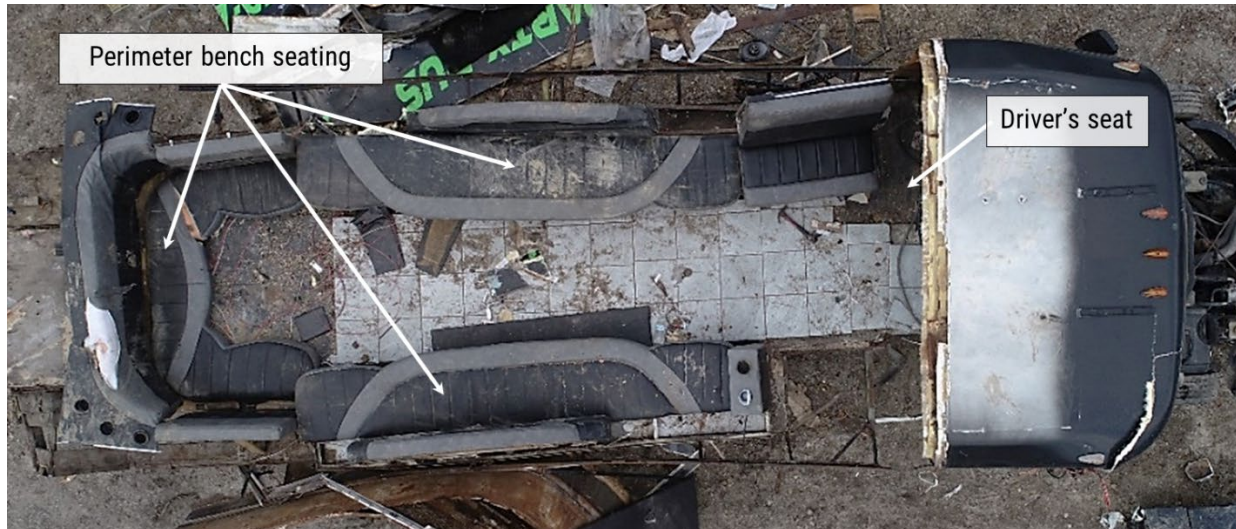
At the time of the crash, the seating configuration consisted of a driver's seat and perimeter seating without defined seating positions in the passenger compartment (see figure 10). The seating configuration observed in the bus was modified from the original vehicle design. Although the build documents were no longer available, the two floor seat tracks observed in the floorboard of the bus and the two seating rails along the sides of the vehicle are consistent with forward-facing seating and inconsistent with a perimeter-seating configuration. The original forward-facing seating arrangement was modified and the perimeter-seating arrangement was installed, though no paperwork regarding the modifications was available. Due to a lack of documentation and records from the vehicle owner, it is unknown where or when the seating modifications were made. The perimeter seating did not anchor into either floor seat track or attach to either side seat rail as designed. Instead, the seat pans were affixed to a custom frame that was welded to a metal

extension, which in turn appeared to have been welded to the inboard C-channel of the seat rail as a connection or anchor point.

**Figure 10.** Overhead view of the bus, showing the reconstructed seating arrangement.

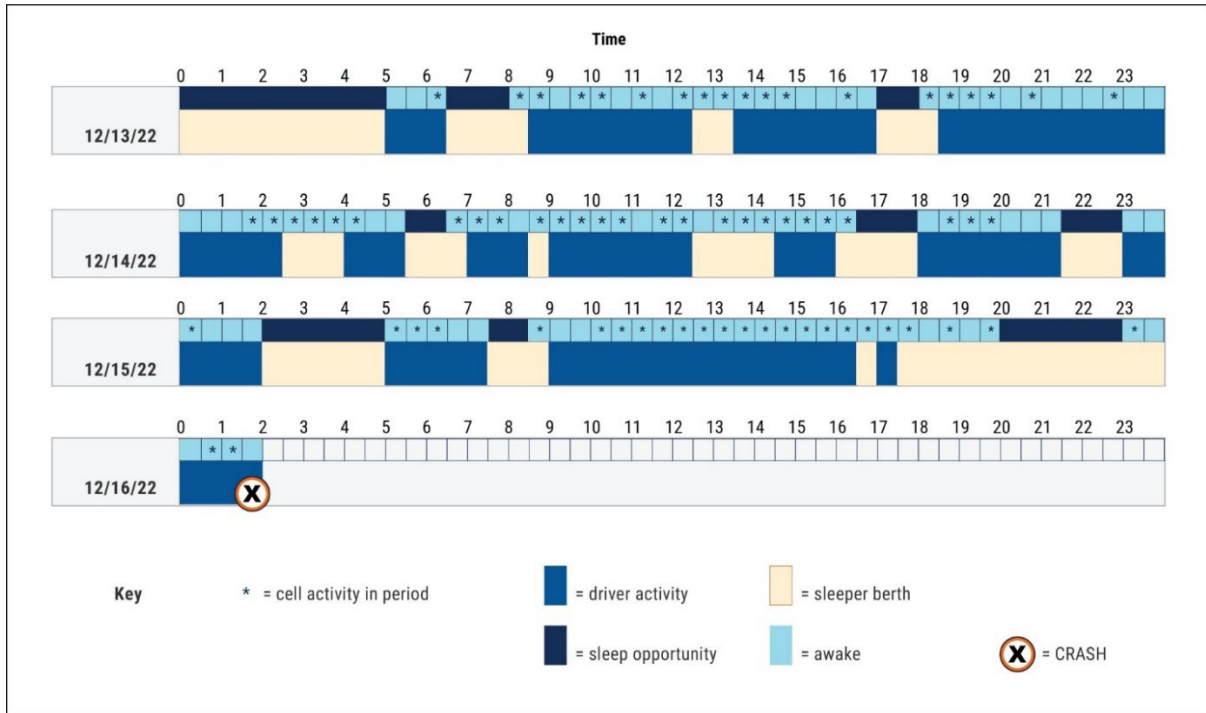
The NTSB estimated the truck driver's sleep opportunities in the 3 days before the crash (see figure 12). Sleep opportunities were determined when the driver was logged off duty or in the sleeper berth and there was no cell phone activity.<sup>21</sup> Additionally, periods of only 30 minutes were not counted as sleep opportunities. It should be noted that sleep opportunity periods are not necessarily time *used* for rest. In the 3 days before the crash, the truck driver had a total of 7.5, 4, and 7 hours available for sleep. However, the available sleep opportunities were brief and non-consecutive throughout the day, each lasting between 1 and 5 hours.

**Figure 12.** The truck driver’s sleep opportunities in the 3 days before the crash.

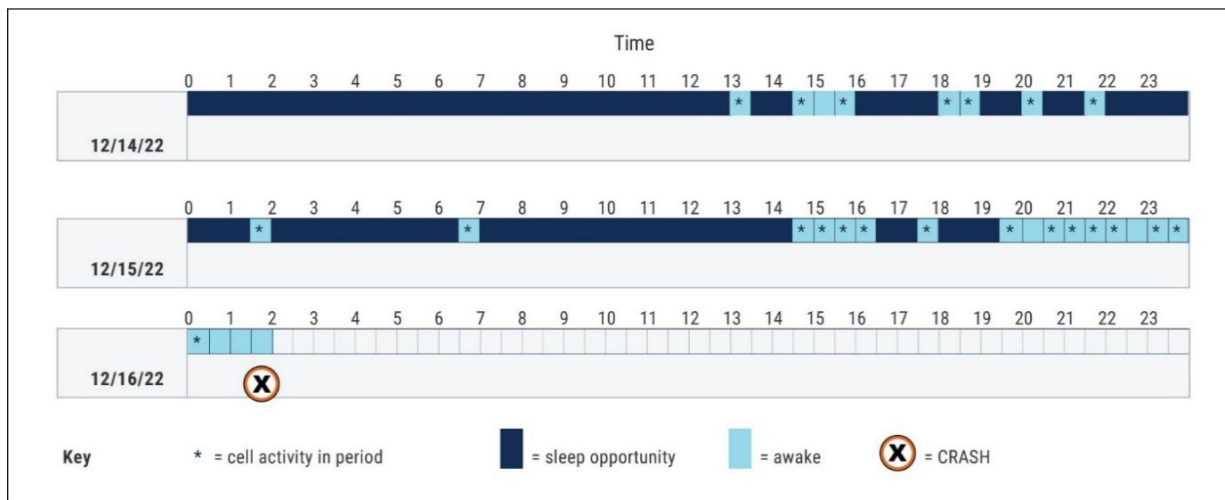
The NTSB determined the bus driver's sleep opportunities in the 2 days before the crash, using his cell phone records.<sup>27</sup> His approximate sleep opportunities are shown in figure 14. During those 2 days, he had a total of about 21.5 and 14.5 hours of available sleep opportunity, in segments between 1 and 13 hours long.

**Figure 14.** Bus driver's sleep opportunities in the 2 days before the crash.

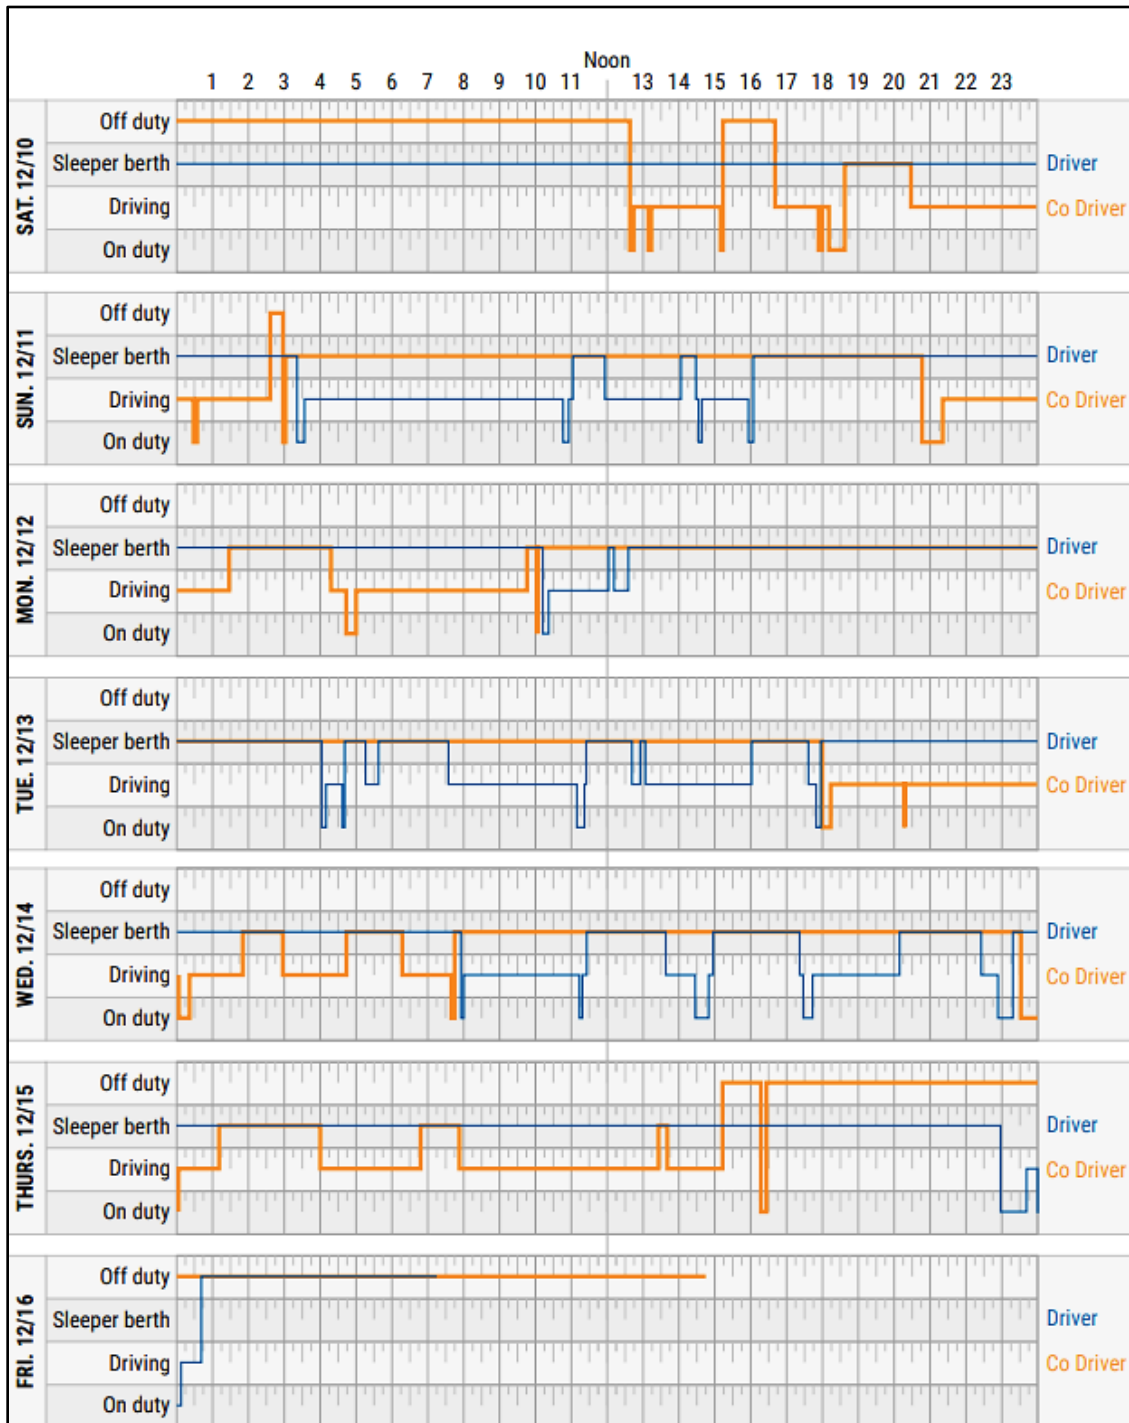
At the time of the crash, the ELD was functioning and connected to the truck-tractor and showed accurate driving and stopped times, location, and other telematics information. The data from the ELD (that is, both the driver and codriver hours) are shown in figure 15 (note that the figure shows the time in central standard time, whereas the crash occurred in the eastern time zone).

**Figure 15.** Record of duty status for the crash-involved driver and alleged codriver (times are recorded in central standard time).
