PRELIMINARY REPORT HIGHWAY HWY19MH001

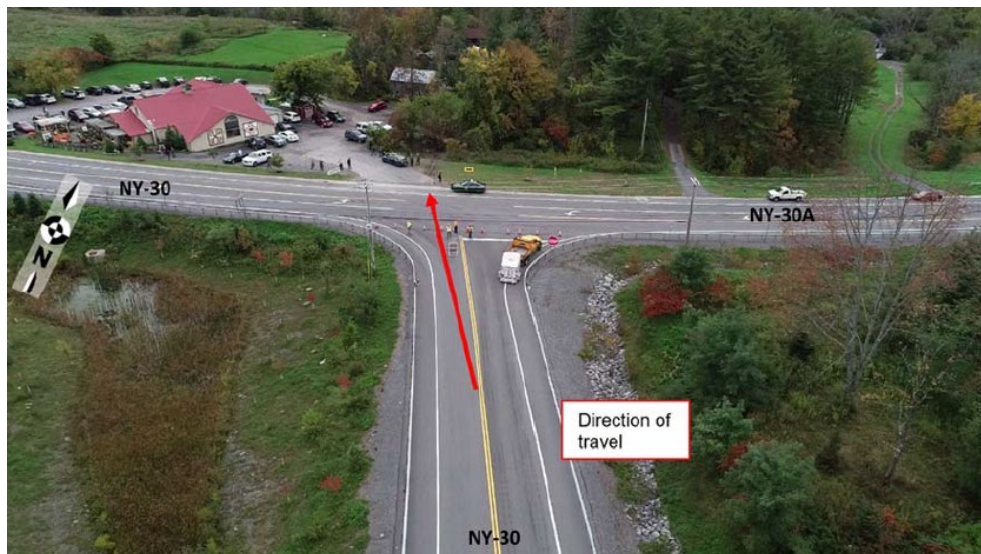
Figure 1. Crash location south of intersection of NY-30 and NY-30A; the limousine's collision with a parked SUV occurred in the parking lot, followed by collision in the ravine.
