NATIONAL TRANSPORTATION SAFETY BOARD

SPECIAL INVESTIGATION REPORT

**PHOSPHORUS TRICHLORIDE RELEASE
IN BOSTON AND MAINE YARD 8
DURING SWITCHING OPERATIONS
SOMERVILLE, MASSACHUSETTS
APRIL 3, 1980**

NTSB-HZM-81-1

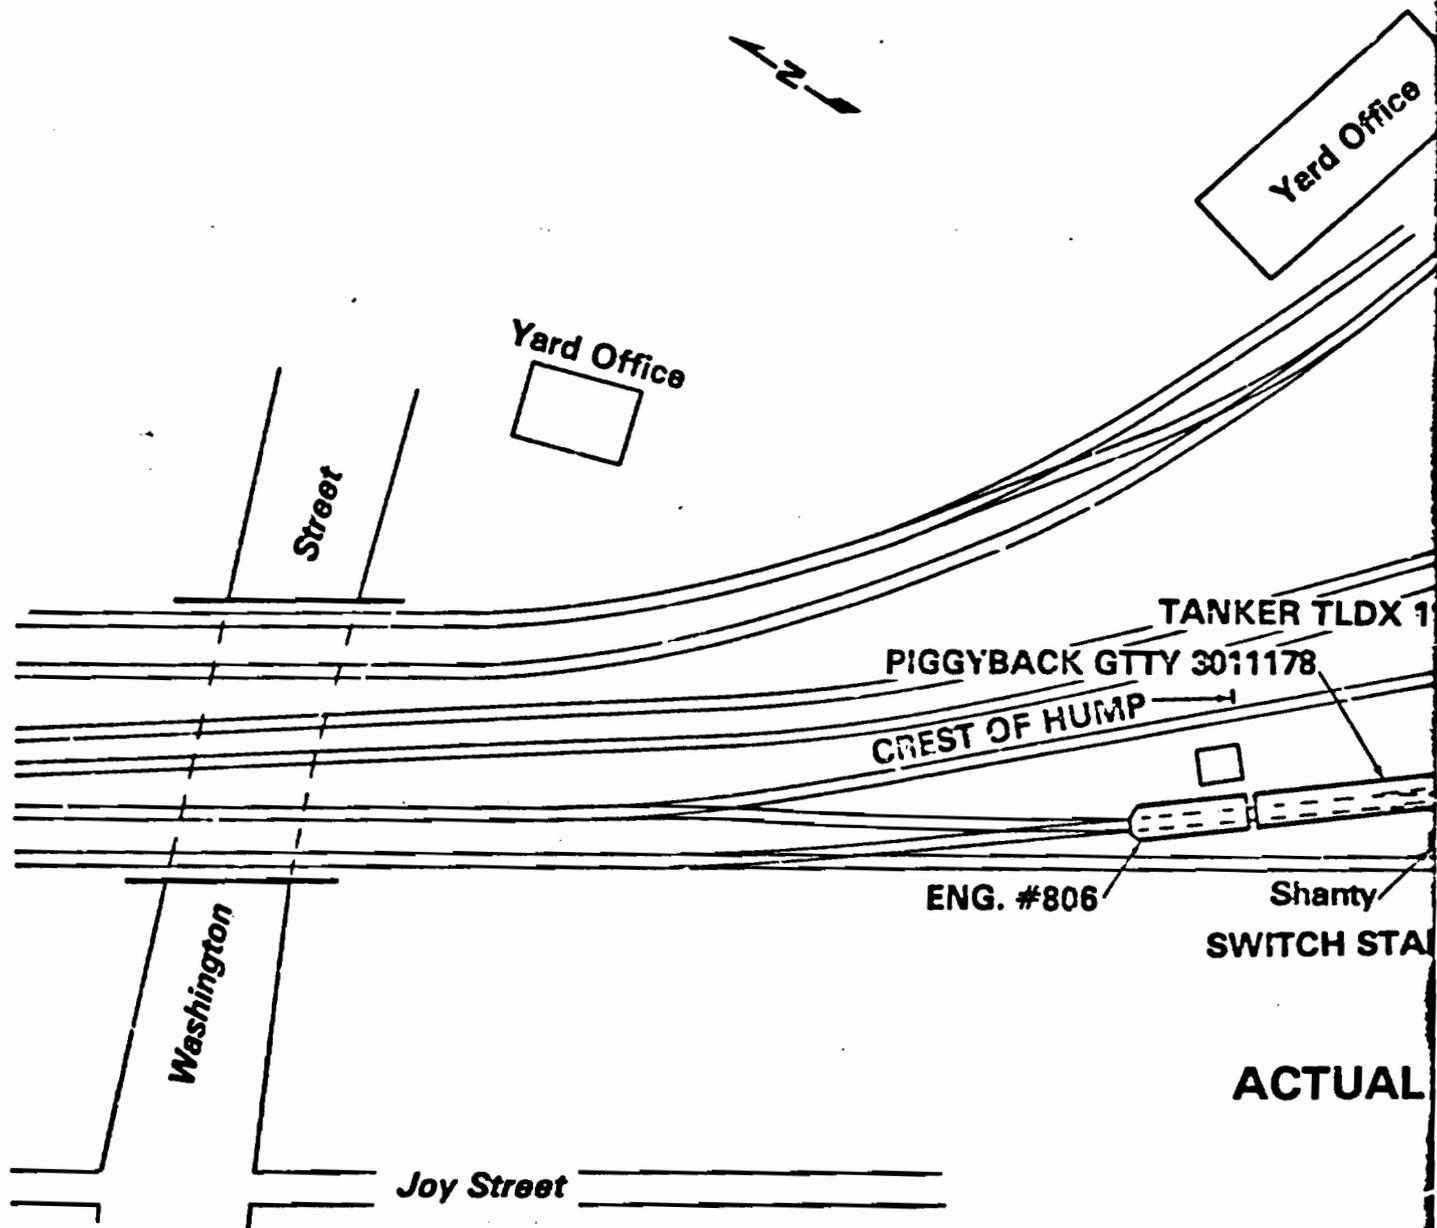
URE 1.--ACCIDENT SCENE

About 9 a.m., e.s.t., April 3, 1980, a Boston and Maine Corporation (BM) Boston switcher (1740) consisting of a locomotive and 38 cars collided, while moving at a speed of 4 mph, with a standing draft of cars in Somerville Yard 8 at Somerville, Massachusetts. (See figures 1 and 2.) The locomotive struck and punctured tank car TLDX 113009, the second car of the standing draft; the tank car contained about 13,000 gallons of phosphorus trichloride (PCl₃), a hazardous material classified by DOT as a corrosive liquid. The product spilled onto the moist ground and created a cloud, which ultimately necessitated an evacuation of a 1 1/2 square mile area containing 23,000 people. During the first 48 hours of the emergency, 418 persons were treated at the Somerville hospital. Damage to train equipment amounted to \$8,100 and cleanup costs were reported to be \$130,253.

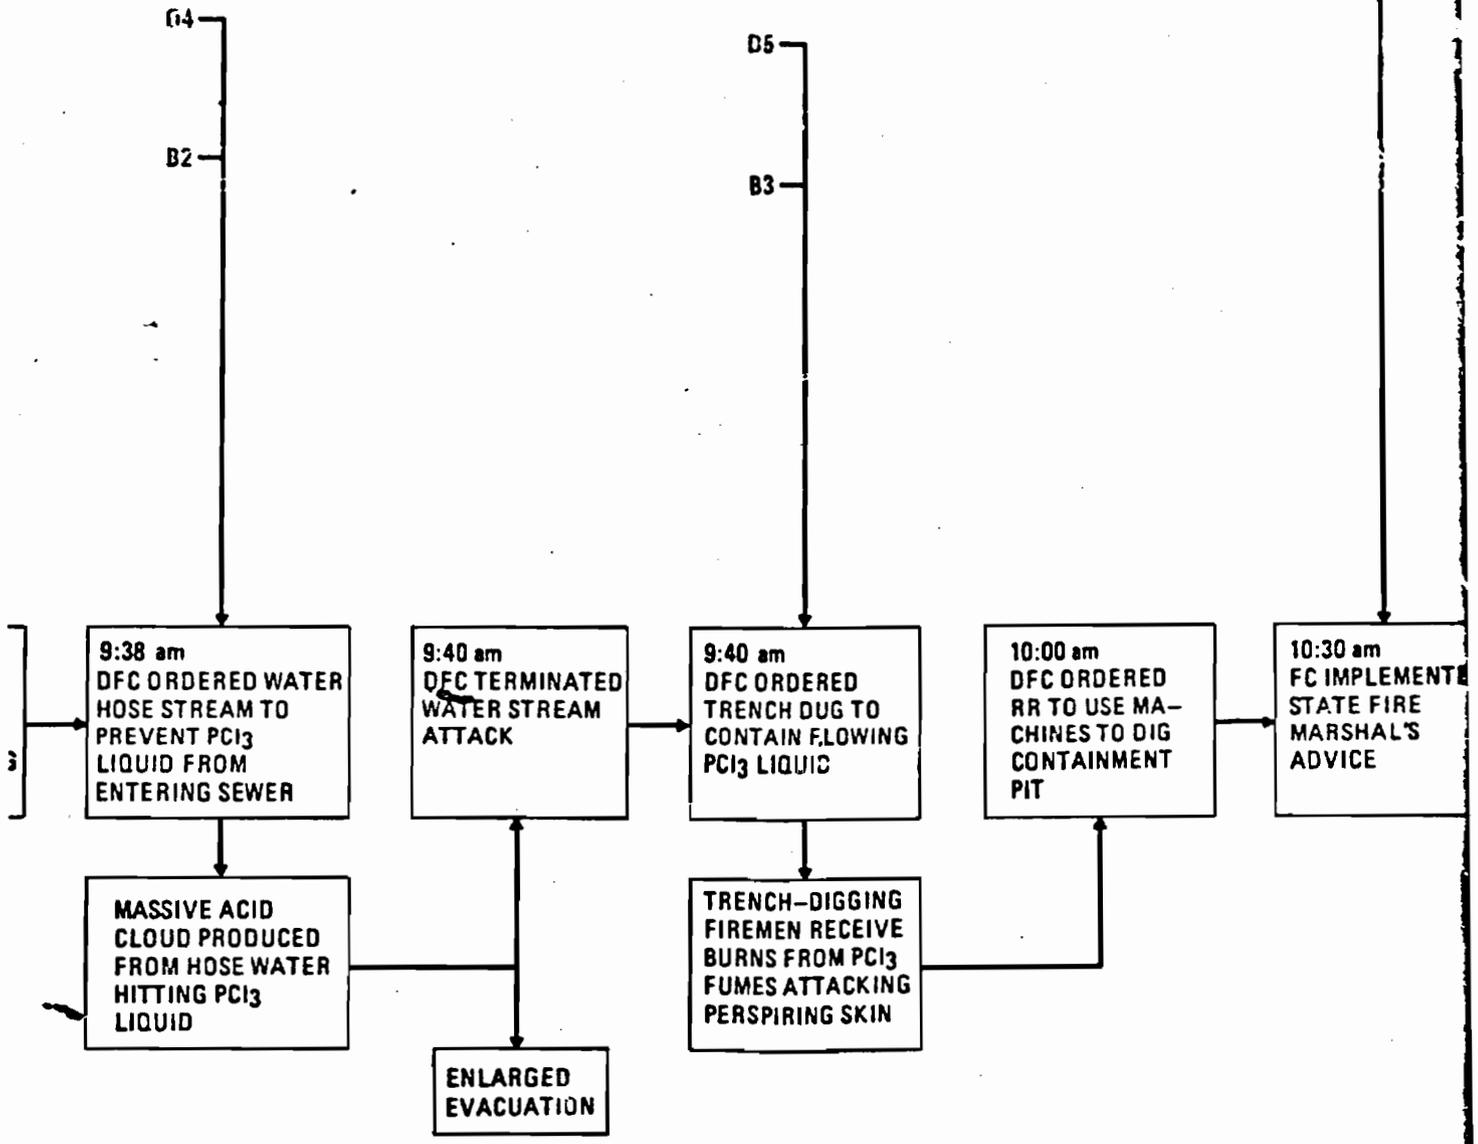
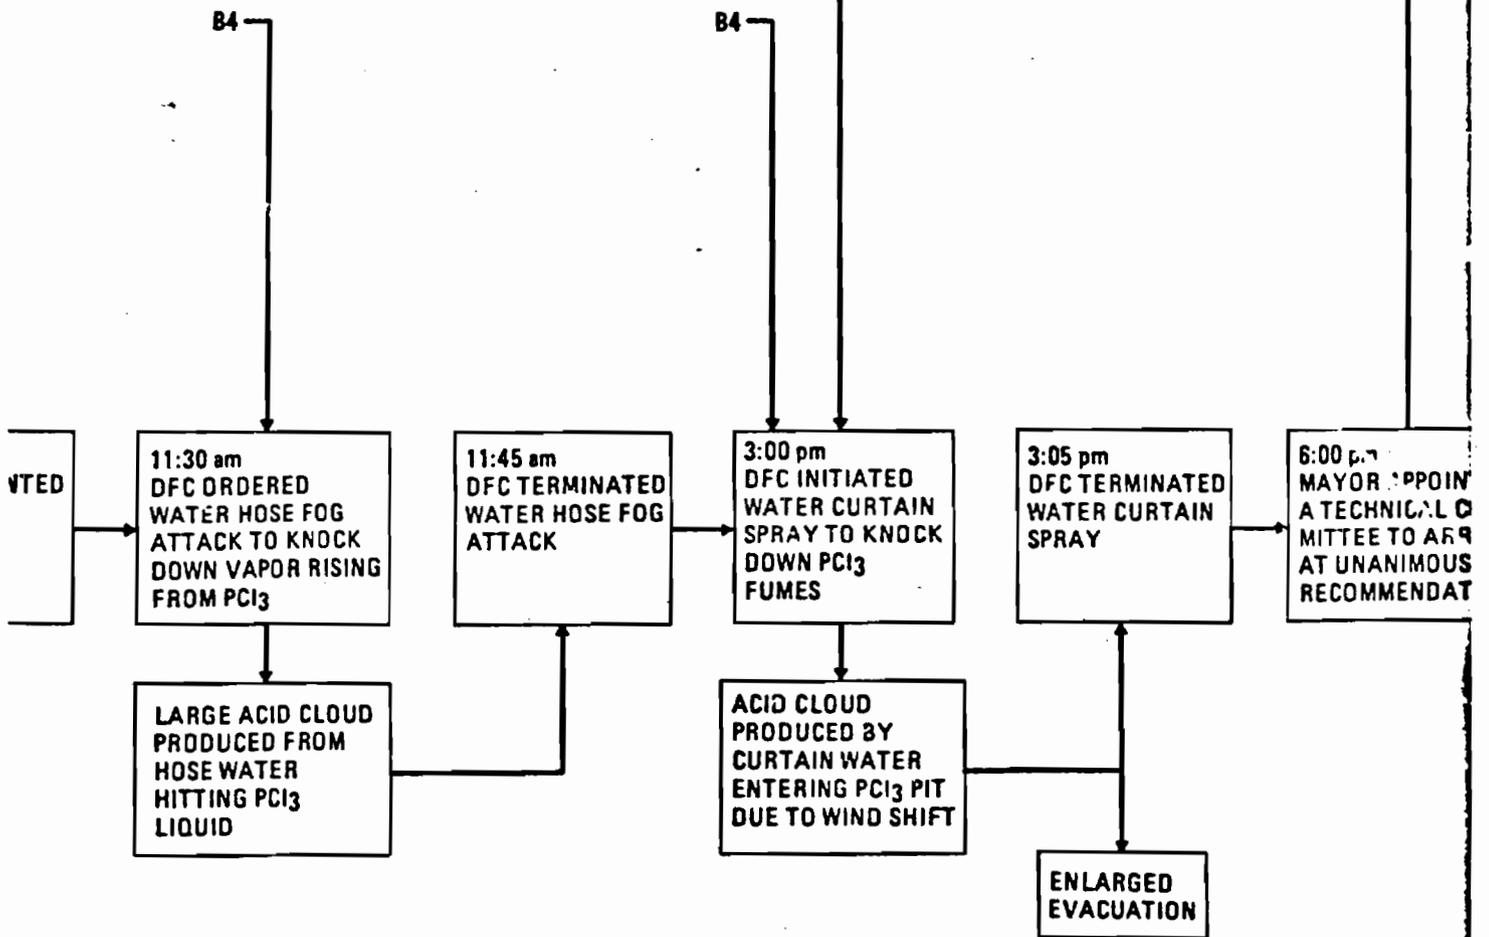
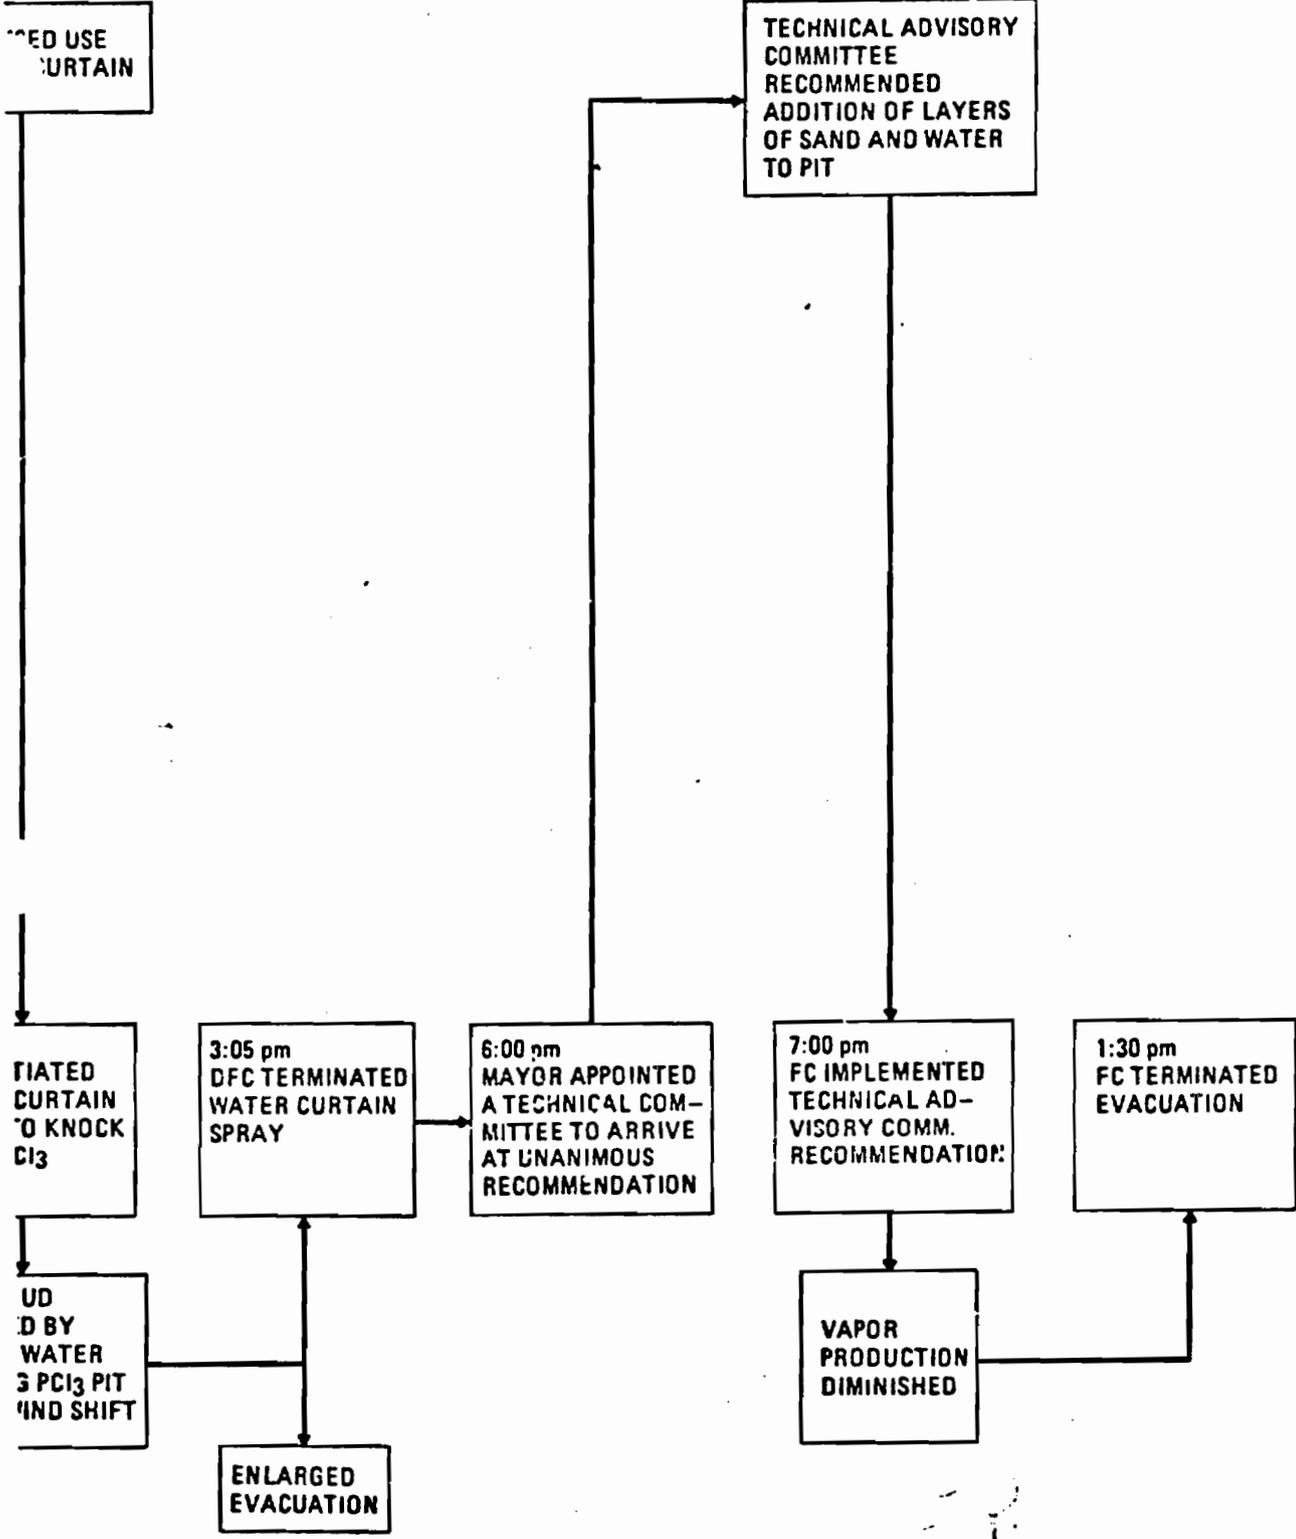
STATE FIRE MARSHAL
RECOMMENDED
EVACUATION

MONSANTO ADVISED
WASHING DOWN AREA

EPA ADVISED USE
OF WATER CURTAIN
