National Transportation Safety Board
Washington, D.C. 20594

Marine Accident Brief No. DCA 99MM024

**Collision of Two Recreational Motorboats on the
St. Croix River near Bayport, MN
July 3, 1999**

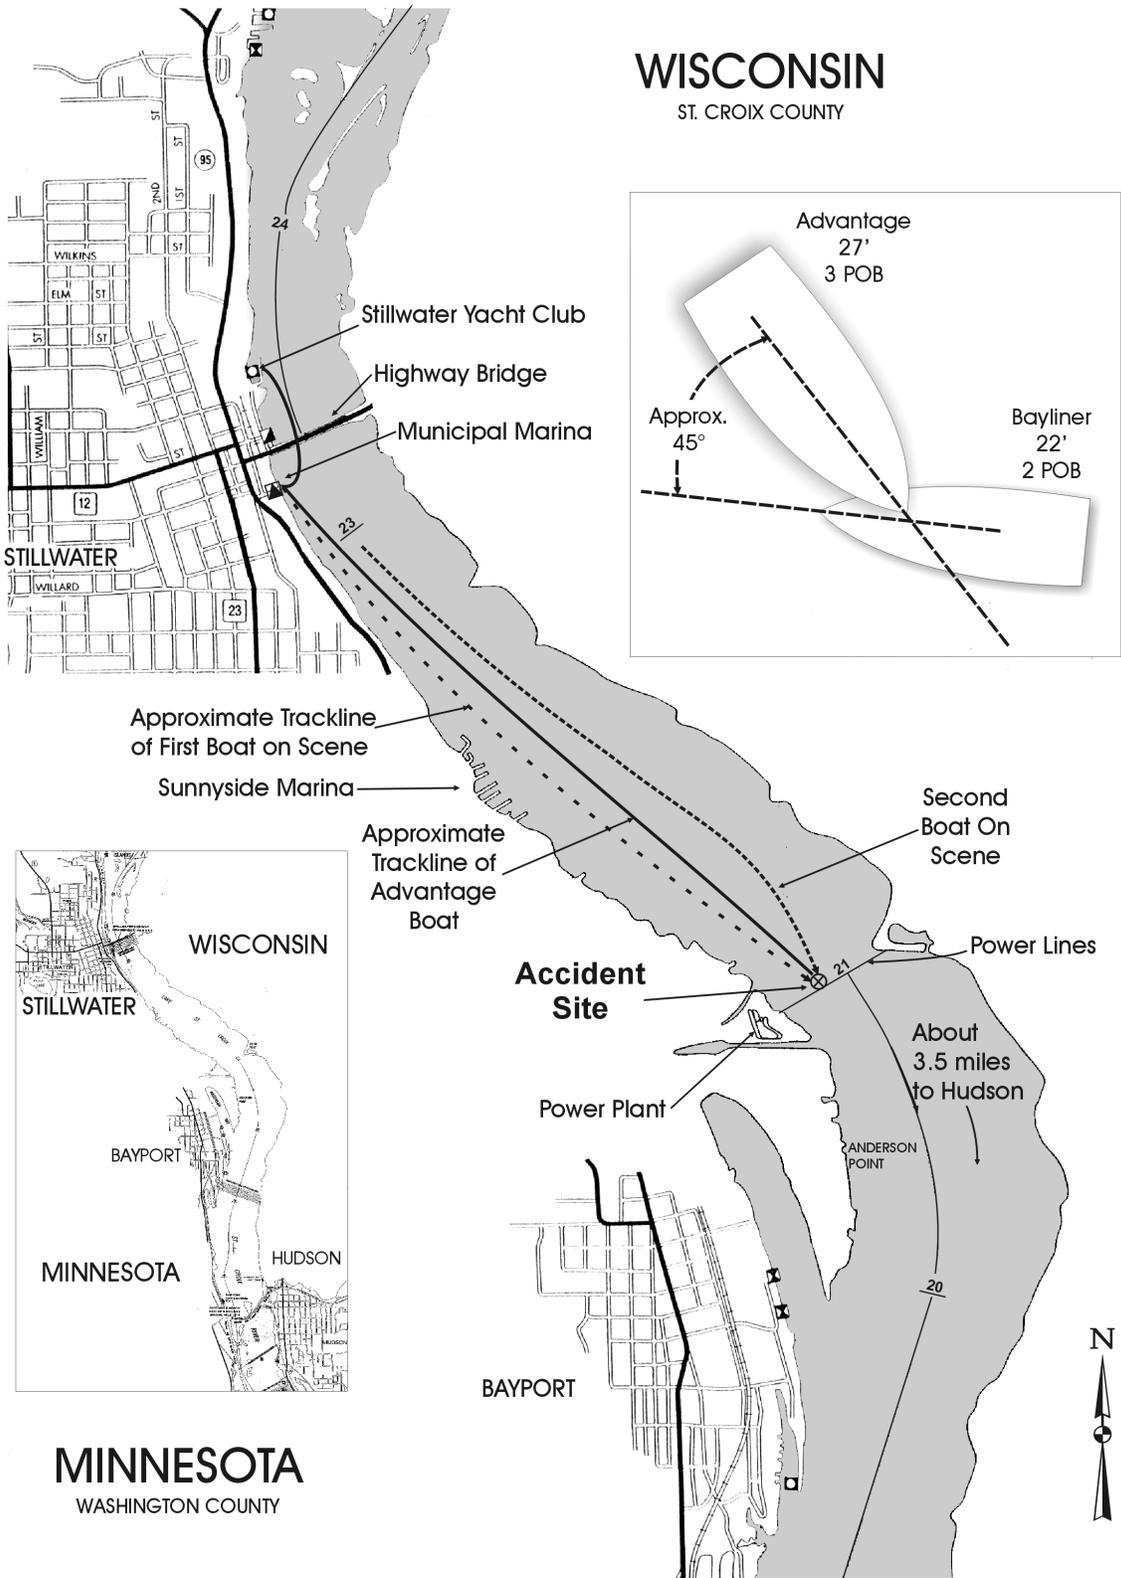
Figure 1. Accident Site

About 0125 on July 3, 1999, a 27-foot Advantage recreational motorboat (Advantage) with three men on board and a 22-foot Bayliner recreational motorboat (Bayliner) with two men on board collided on the St. Croix River near Bayport, Minnesota. (See figure 1.) No one witnessed the accident; however, the damage path across the top of the Bayliner indicated that the Advantage struck the starboard side of the Bayliner, forward of the windshield, and passed over the motorboat. All five occupants of the two motorboats died as a result of the collision. The three occupants of the Advantage died from drowning. The two occupants of the Bayliner died from blunt force trauma.
