## Marine Accident Brief

**Accident No.:** DCA-05-MM-008

**Vessel:** Malaysian-registered bulk carrier M/V *Selendang Ayu*, International Maritime Organization No. 9145528, 738 feet long, 39,755 gross tons, steel construction, built in 1998

**Accident Type:** Loss of power with subsequent grounding

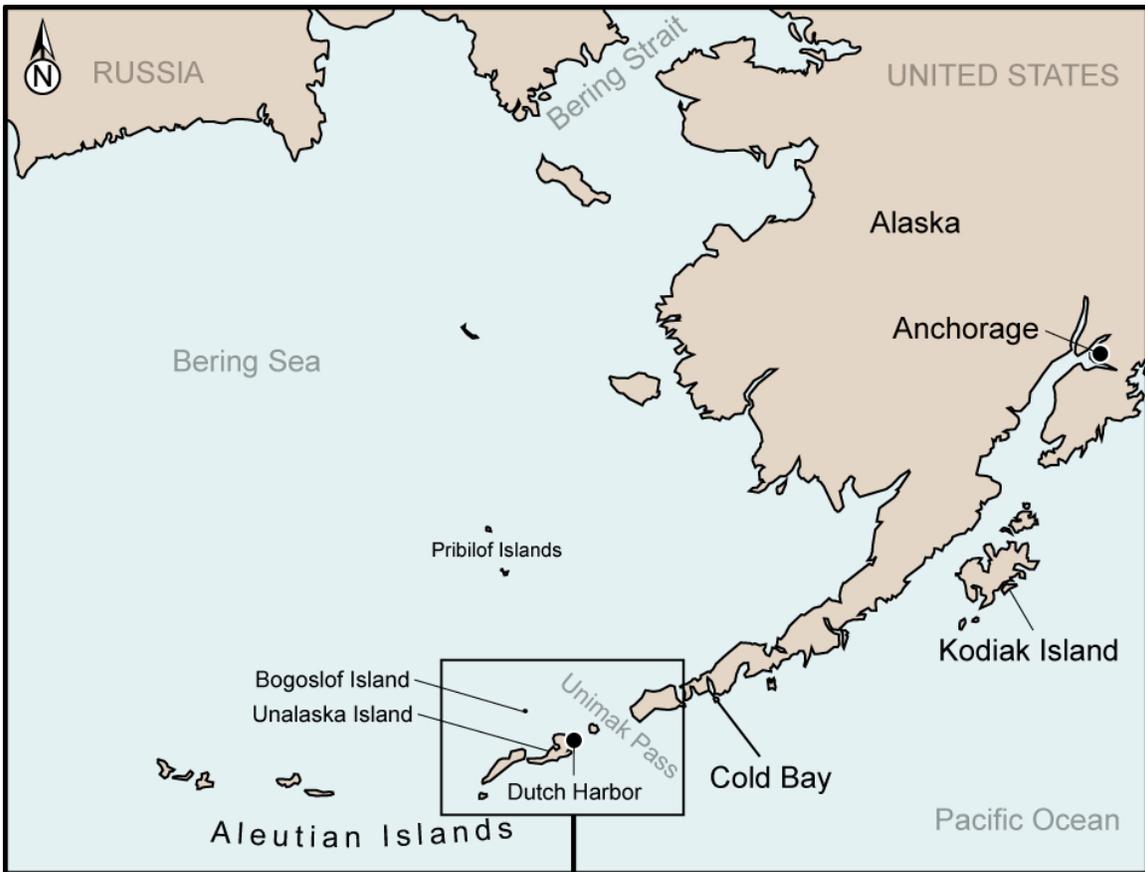
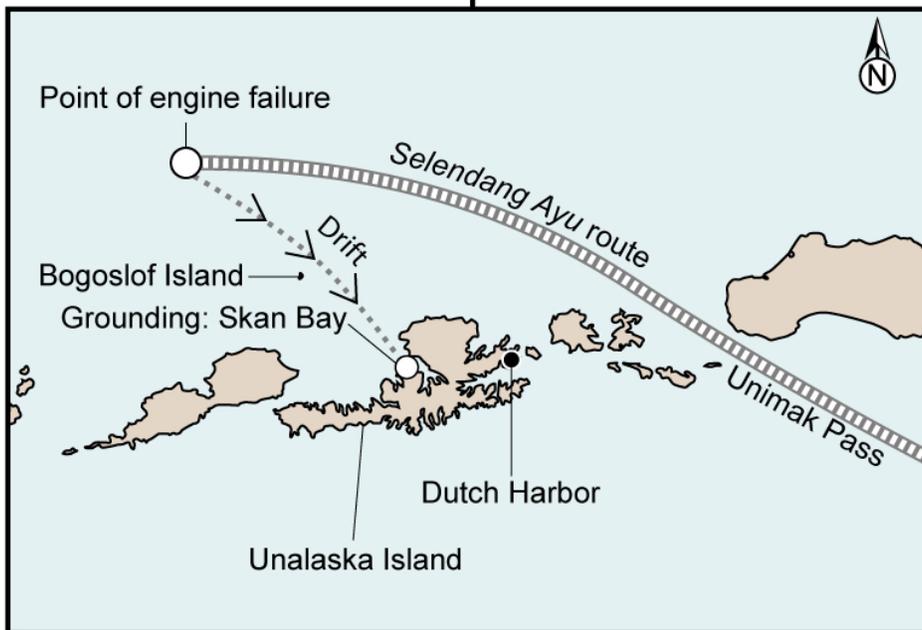
**Figure 1.** Accident location in Bering Sea. Inset shows route of *Selendang Ayu* through Unimak Pass, approximate point at which engine failed, path of vessel's drift without power, and site on Unalaska Island where it grounded.

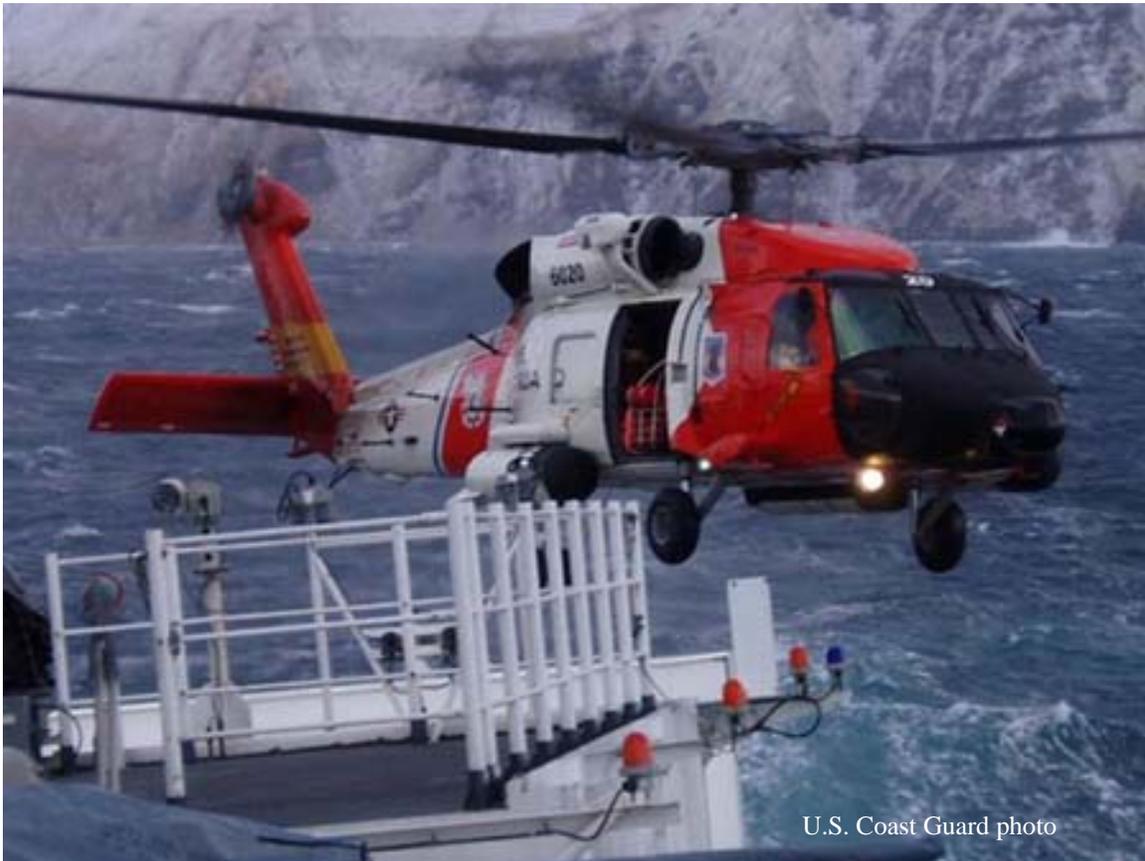
**Figure 4.** Coast Guard HH-60 Jayhawk helicopter hovering above *Alex Haley*'s deck during rescue of *Selendang Ayu* crew.
