National Transportation Safety Board

Marine Accident Brief

Accident No.: DCA-09-LM-010

Vessel: U.S. commercial fishing vessel *Lady Mary*, official number 520834, 76-foot length overall (71.2-foot documented length), 105 gross registered tons, 21.2-foot beam steel construction, built 1969, converted 2001

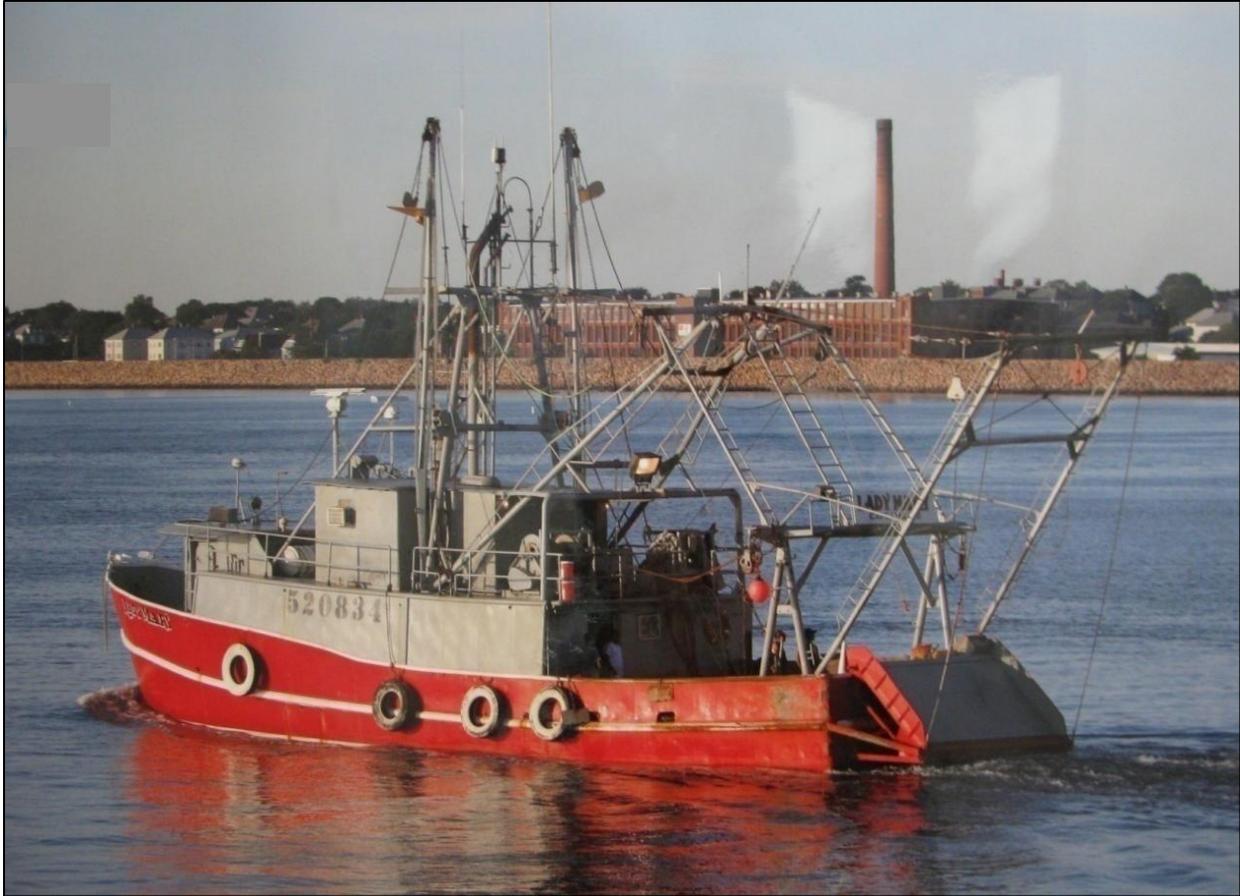
Figure 1. Fishing vessel *Lady Mary* outbound from New Bedford, Massachusetts, July 2006. (Photo by Steven Kennedy of *Commercial Fisheries News*)

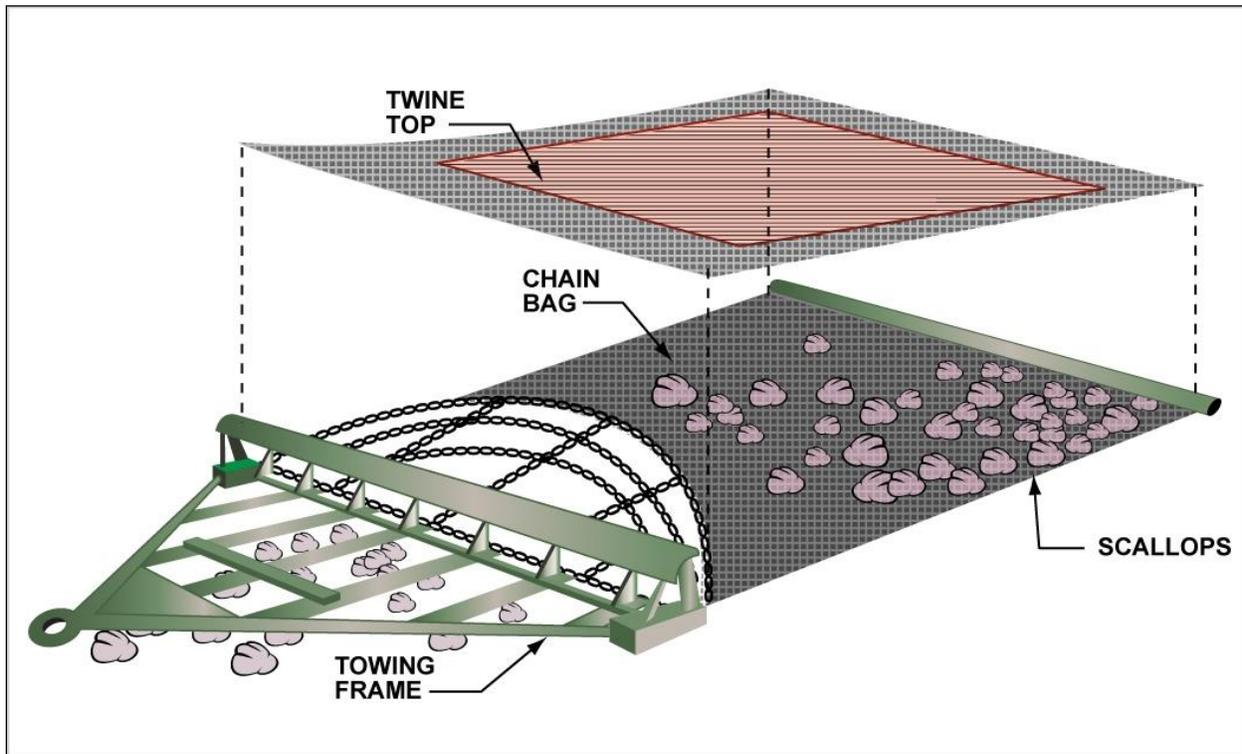
The vessel's shrimp net was also replaced with a scallop dredge. The dredge consisted of a heavy steel towing frame and a chain bag that dragged along the ocean floor behind the vessel (figure 5). At the end of a towsing run, the crew would hoist the dredge on board, empty the bag, and shuck the scallops while the dredge was being towed again. The shucked scallops were kept on ice in the vessel's fish hold awaiting transport to shore.

Figure 5. Scallop dredge, with twine top removed for illustrative purposes. Front of towing frame rides off sea floor, chain bag drags on bottom, and bar at rear maintains bag's shape.⁸
