National Transportation Safety Board

Marine Accident Brief

Dockside Capsizing and Sinking of Towing Vessel *Invader* and *Dry Dock #3*

Accident no.	DCA-12-LM-013
Accident type	Capsizing and sinking
Vessels	Uninspected towing vessel <i>Invader</i> and <i>Dry Dock #3</i>
Location	Vigor Industrial Shipyard, Port of Everett, Washington (47°58.904' N, 122°13.101' W)
Date	March 18, 2012
Time	0630 Pacific standard time (UTC -8)
Injuries	None
Property damage	<i>Invader</i> : More than \$5 million <i>Dry Dock #3</i> : \$818,000
Environmental damage	Minor
Weather	Mostly cloudy with a trace of rain; east winds at about 5 mph; air temperature about 40° F
Waterway characteristics	Port Gardner Bay, eastern Puget Sound, Washington (see NOAA chart 18444 for additional information)

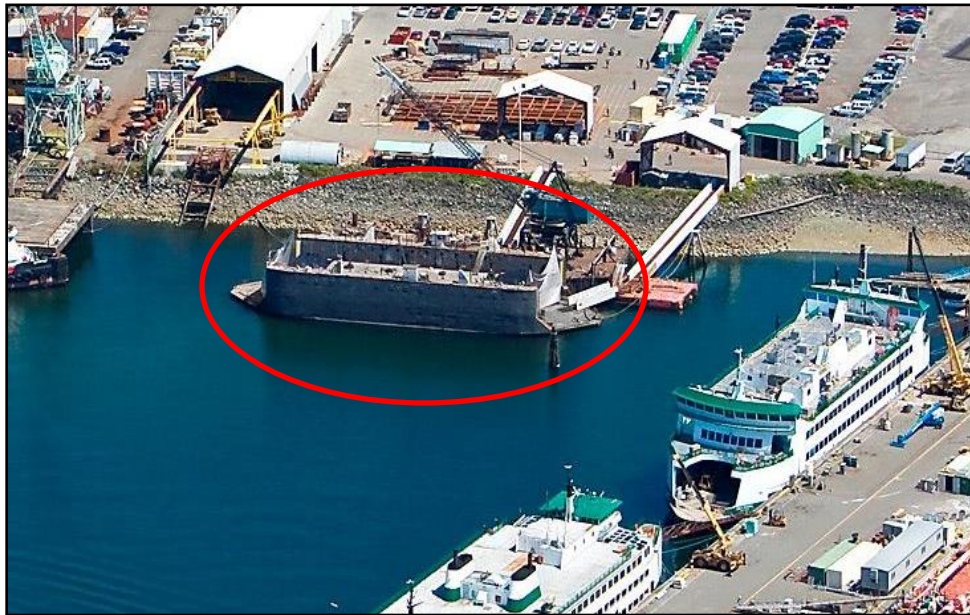
Aerial View of Dry Dock #3 at Port of Everett. (Photo by Vigor Industrial, LLC)

Dry Dock #3 had eight symmetrical ballast tanks, four on each side of the centerline, with similar design and capacity. Each of these eight tanks had an access manhole from the floor of the dry dock pontoon. The tanks were equipped with independent electric pumps, valves for flooding and discharge, and piping for pumping single or multiple tanks. Each tank had an overboard discharge for the pumps. The discharge line included a cast iron check valve bolted directly to, and inboard of, a manually-operated discharge valve located about 8 feet above the keel in the dry dock's side shell.
