# National Transportation Safety Board

## Marine Accident Brief

### Foundering of the Fishing Vessel *Moonlight Maid*

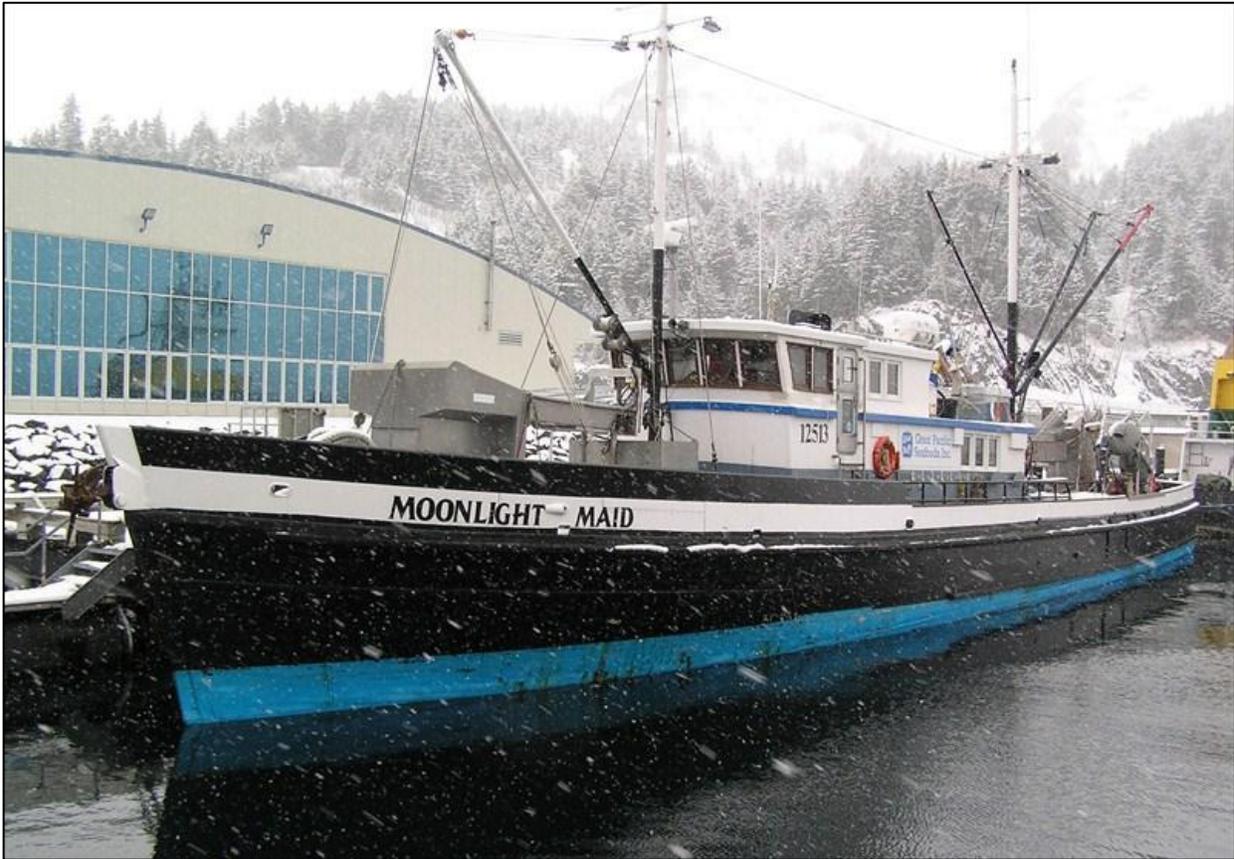
Fishing vessel *Moonlight Maid* docked in Whittier, Alaska, in March 2011.  
(Photo © Clayton M. Paddock, [www.marinetraffic.com](http://www.marinetraffic.com))
