National Transportation Safety Board

Marine Accident Brief

Allision of Tanker *Wawasan Ruby* with CSX Bayside Coal Pier

Accident no.	DCA-12-LM-025
Vessel name	<i>Wawasan Ruby</i>
Accident type	Allision
Location	CSX Bayside Coal Pier, Curtis Bay coal facility, Baltimore, Maryland 39° 13.30' N, 76° 34.57' W
Date	August 25, 2012
Time	1245 eastern daylight time (coordinated universal time –4 hours)
Injuries	One worker on the pier sustained moderate back and shoulder injuries
Damage	Pier: More than \$2 million; <i>Wawasan Ruby</i> : \$15,000
Environmental damage	None
Weather	Partly cloudy; good visibility; winds out of the east at 10 knots; air temperature 77°F
Waterway information	Baltimore Harbor, Curtis Bay, Curtis Bay Channel

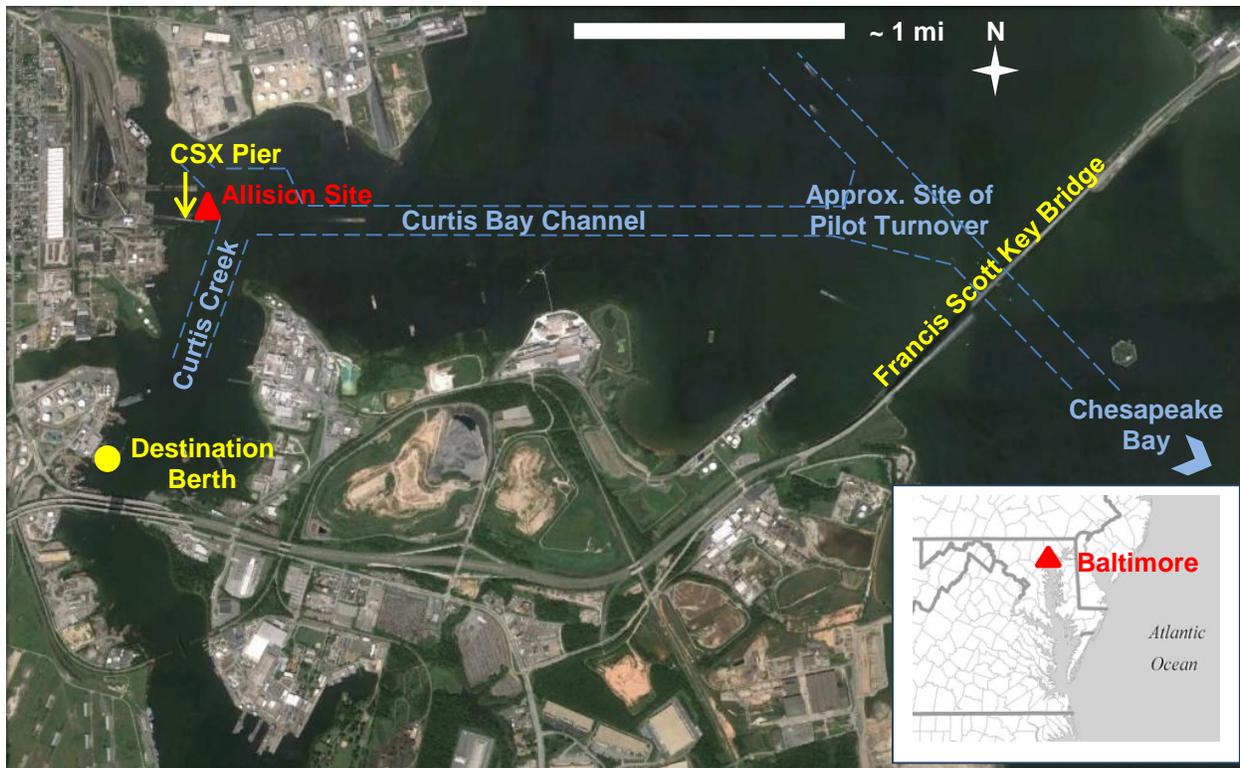
Aerial view of the accident area. (Background by Google Earth)

As the *Wawasan Ruby* approached the turn from the Curtis Bay Channel into Curtis Creek, the pilot ordered the engine to dead slow ahead and shortly thereafter gave a rudder order of starboard 10 degrees. The pilot later told investigators that he maneuvered the ship to the starboard side of the channel to give maximum room for the port turn into Curtis Creek. Also, before turning, he informed the master of his intention, and the master did not object. The ship was proceeding at 9.6 knots at the time. Less than a minute after the starboard 10-degree order, the pilot ordered midship, then port 20 degrees, and then quickly hard to port. The pilot told investigators that he gave these orders within a minute because he realized that the vessel's bow was not turning fast enough to port. He also initially ordered the assist tugboat that had been trailing the ship to come up and push on the vessel's port quarter to aid in the port turn attempt.
