National Transportation Safety Board

Marine Accident Brief

Grounding and Sinking of the Harbor Tug *Kaleen McAllister*

Accident no.	DCA13LM020
Vessel name	<i>Kaleen McAllister</i>
Accident type	Grounding and sinking
Location	Northwest Harbor, Baltimore, Maryland (39°16'9.38" N, 76°34'47.73" W)
Date	May 4, 2013
Time	1951 eastern daylight time (coordinated universal time – 4 hours)
Injuries	None
Damage	Est. \$1.5 million in repair costs
Environmental damage	Est. 2,400 gallons of marine diesel fuel discharged to the harbor
Weather and sea conditions	Clear skies, winds northeast 14 to 18 knots, air temperature 61°F, water temperature 61°F, mean wave height 1 foot, tide ebbing (1 foot higher than predicted)
Astronomical data	Sunset 2003, civil twilight ending 2032 eastern daylight time
Waterway	Patapsco River, sheltered harbor channel

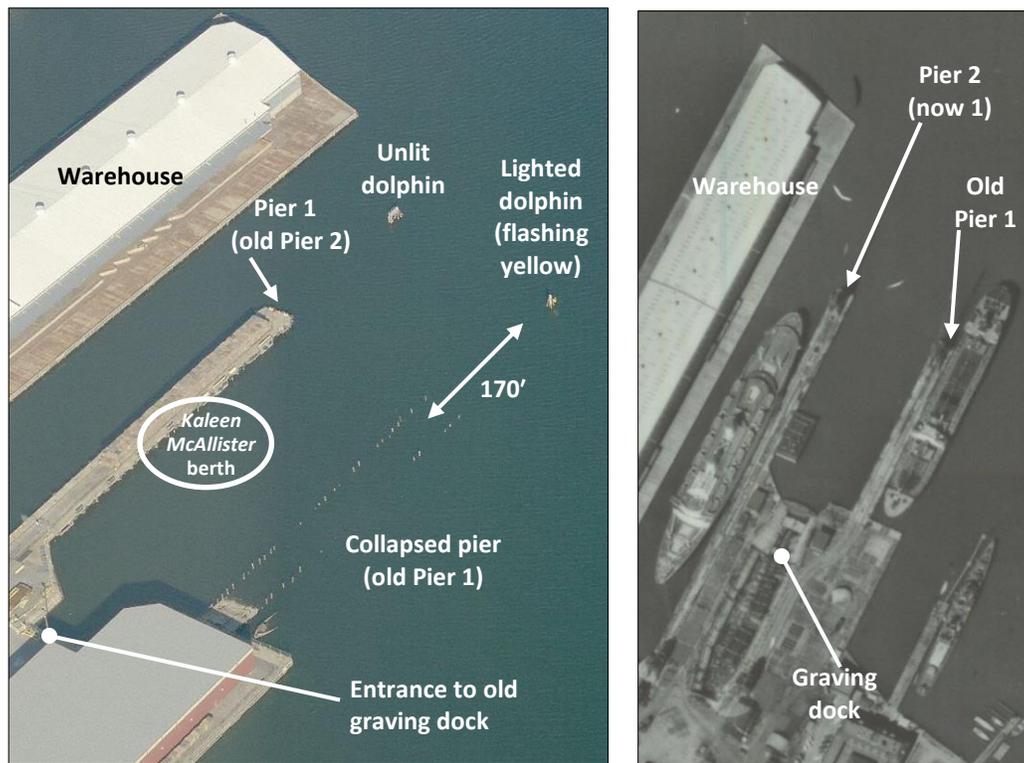
Left, aerial view looking north of the accident area in 2012 (photo by Bing Maps). Right, piers 1 and 2 associated with a graving dock in 1972 (photo from John Hopkins University, <https://jscholarship.library.jhu.edu/>).

McAllister harbor tow operations had recently moved to the property near the accident location. In July 2011, McAllister towing contracted for berthing its Baltimore Harbor towing vessels at what is now chartered as North Locust Point Pier 1. This pier was part of the Lower Yard of the Bethlehem Key Highway Shipyard and included a graving dock. The operating graving dock had an eastern Pier 1 and a western Pier 2.
