National Transportation Safety Board

Marine Accident Brief

Subsea Pipeline Damage by Tug and Barge *Valiant/Everglades*

Accident no.	DCA15LM003
Vessel name	Tug <i>Valiant</i> and barge <i>Everglades</i>
Accident type	Loss of propulsion/pipeline damage
Location	Gulf of Mexico about 120 nautical miles southeast of Galveston, Texas 28° 14' N, 92° 46' W
Date	November 17, 2014
Time	0600 central standard time (coordinated universal time – 6 hours)
Injuries	None
Damage	Natural gas pipeline: est. \$2 million
Environmental damage	None reported
Weather	Northerly wind 30 knots with gusts to 35 knots, visibility 8 nautical miles, wave height 8–10 feet
Waterway information	Gulf of Mexico, open water, East Cameron production field

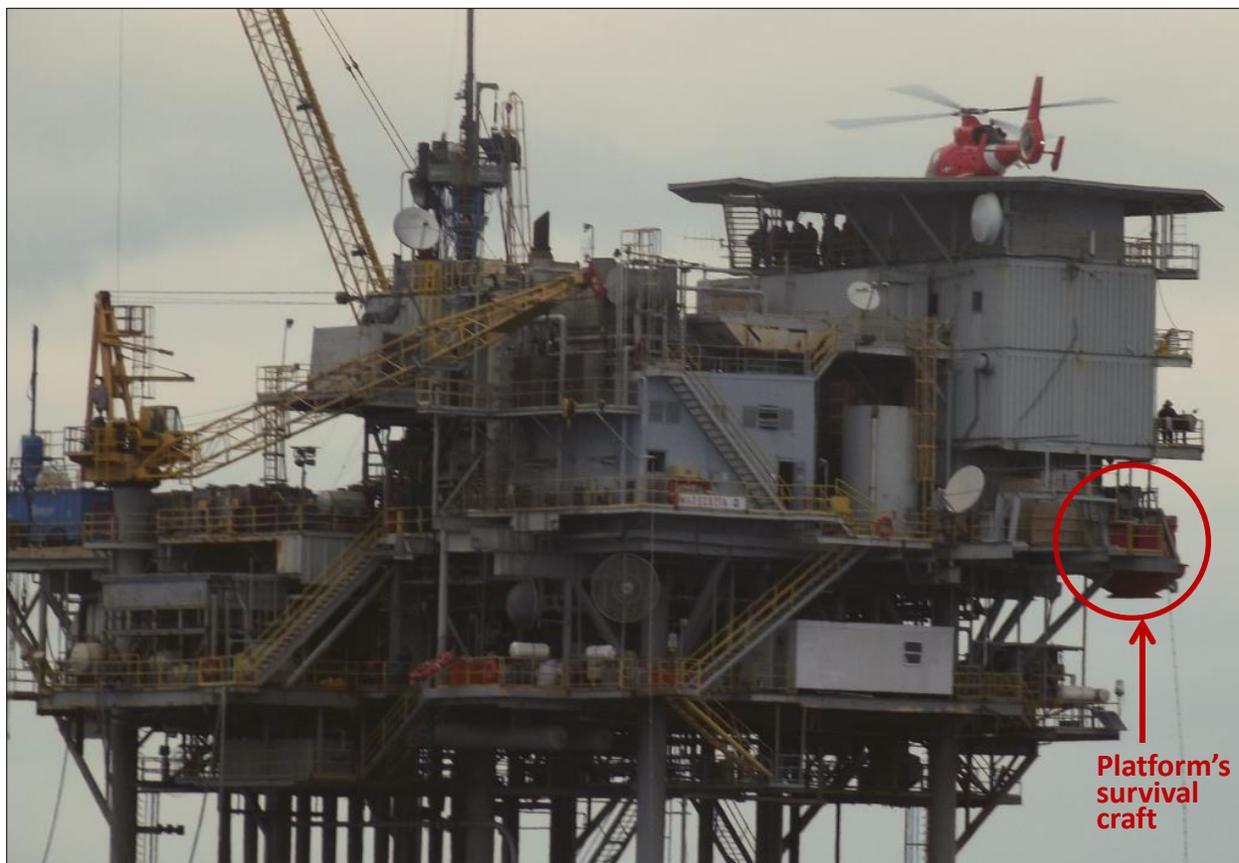
When the *Valiant* was about 500 feet from platform EC321A, the captain ordered the anchor let go. As the anchor began to fetch up on the bottom, the vessel's movement toward the platform began to slow. The captain then noticed air pressure building up and was able to start the port engine in astern propulsion, noting this was the best option to clear the platform. He momentarily ordered the rudders 10 degrees to port, but when this had no effect in clearing the bow from the platform, he went back hard to starboard. The starboard engine started moments later, and he backed on both engines. The anchor chain tightened, and he ordered more chain paid out and continued to back until the ATB was clear of the platform. A witness on EC321A estimated the *Valiant/Everglades* was about 20 yards from the platform at its closest point below the platform's survival craft.

Platform EC321A with Coast Guard HH-65 helicopter on deck and platform's survival craft at right. (Photo by Penny F crew)
