National Transportation Safety Board

Marine Accident Brief

Grounding and Sinking of Commercial Fishing Vessel *Titan*

Accident no.	DCA15LM007
Vessel name	<i>Titan</i>
Accident type	Grounding and sinking
Location	Jetty A off Cape Disappointment, Ilwaco, Washington, on the north side of the Columbia River bar, 46°15.8' N, 124°02.3' W
Date	December 5, 2014
Time	About 0215 Pacific standard time (coordinated universal time – 8 hours)
Injuries	None
Property damage	Total loss of vessel, estimated at \$1.825 million
Environmental damage	Unknown quantity of diesel, hydraulic, and lubricating oil on surface of water
Weather	Overcast skies, winds north-northeast at 10 to 20 knots, intermittent rain and mist, air temperature 48 to 49°F, dew point 45 to 47°F, water temperature 55°F, visibility more than 5 nautical miles, ebb current 1 to 2 knots (estimated)
Waterway information	The Columbia River runs along the border between Washington and Oregon and flows into the Pacific Ocean. At the mouth of the river are three rubble-mound jetties—the north jetty, south jetty, and jetty A—that are maintained by the US Army Corps of Engineers. These jetties are intended to minimize navigational channel

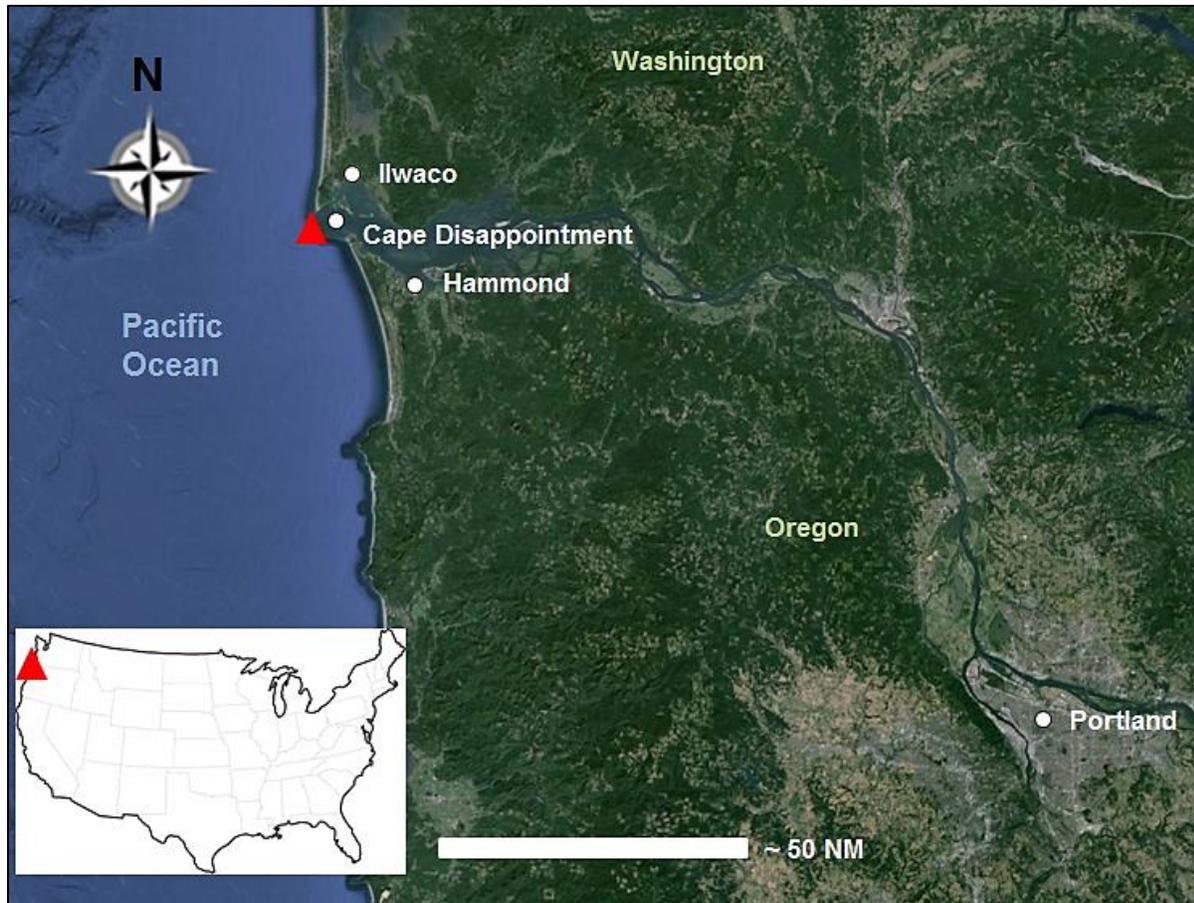
About 0215 Pacific standard time on December 5, 2014, the commercial fishing vessel *Titan* was proceeding outbound on the Columbia River when it grounded at the southern end of Jetty A off Cape Disappointment, Ilwaco, Washington. The vessel sustained hull damage and began to flood. Efforts to dewater the *Titan* were unsuccessful, and the five crewmembers abandoned the vessel after a US Coast Guard motor lifeboat arrived on scene. The *Titan* remained partially afloat by the stern and sank the next day. None of the *Titan*'s five crewmembers were injured. The *Titan* and its catch, an estimated 40,000 pounds of Dungeness crab, were declared a total loss. The vessel had an estimated 3,500 gallons of diesel oil, 700 gallons of hydraulic oil, and 400 gallons of lube oil on board. Oil sheens were sighted after the vessel sank. The vessel was not salvaged or recovered.

Site of the grounding and sinking of the *Titan*. (Background by Google Earth)
