National Transportation Safety Board

Marine Accident Brief

Collision between the Tows of Towing Vessels *Capt. Shorty C* and *Jackie*

Accident no.	DCA15FM027
Vessel names	<i>Capt. Shorty C</i> , Kirby 29116, Kirby 30040B, <i>Jackie</i> , EMS 343, and EMS 344
Accident type	Collision
Location	Gulf Intracoastal Waterway, mile marker 349.5, Port Bolivar, Texas; 29°22.2 N, 094°47.1 W, between buoys 17 and 19
Date	July 20, 2015
Time	0102 central daylight time (coordinated universal time – 5 hours)
Injuries	None
Damage	Estimated \$608,000
Environmental damage	None reported
Weather	Clear night, winds about 10 knots from the west-southwest
Waterway information	Entrance to Gulf Intracoastal Waterway, Galveston Bay, Texas

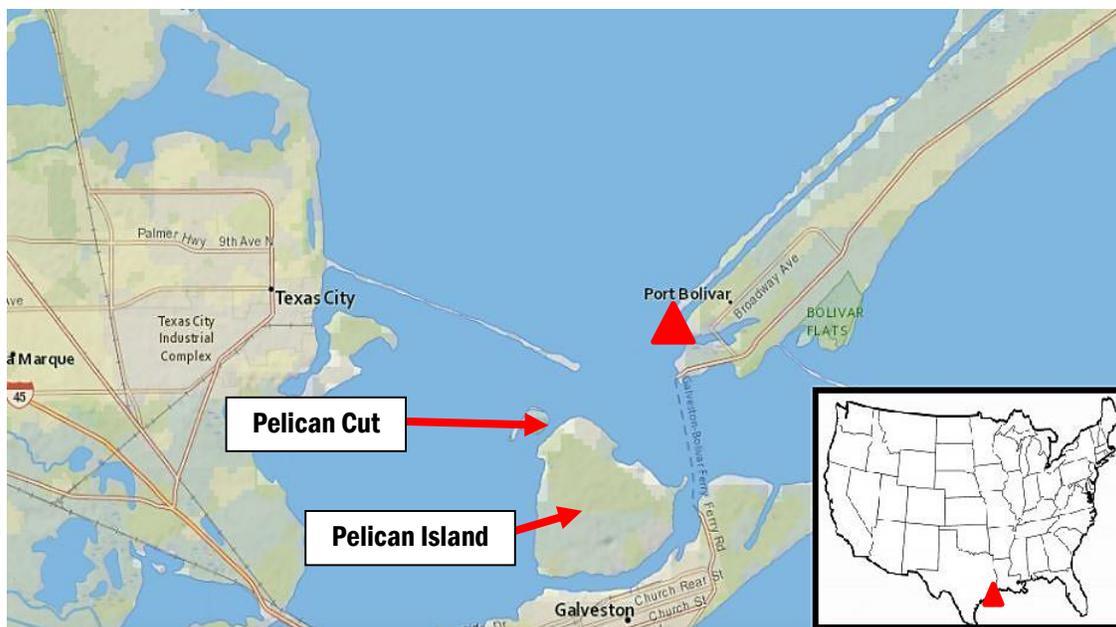
**Map of Galveston Bay with red triangles depicting the accident location.
(Image from National Geographic MapMaker Interactive)**
