National Transportation Safety Board

Marine Accident Brief

Fire on board Fishing Vessel *Northern Pride*, with Subsequent Capsizing

NTSB/MAB-16/12

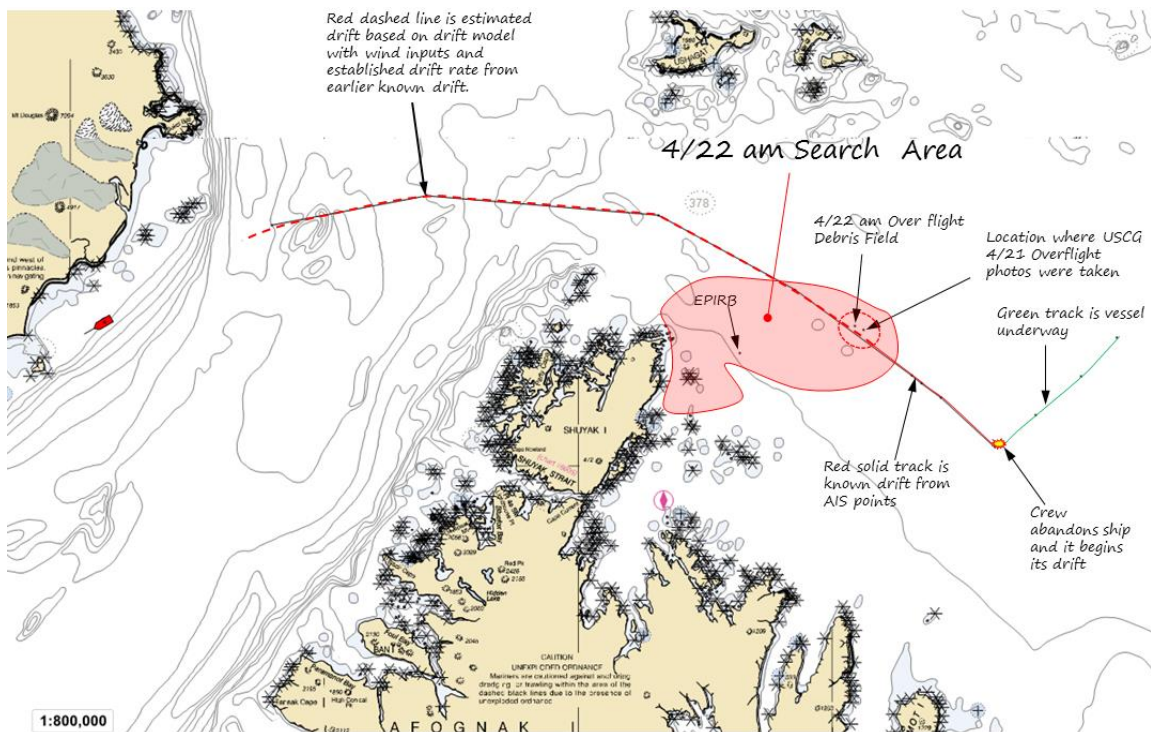
About 1445, the *Northern Pride* capsized but did not sink. The overturned vessel drifted northwest towards the Shakun Islets as depicted in the chart image below. On May 7, the *Northern Pride*'s splintered hull washed ashore at Cape Chiniak within Katmai National Park, Alaska. All superstructure above the main deck was missing. Planking and vessel debris extended south of the wreck several hundred yards along the shore. A hull examination by a salvage company found all that remained attached were the main propulsion engines and fuel, potable water, and chill water tanks. All tanks were inspected through tank fittings, manhole covers, or piping. They were found to be either empty or have trace amounts of fuel mixed with seawater. Residual lubrication and diesel oil remained in the engine.

Coast Guard chart showing the location where *Northern Pride* capsized, the rescue site, and the estimated track line of the drifting capsized vessel.
